EQUIPMENT INSPECTION / EVALUATION REPORT

MORRIS DAM INLET/OUTLET WORKS
MODERNIZATION
County of Los Angeles
Department of Public Works

MECHANICAL EXAMINATION REPORT

Morris Dam Inlet/Outlet Works Modernization

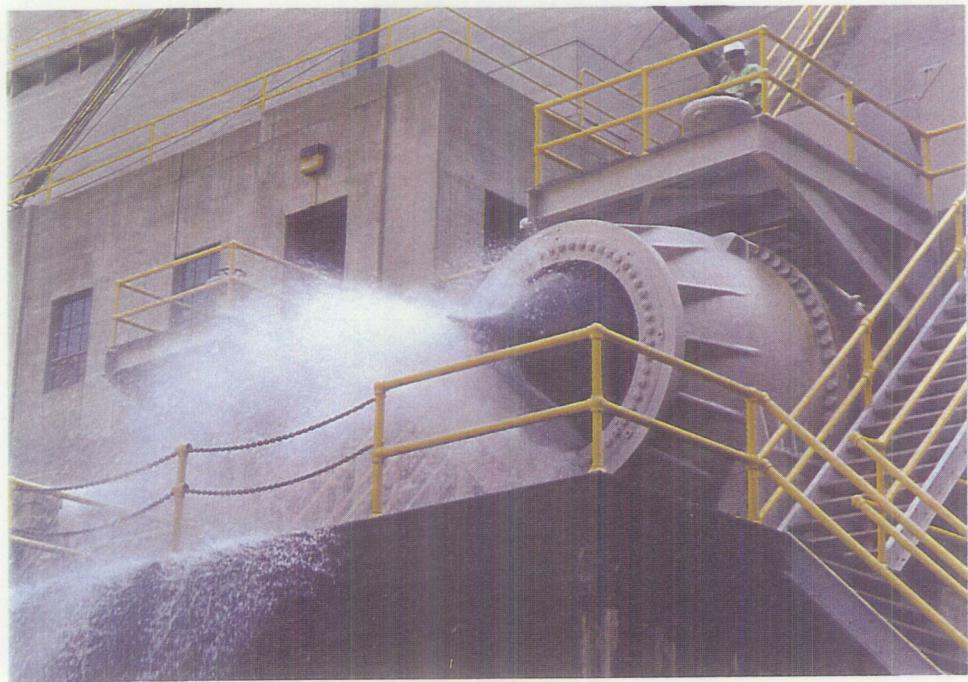
Photo 1 - Morris Dam - Needle Valve 1 - View of needle valve leakage
under full head.
07/01/98

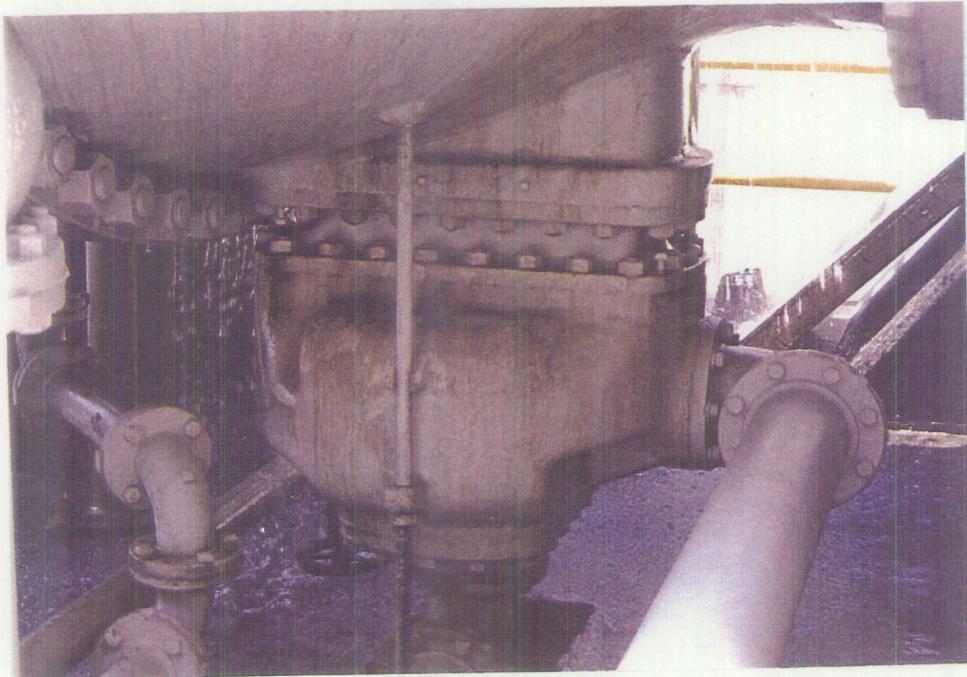
Photo 4 - Morris Dam - Needle Valve 1 - View of needle valve paradox
valve and high pressure water pipe. Note leakage from valve is from air
vent manifold at top.
07/01/98

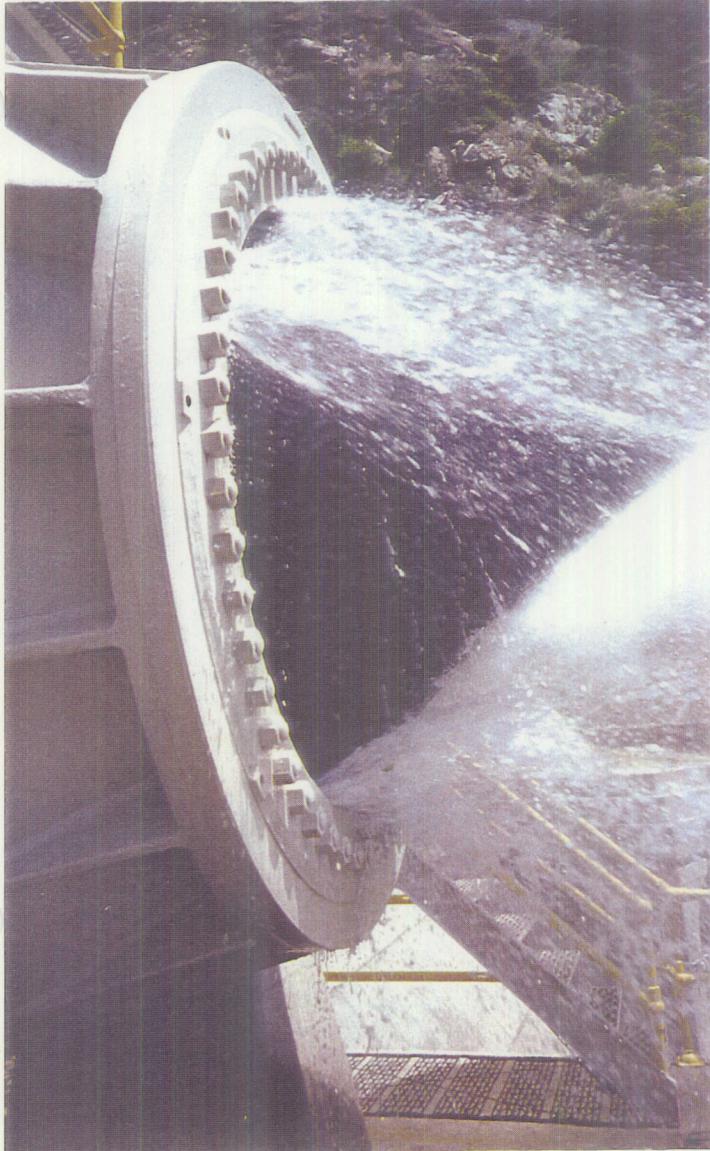
Photo 5 - Morris Dam - Needle Valve 1 -
View of needle valve leakage at full head.
07/01/98

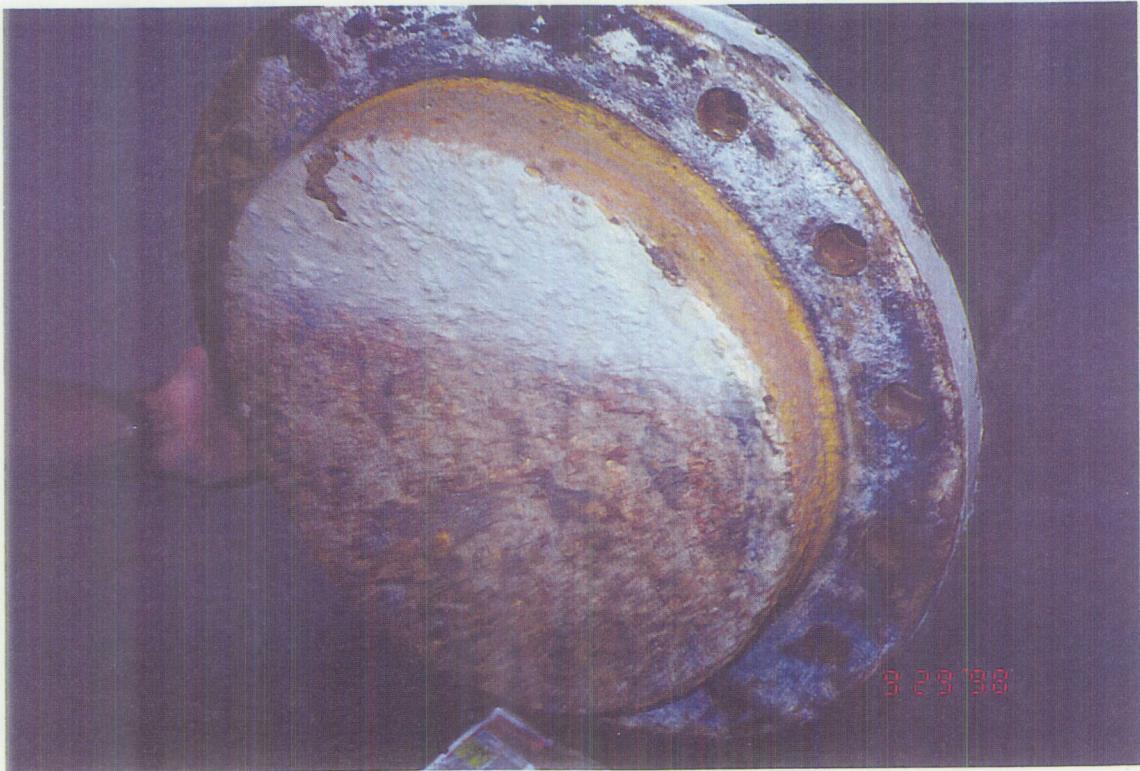
Photo 12- Morris Dam - Needle Valve 1 - View corrosion on interior of access manhole
cover
09/29/98

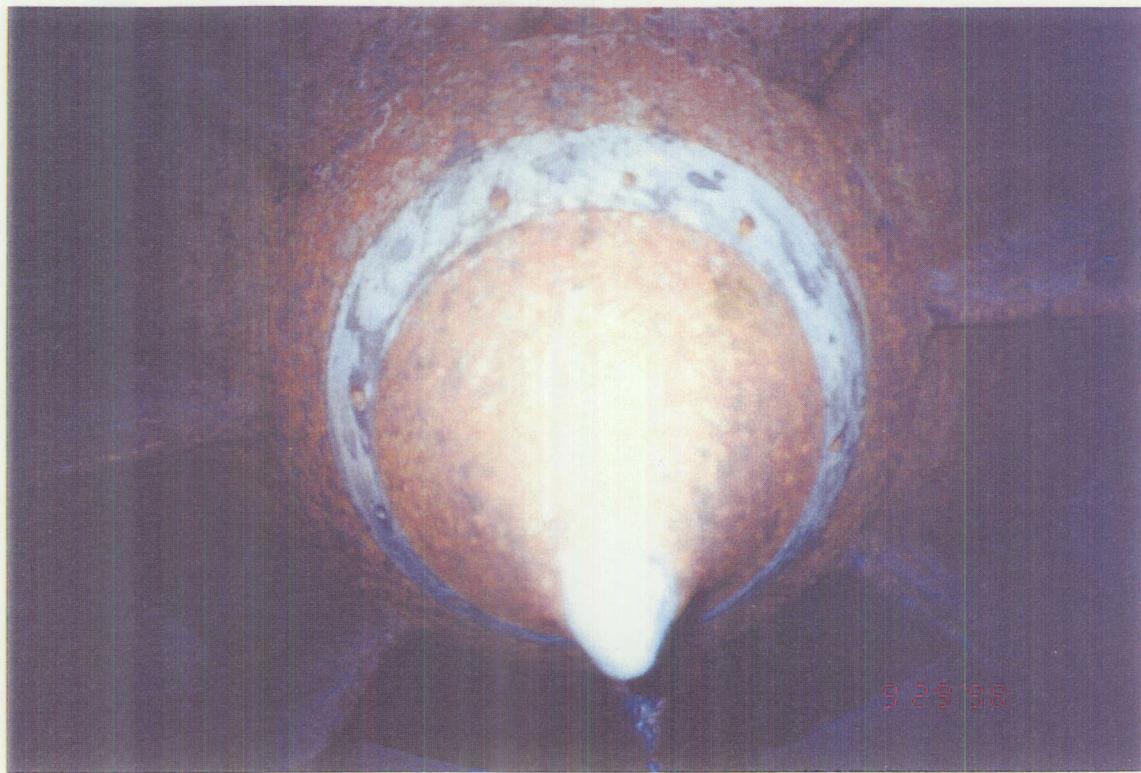
Photo 13- Morris Dam - Needle Valve 1 - View of corrosion on upstream body tip, bronze body tip ring, and valve body.

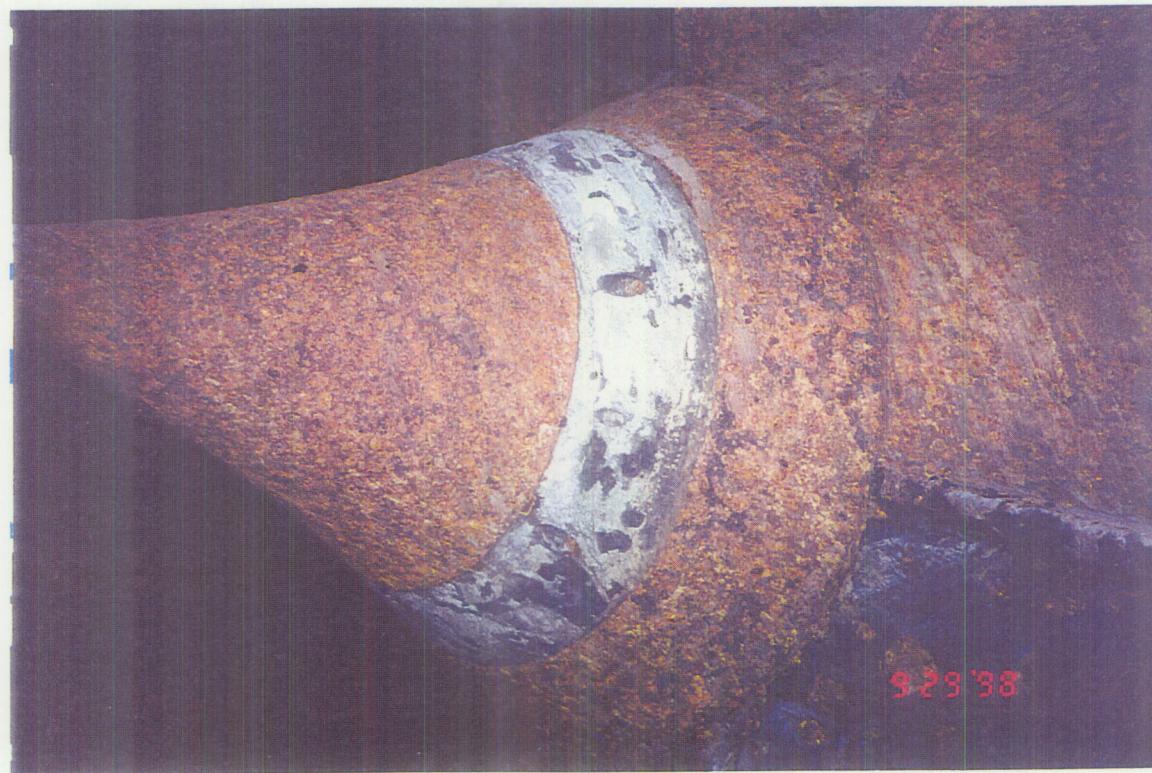
Photo 14- Morris Dam - Needle Valve 1 - Side view of corrosion on upstream body tip, bronze body tip ring, and valve body.

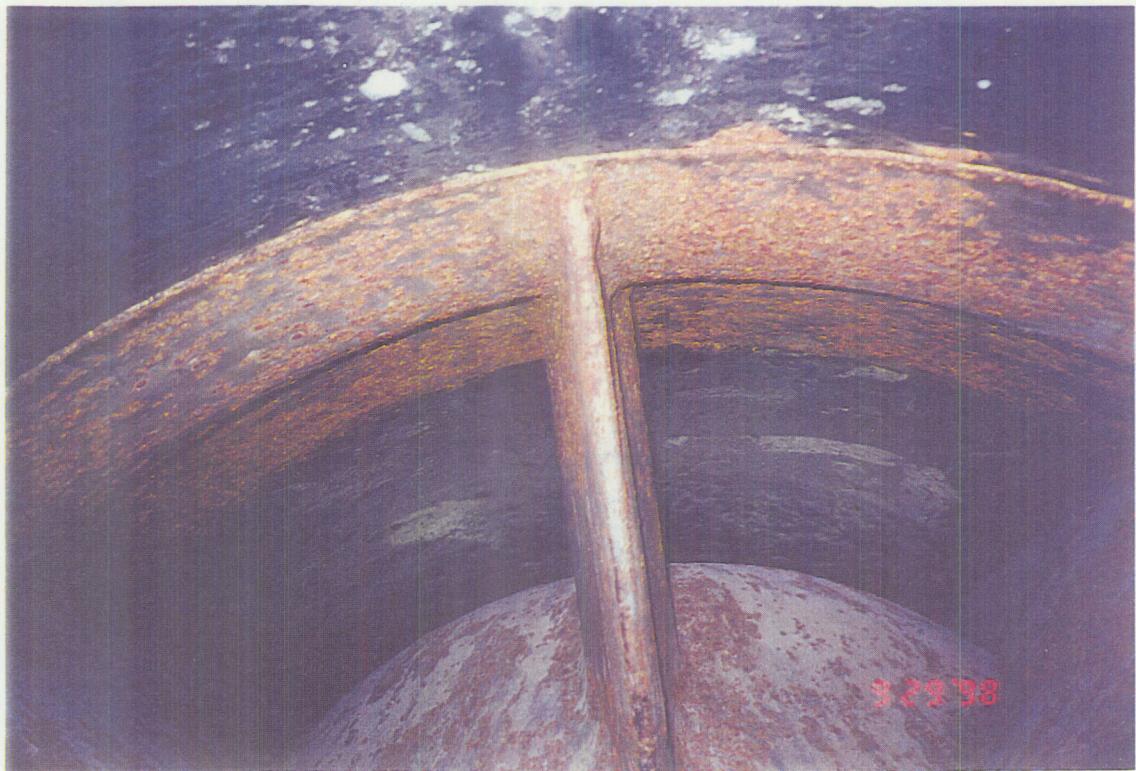
Photo 15- Morris Dam - Needle Valve 1 - View of corrosion on valve body and 12 o'clock splitter looking downstream.

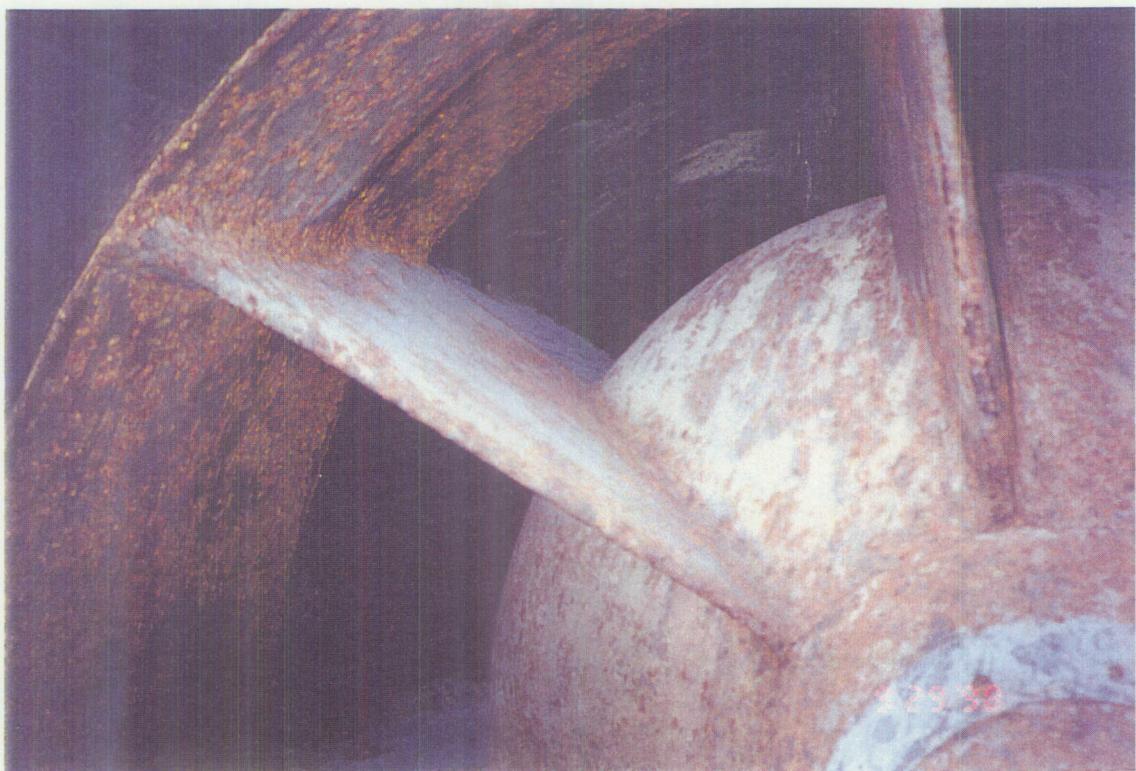
Photo 16- Morris Dam - Needle Valve 1 - View of corrosion on valve body and 1030 o'clock splitter looking downstream.

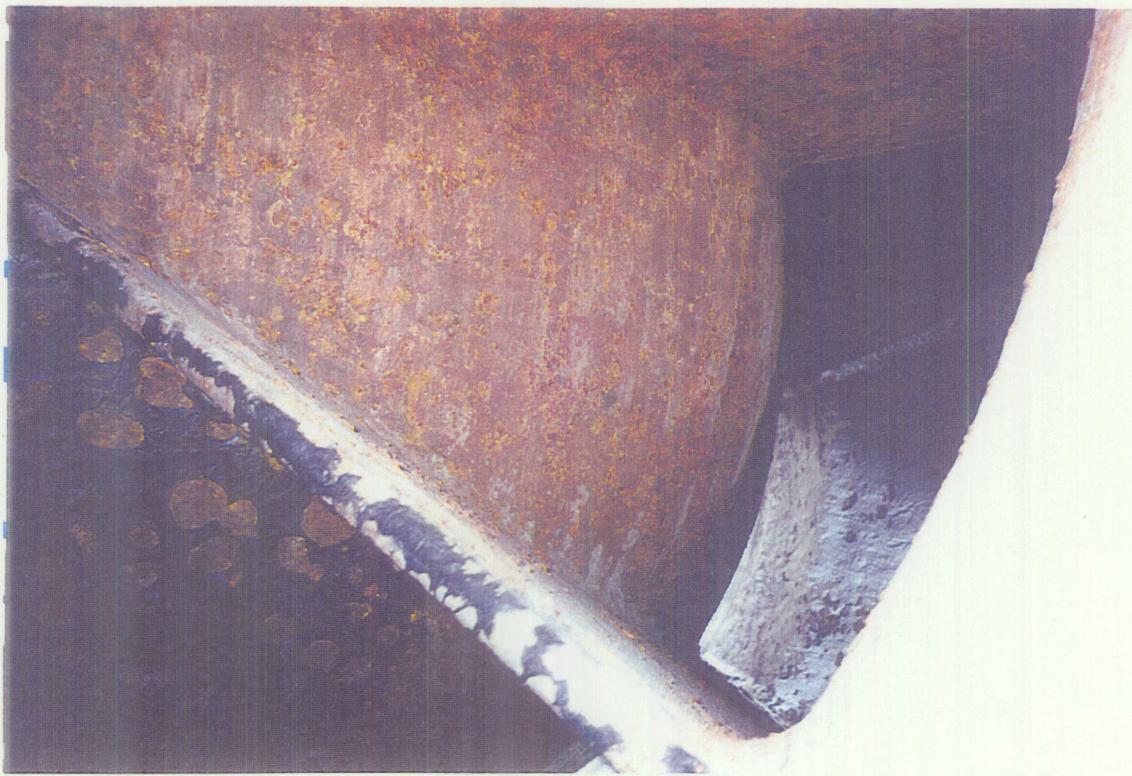
Photo 17- Morris Dam - Needle Valve 1 - View looking downstream of corrosion on inner valve body shell between 3 and 5 o'clock splitters.

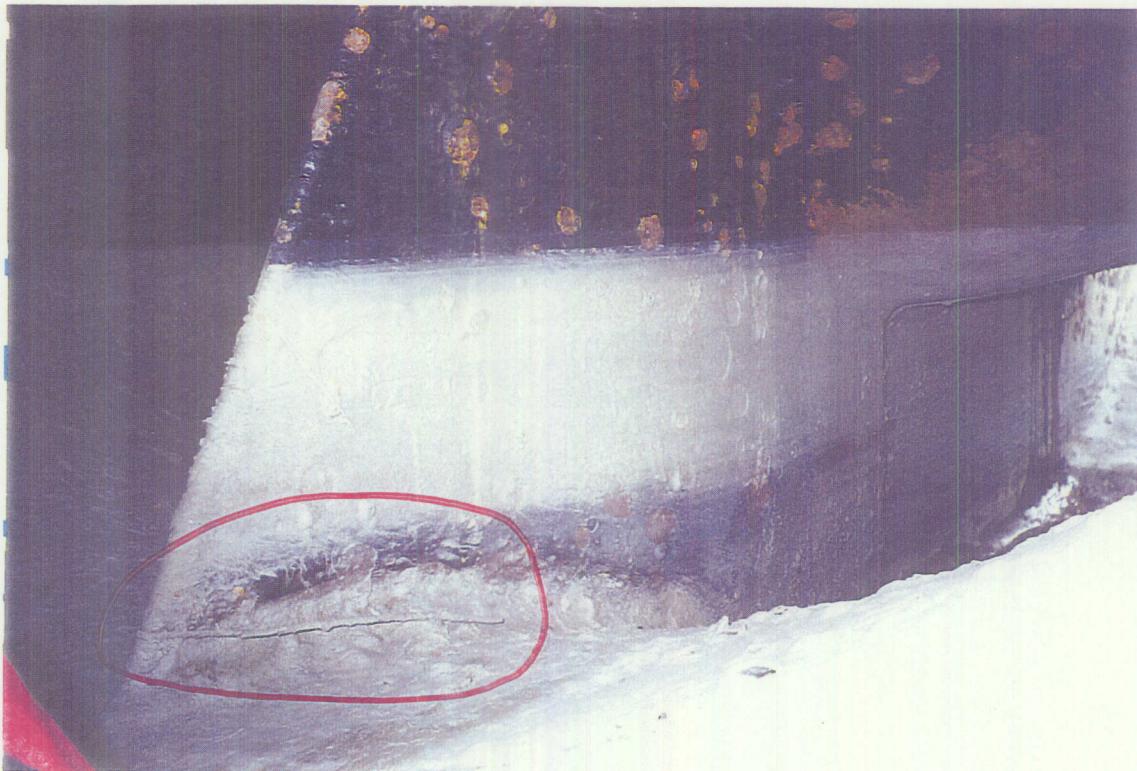
Photo 19- Morris Dam - Needle Valve 1 - View of crack in 6 o'clock splitter at upstream end at connection to outer valve body shell.

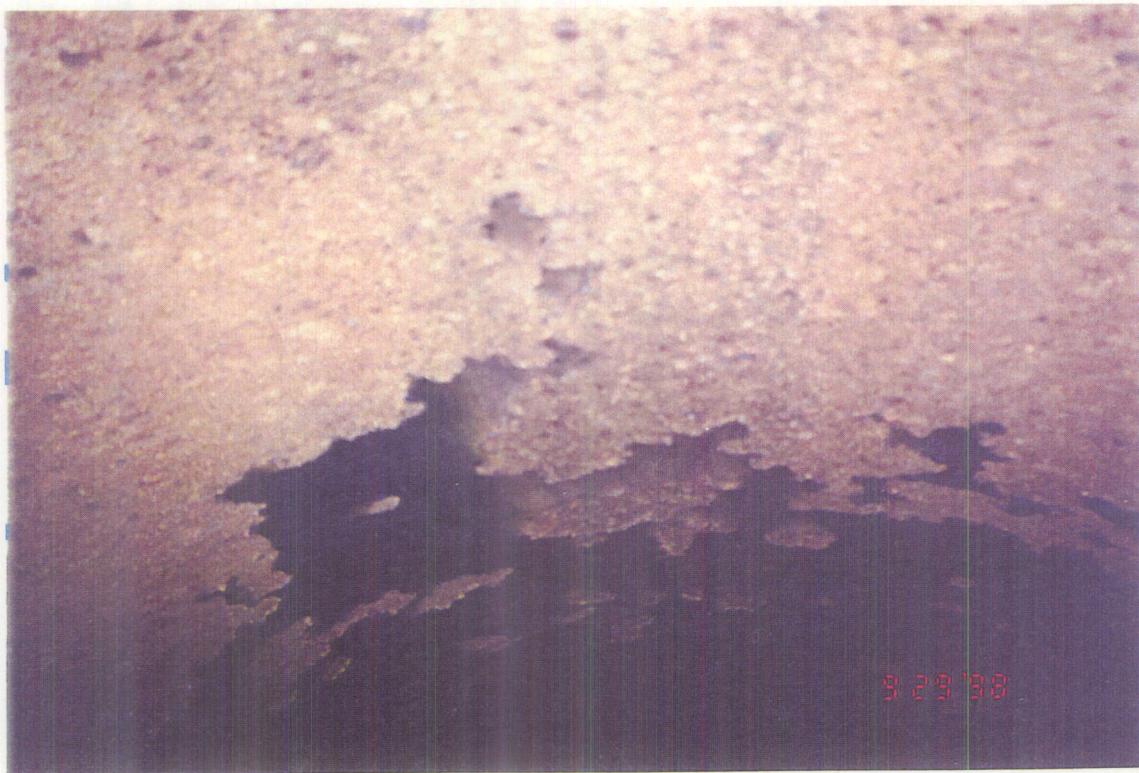
Photo 14 - Morris Dam - Butterfly Valve 1A - View of corrosion on pipe immediately downstream of disc seat.

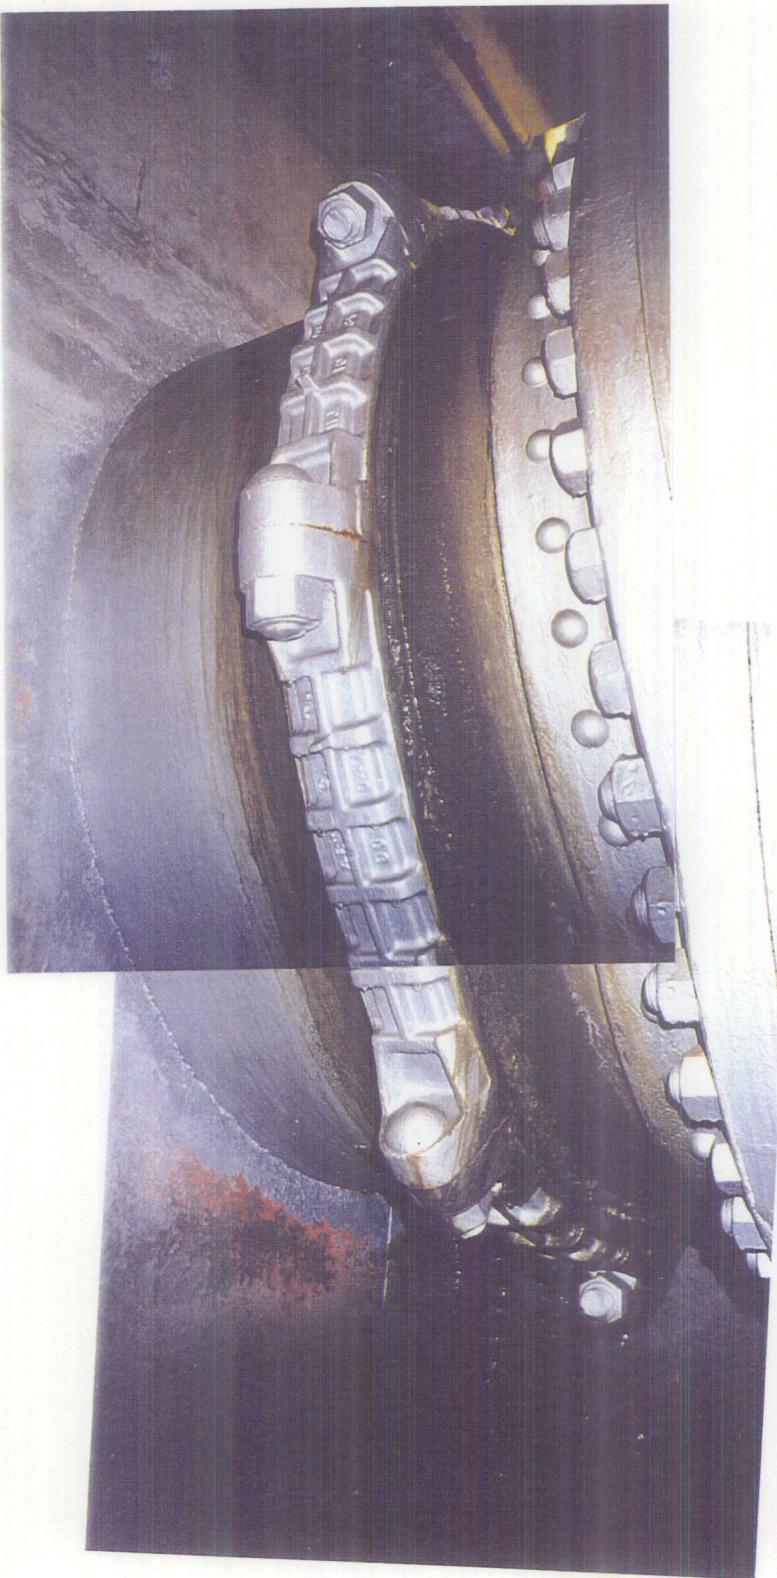
Photo 5 - Morris Dam - Slide Gate
4A - View left side of Victaulic
coupling on pipe downstream from
gate. Note minor leakage. 07/01/98

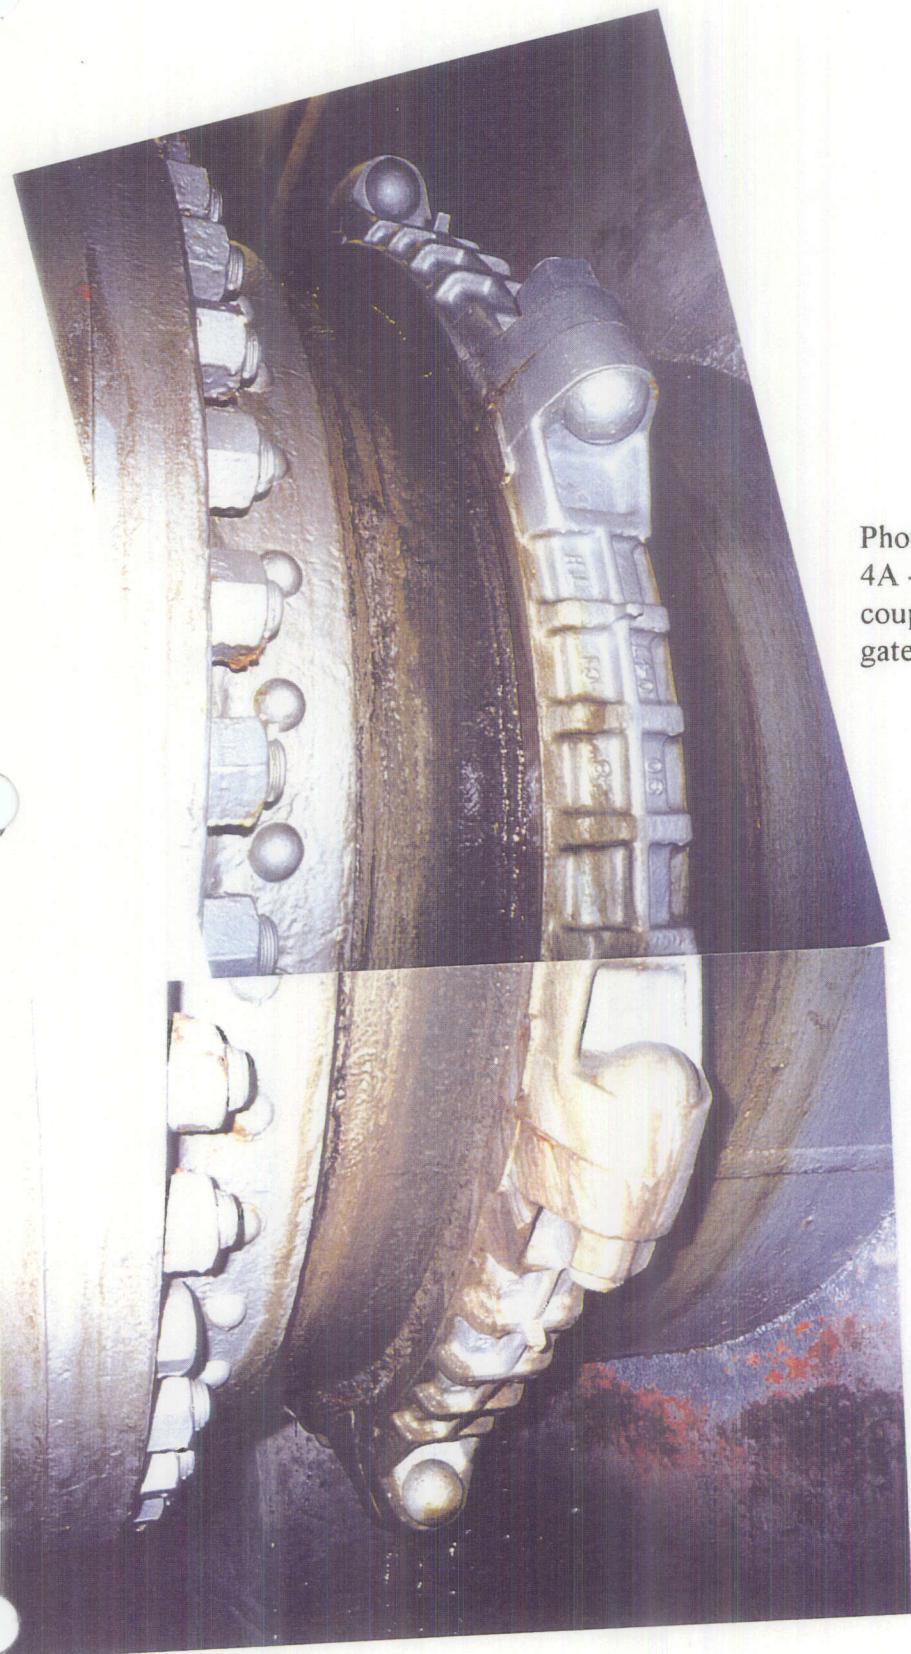
Photo 6 - Morris Dam - Slide Gate
4A - View right side of Victaulic
coupling on pipe downstream from
gate. Note minor leakage. 07/01/98

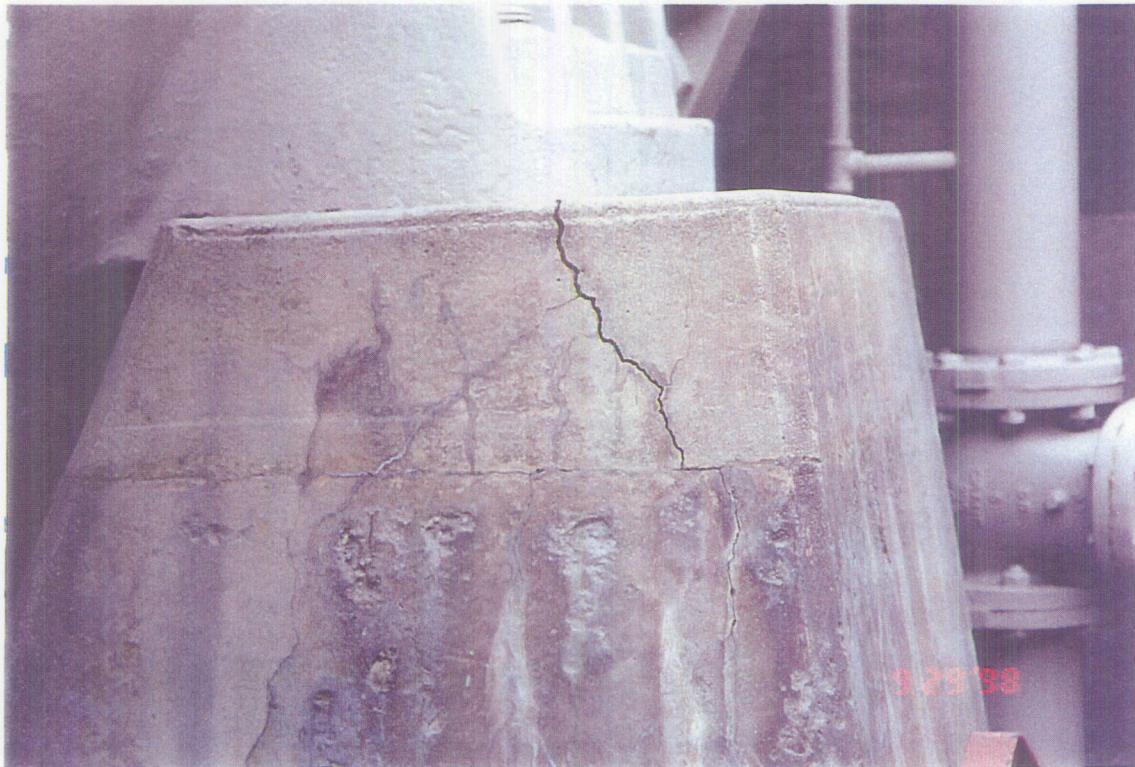
Photo 12 - Morris Dam - Needle Valve 6 - View of crack in left (looking downstream)
valve support pedestal.
09/29/98

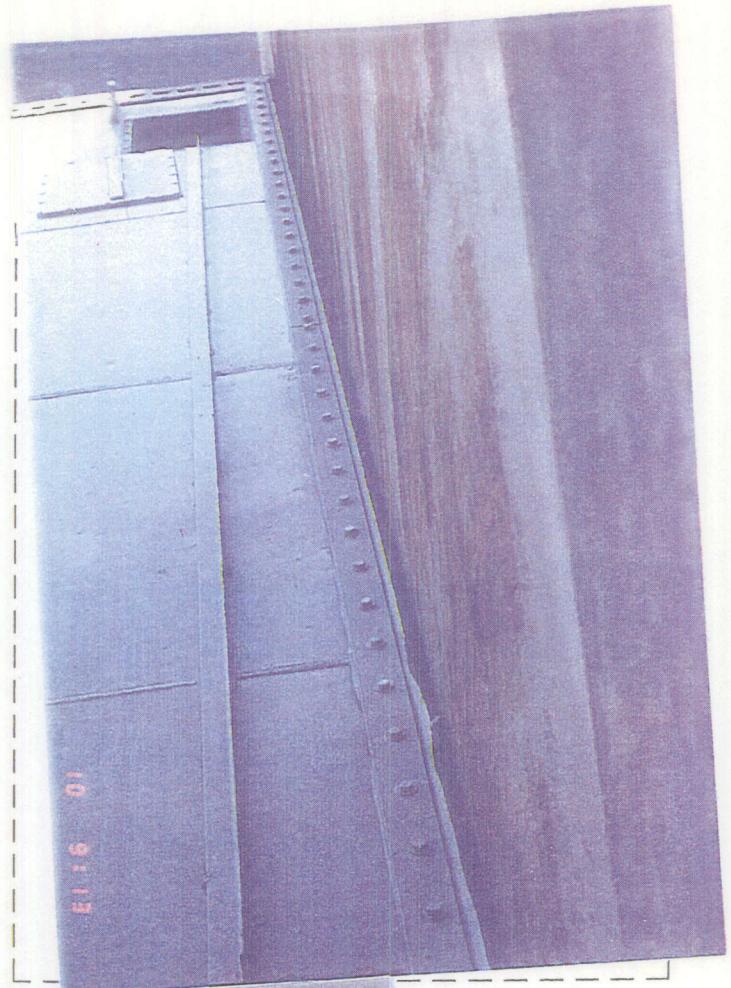
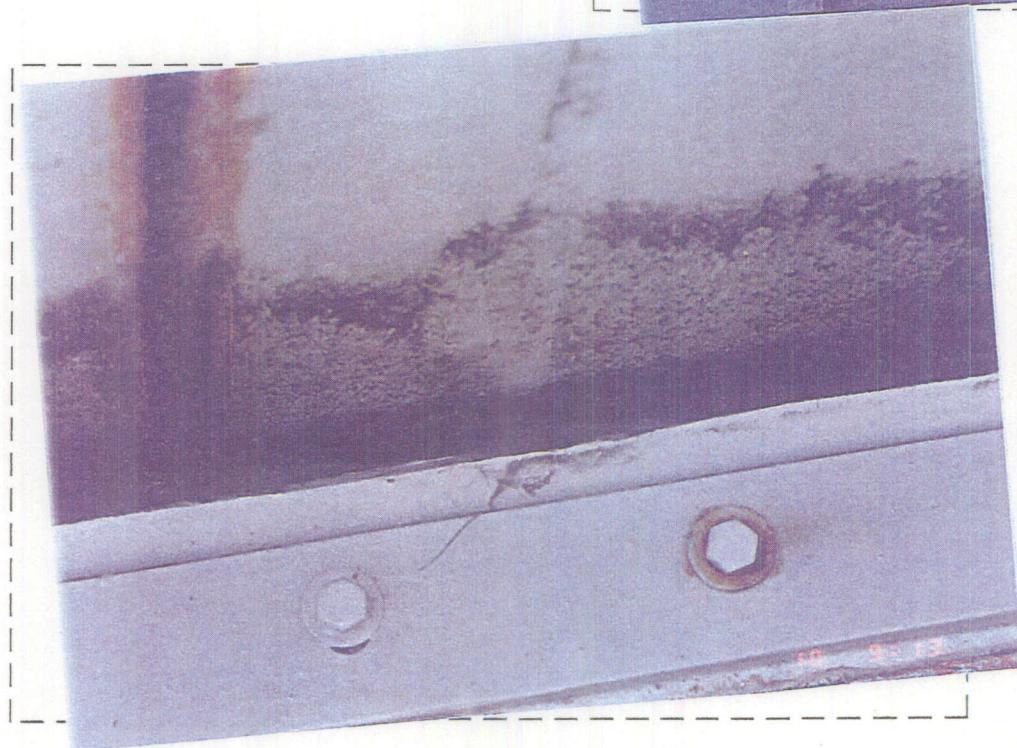
Photo 2. - Morris Dam - 70' x 18' Drum Gates - Gate #1, downstream faceplate, left side. Closeup of torn seal and wallplate. Note portion of gouged concentric arc on upper left of photo. - Sept 10, 1998.

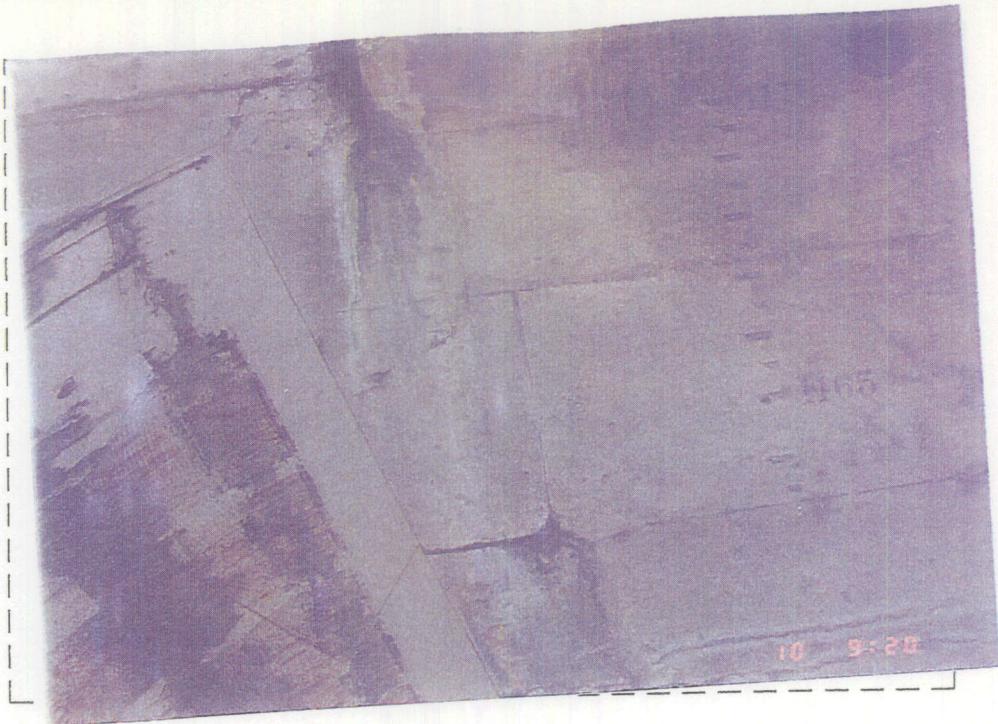
Photo 5. - Morris Dam - 70' x 18' Drum Gates - Gate #1, left side embedded wallplate. View of wallplate and faded, painted reservoir elevation marks to show maximum raised height of gate #1 at point where gate became stuck (approx. El. 1167.5') - Sept 10, 1998.

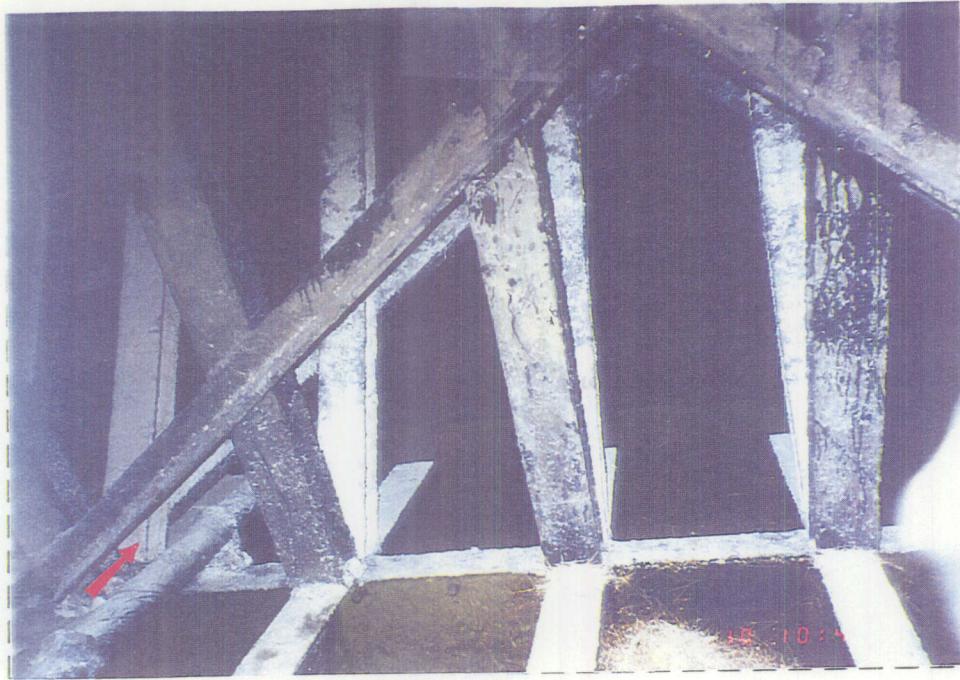
Photo 19. - Morris Dam - 70' x 18' Drum Gates - Gate #2 - View of internal bracing inside gate at right hatchway. Note ponding water inside webs of structural members for bottom faceplate, and note 3" ejector piping on right. Arrow points towards bottom of gate. - Sept 10, 1998.

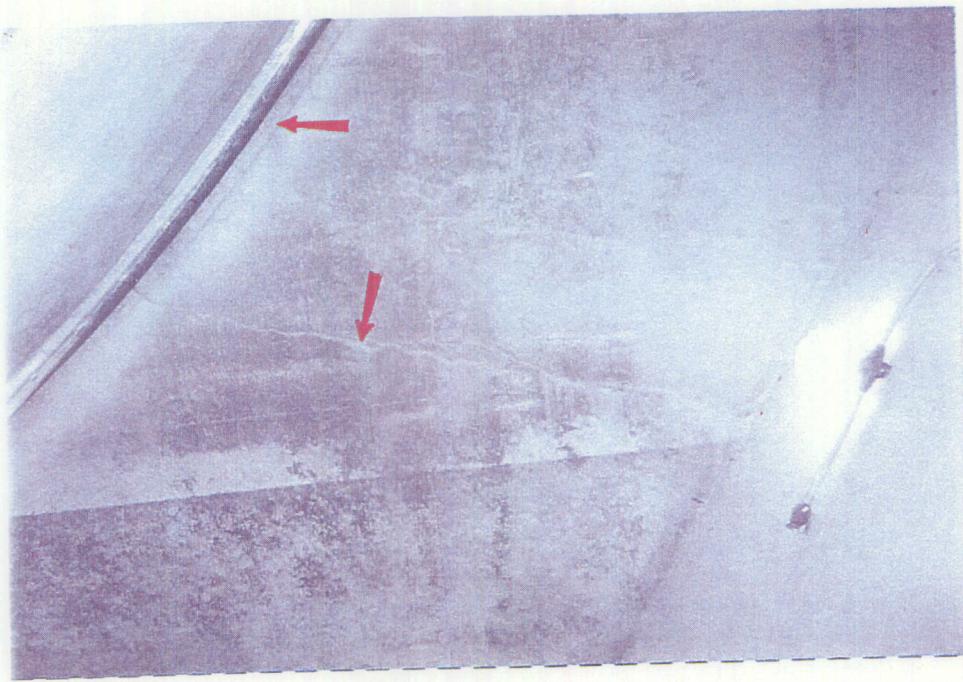
Photo 12 - Morris Dam - 70' x 18' Drum Gate #1 (east) - Upstream side of gate chamber and of gate. Looking at right end chamber wall. Arrow (down) points at crack in wall. Left arrow points to right side upstream music not end seals.. - (9/10/98).

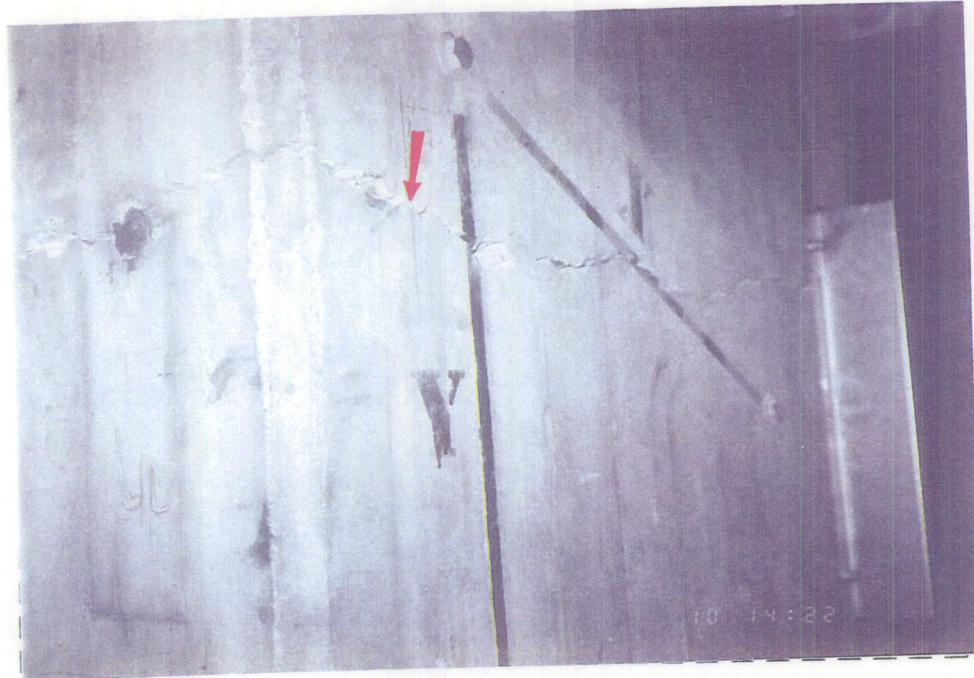
Photo 1 - Morris Dam - 70' x 18' Drum Gate #2 - Doorway entrance, El. 1136. to controls, Gate #2. Cracking due to earthquake (4/14/65) in concrete column. Crack movement is monitored. - (9/10/98).

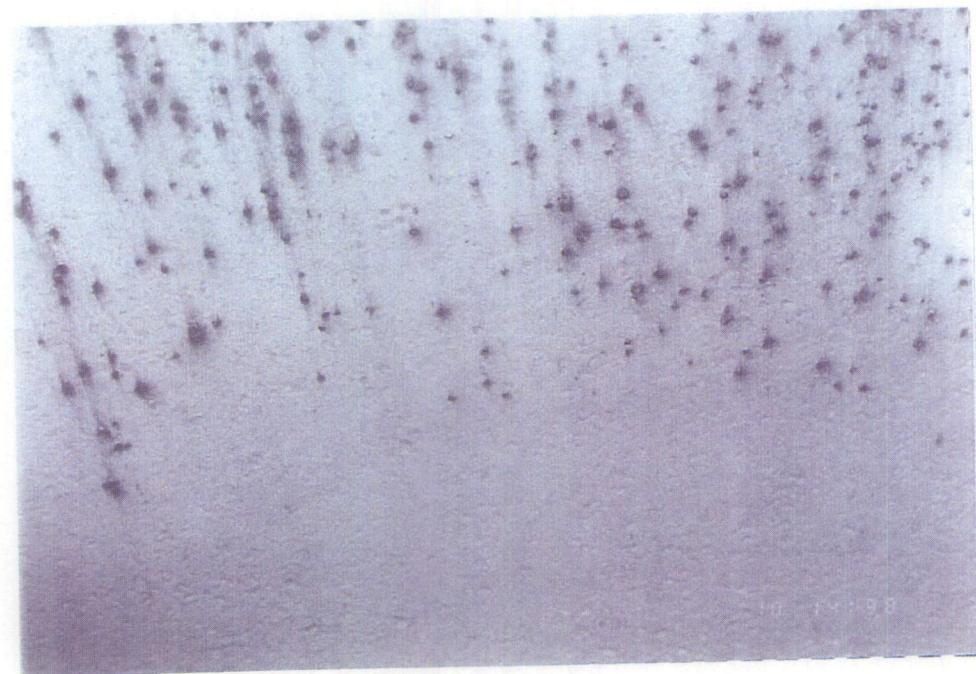
Photo 6 - Morris Dam - 70' x 18' Drum Gate #2 - 2nd closeup of u/s faceplate showing rust nodules and pitting.. - (9/10/98).

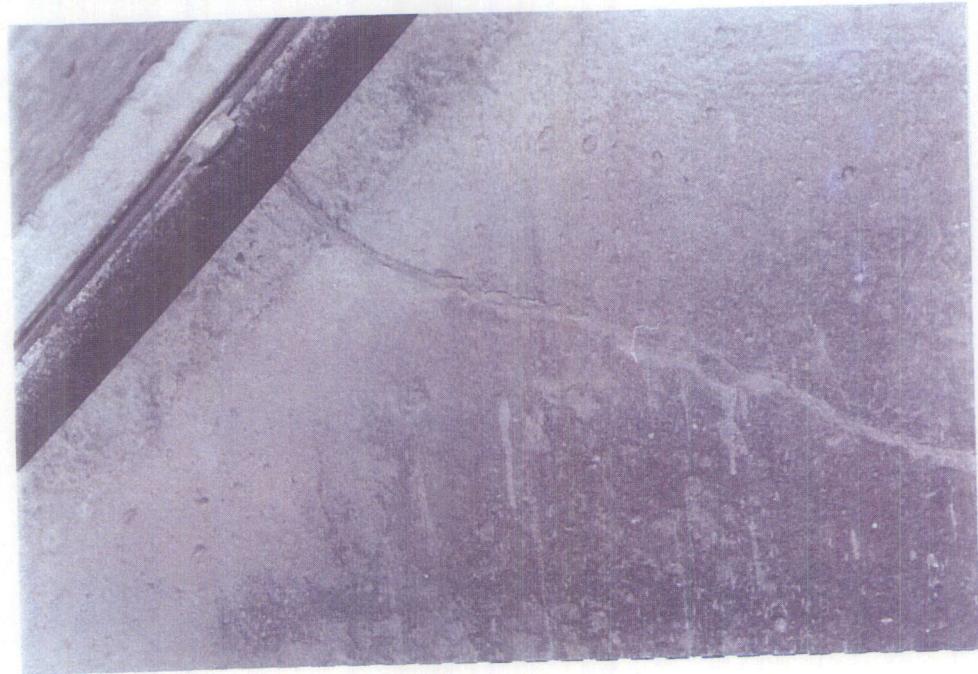
Photo 8 - Morris Dam - 70' x 18' Drum Gate #2 - Closeup of crack of lower (down) arrow previous photo.. - (9/10/98).

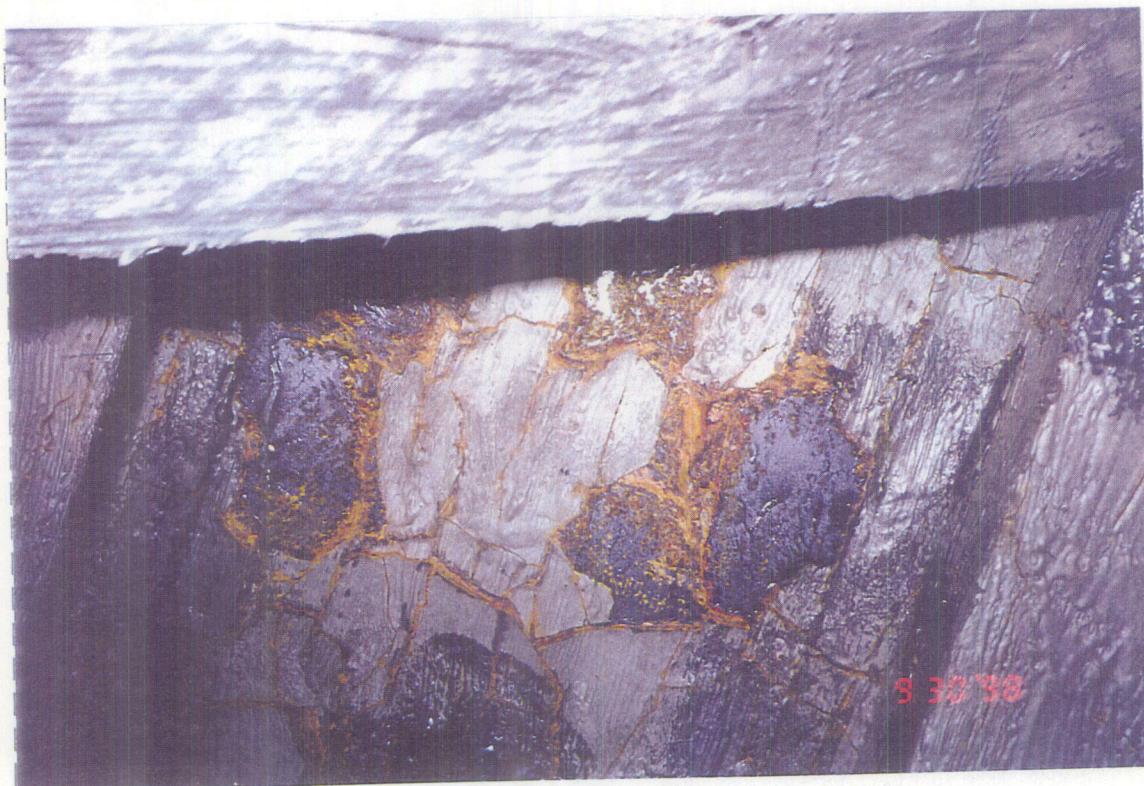
Photo 2 - Morris Dam - 70' x 18' Drum Gate #3 (interior)- Poor condition of coal tar enamel on inside surface of downstream facepalte. Gate #3 d/s faceplate was in worst condition for localized coating damage. (9/30/98).

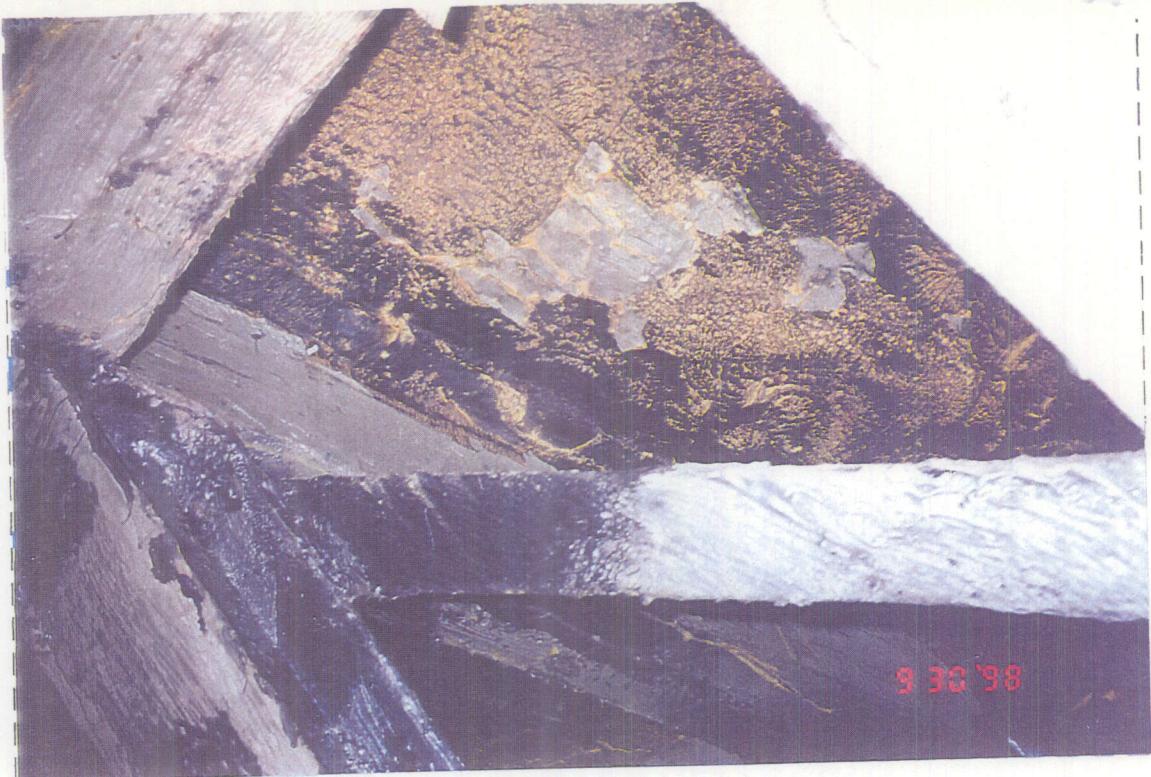
Photo 3 - Morris Dam - 70' x 18' Drum Gate #3 (interior)- Localized coal tar coating damage on downstream faceplate.- (9/30/98).

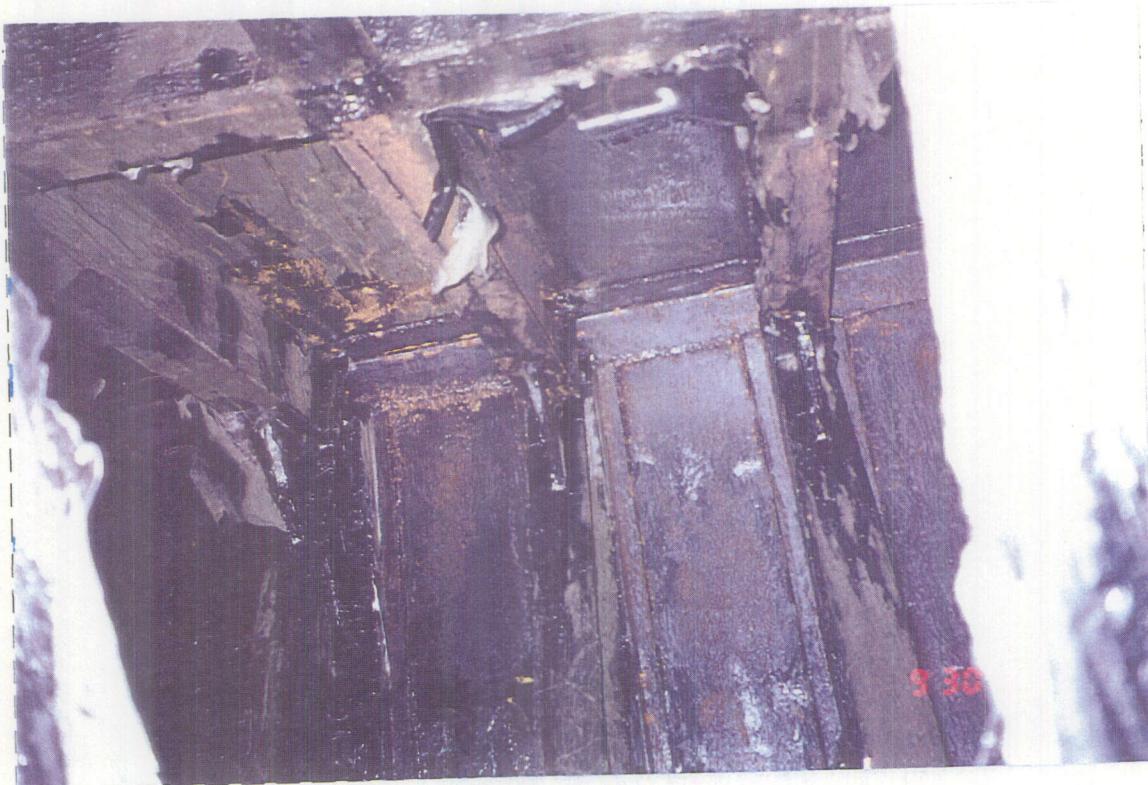
Photo 4 - Morris Dam - 70' x 18' Drum Gate #3 (interior)- Localized damage on downstream faceplate. (9/30/98).

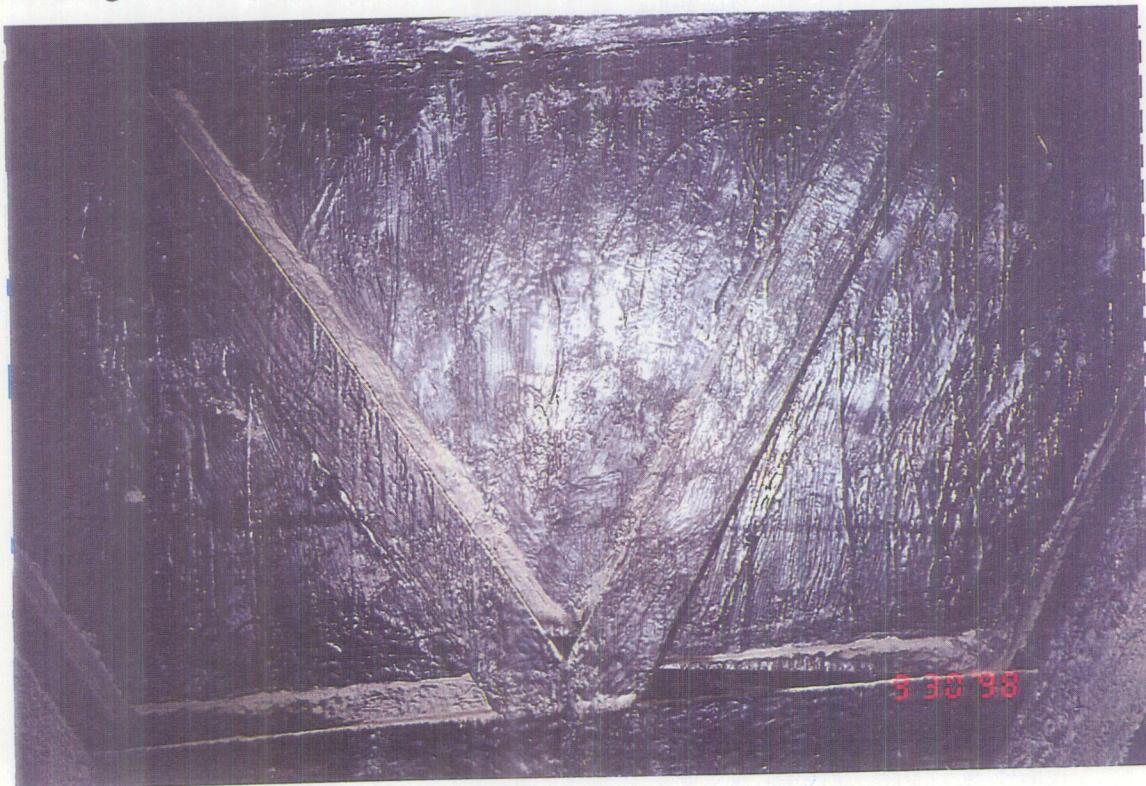
Photo 6 - Morris Dam - 70' x 18' Drum Gate #3 (interior)- Right side, end plates of gate. Note water ponding in web of girder. Coating in good condition. (9/30/98).
