EQUIPMENT INSPECTION / EVALUATION REPORT

MORRIS DAM INLET/OUTLET WORKS
MODERNIZATION
County of Los Angeles
Department of Public Works

MECHANICAL EXAMINATION REPORT

Morris Dam Inlet/Outlet Works Modernization

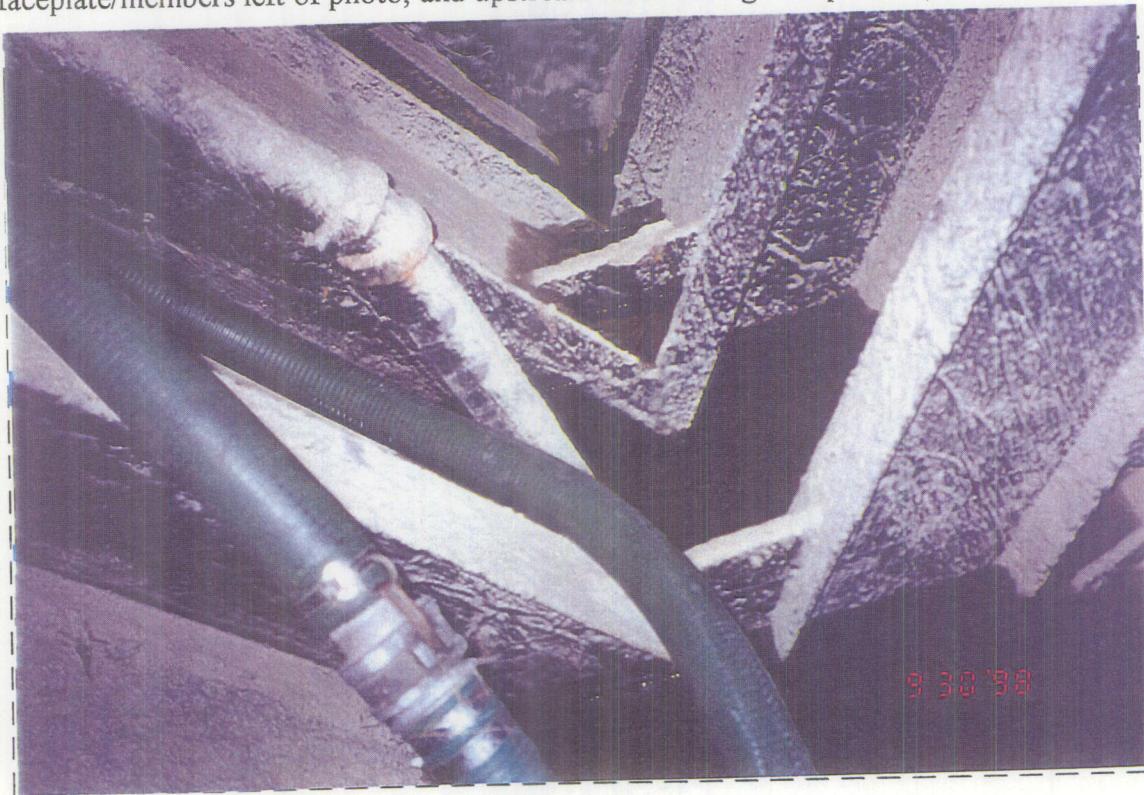
Photo 11 - Morris Dam - 70' x 18' Drum Gate #3 (interior)- Closeup of photo above, showing remainder of leakage water in bottom of gate.- (9/30/98).

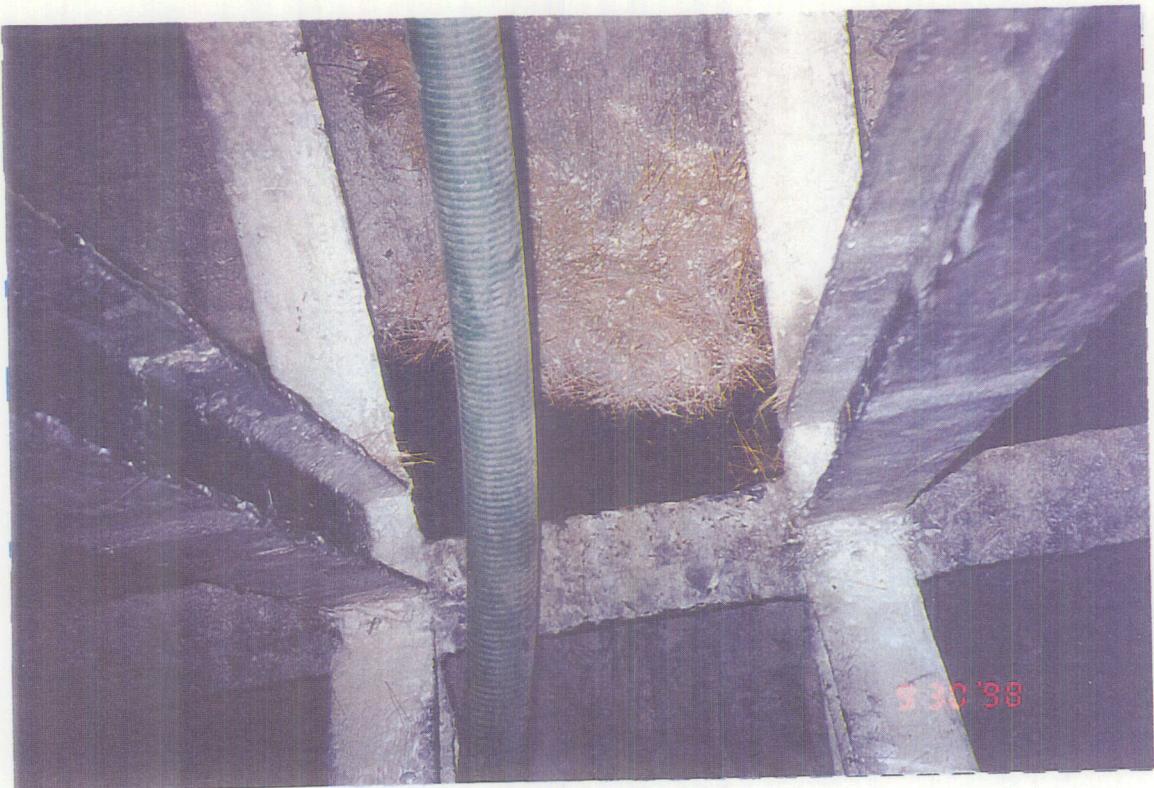
Photo 12 - Morris Dam - 70' x 18' Drum Gate #3 (interior)- Debris inside gate. (9/30/98).

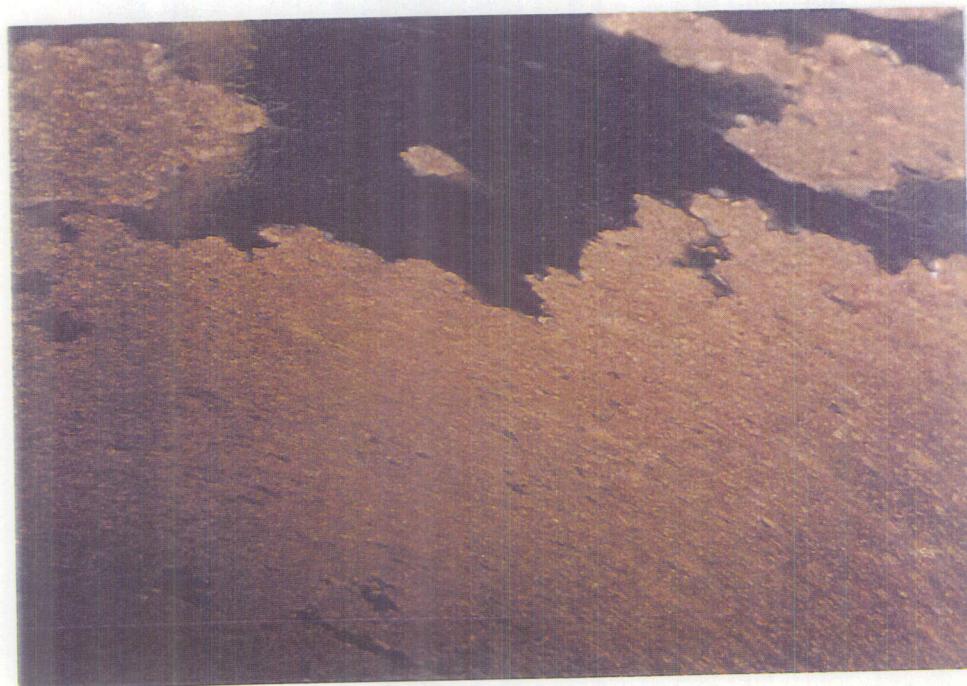
Photograph 2 - Damage to coal tar epoxy lining located on the interior of outlet pipe No. 1 just downstream of the butterfly valve leaf.

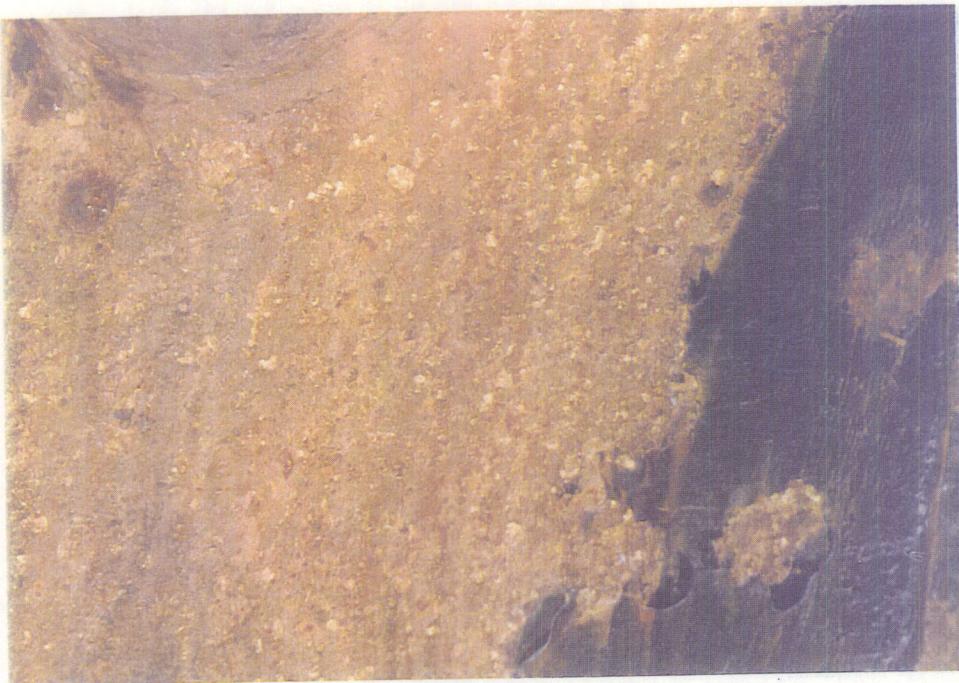
Photograph 3 - Damage to coal tar epoxy lining on interior of outlet pipe No. 1.

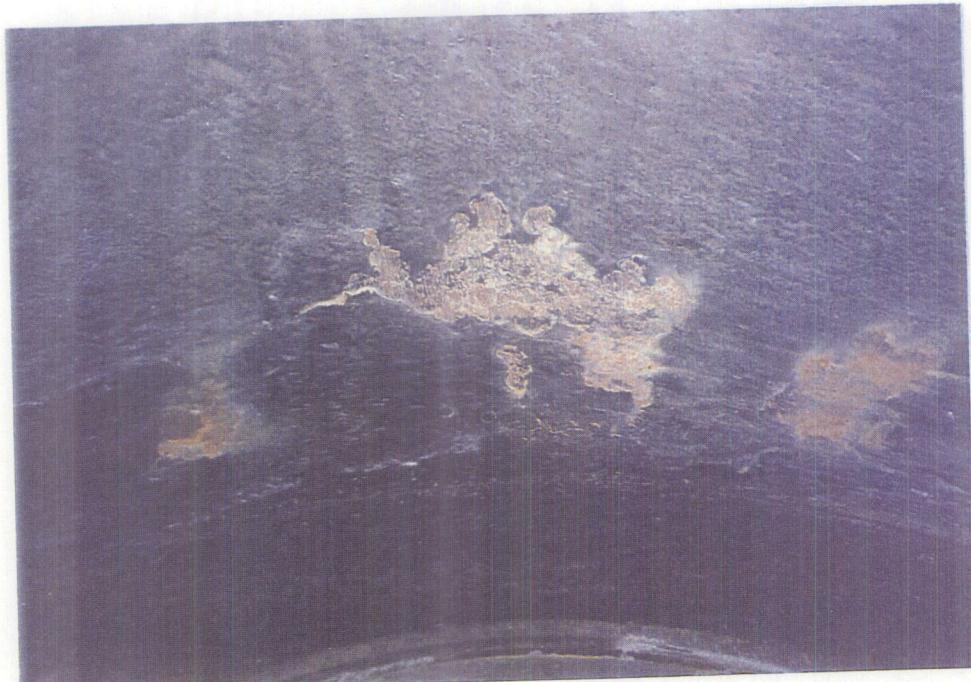
Photograph 8 - Damaged coal tar epoxy lining located at top of outlet pipe just downstream of the 96-inch butterfly valve leaf.

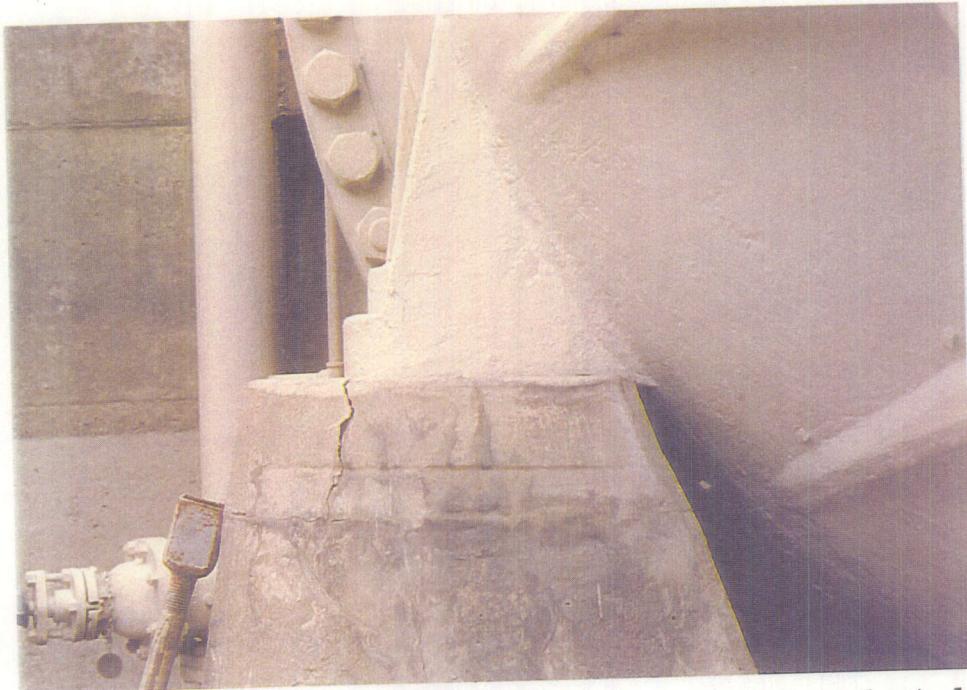
Photograph 17 - Damage to grout cap of concrete pedestal support for needle valve assembly.

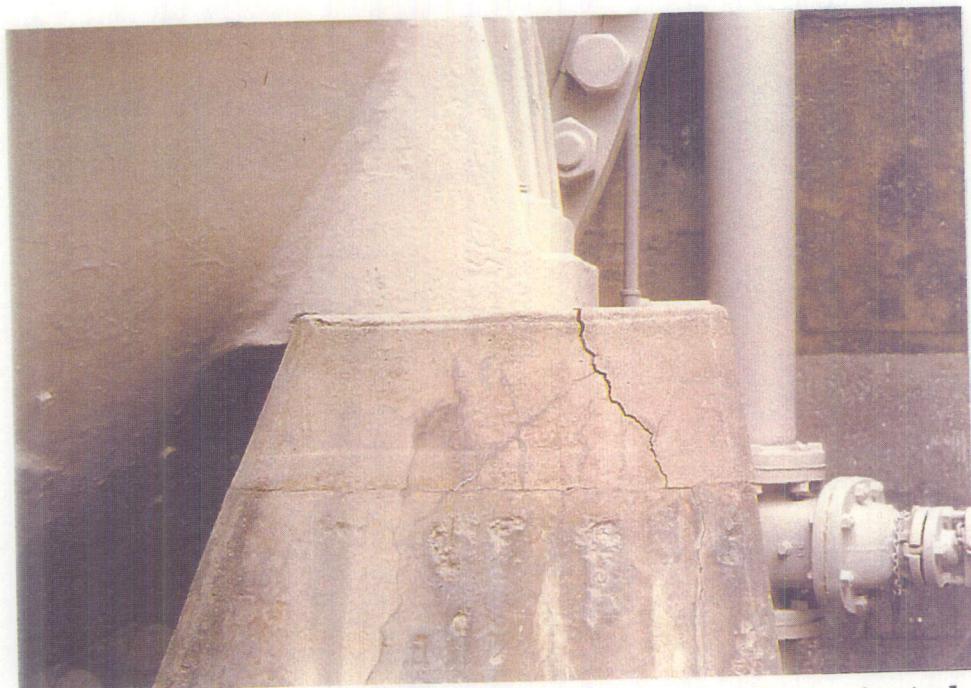
Photograph 18 - Damage to grout cap of concrete pedestal support for needle valve assembly.
