EQUIPMENT INSPECTION / EVALUATION REPORT

MORRIS DAM INLET/OUTLET WORKS
MODERNIZATION
County of Los Angeles
Department of Public Works

MECHANICAL EXAMINATION REPORT

Morris Dam Inlet/Outlet Works Modernization

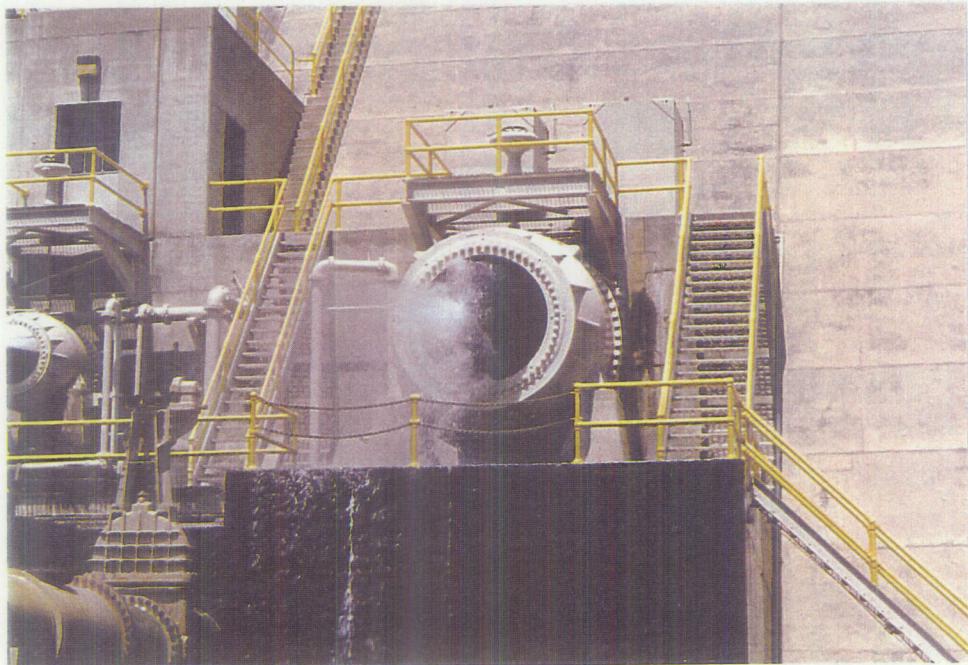
Photo 2 - Morris Dam - Needle Valve 1 - View of needle valve leakage
under full head.
07/01/98

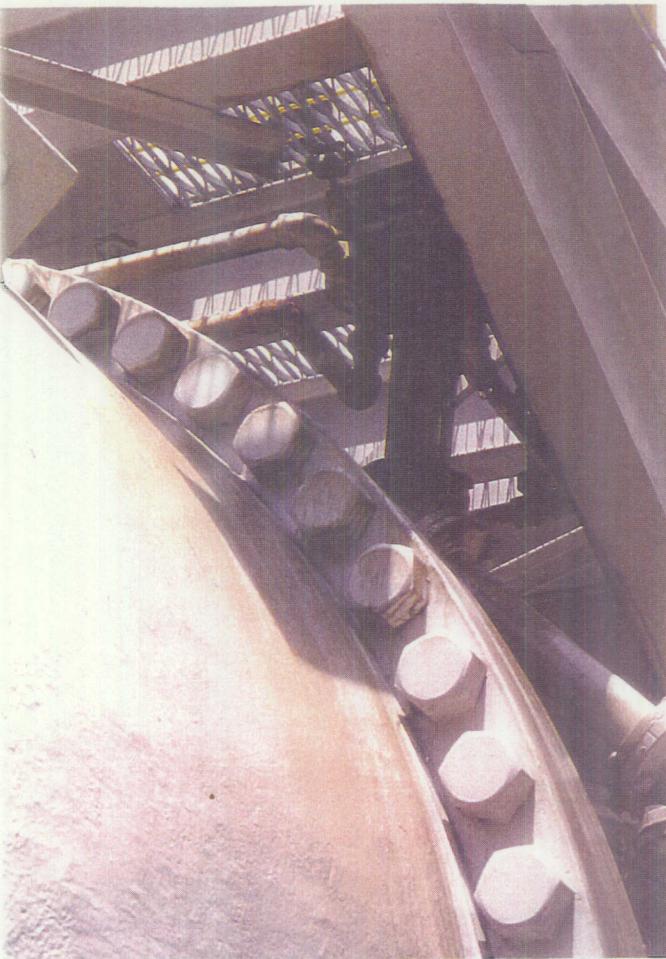
Photo 3 - Morris Dam - Needle Valve 1 -
View of needle valve body flange and air vent
manifold.
07/01/98

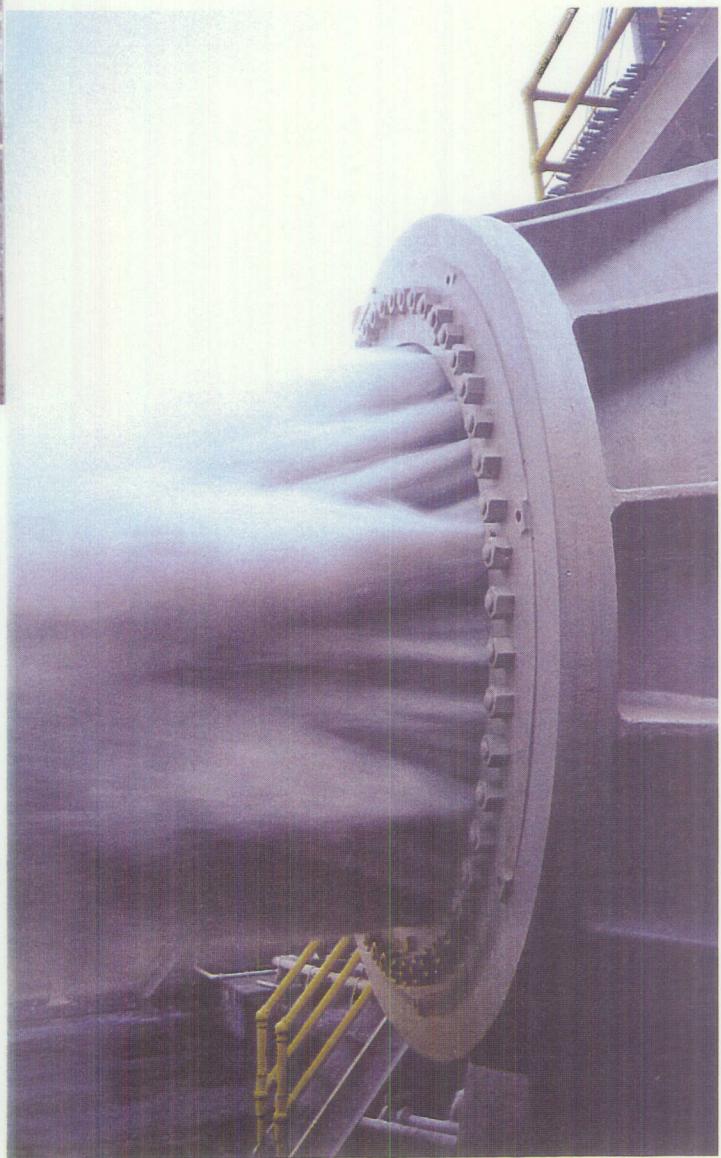
Photo 6 - Morris Dam - Needle Valve 1 - View
of needle valve discharge at full head.

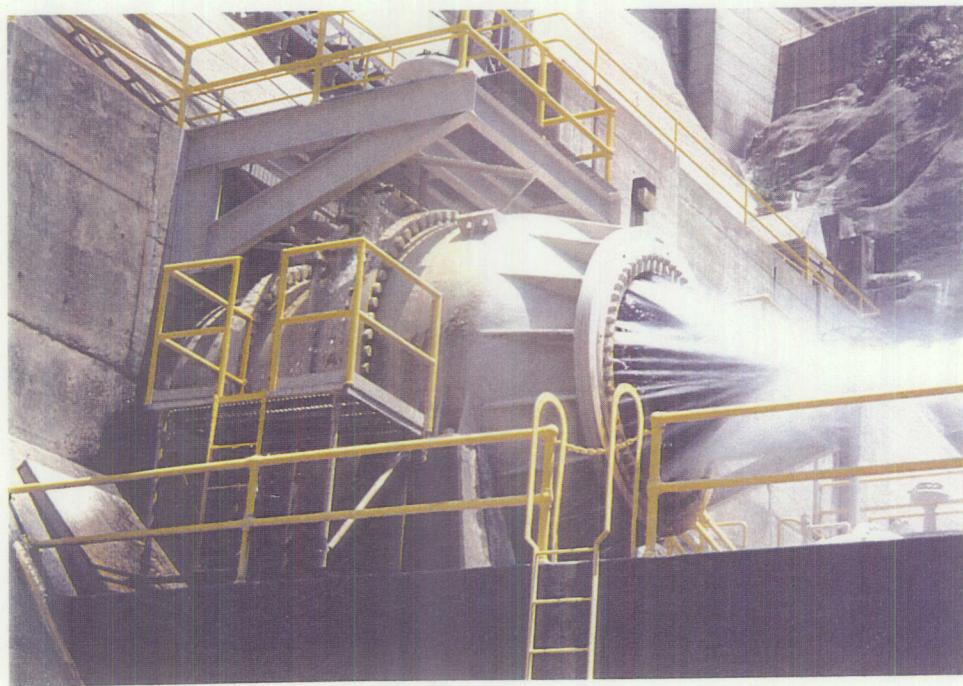
Photo 7 - Morris Dam - Needle Valve 1 - View of needle valve discharge under full head.
07/01/98

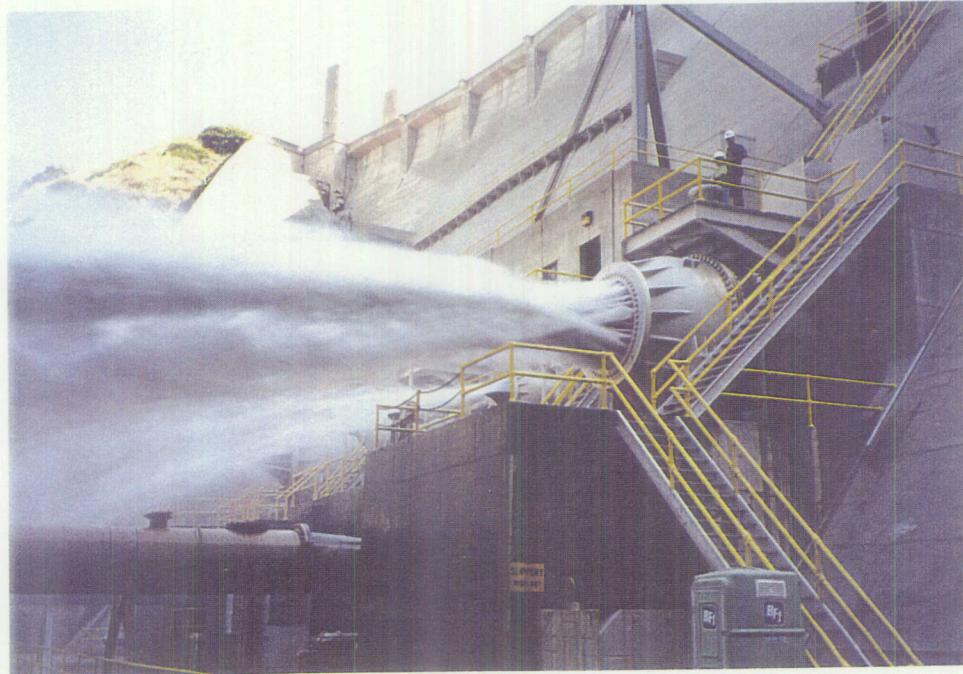
Photo 8 - Morris Dam - Needle Valve 1 - View of needle valve discharge under full head.
07/01/98

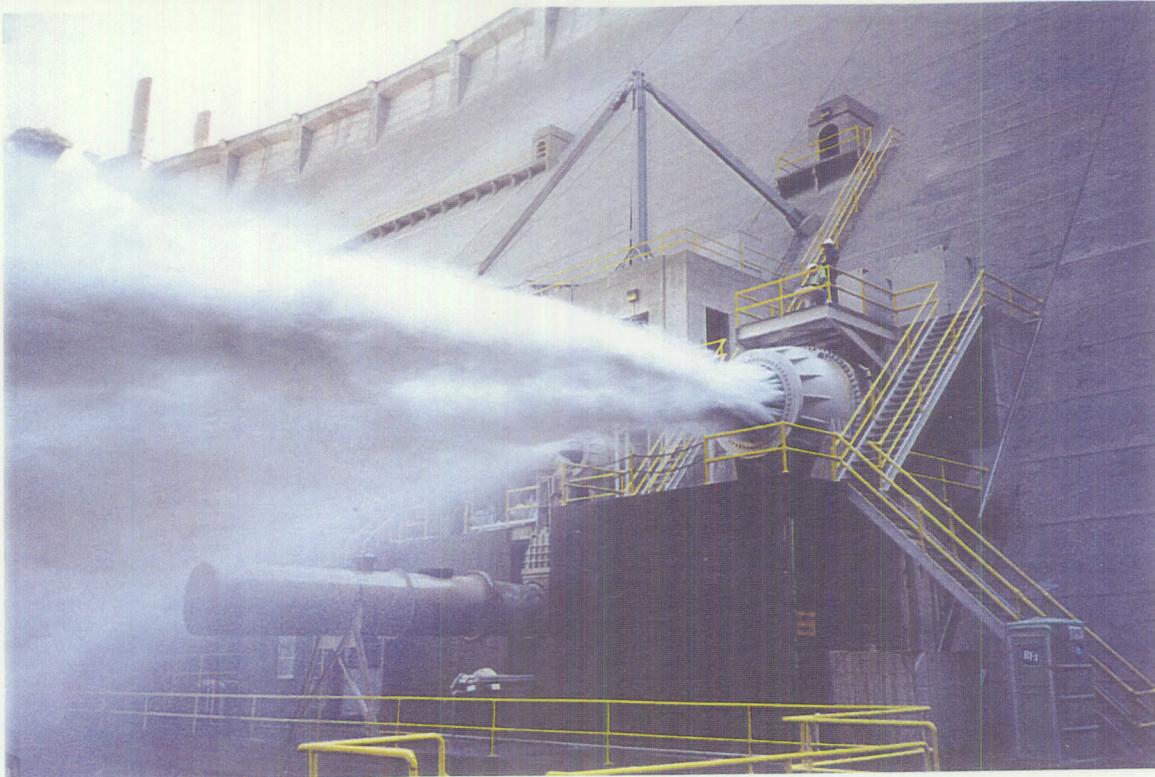
Photo 9 - Morris Dam - Needle Valve 1 - View of needle valve discharge under full head.
07/01/98

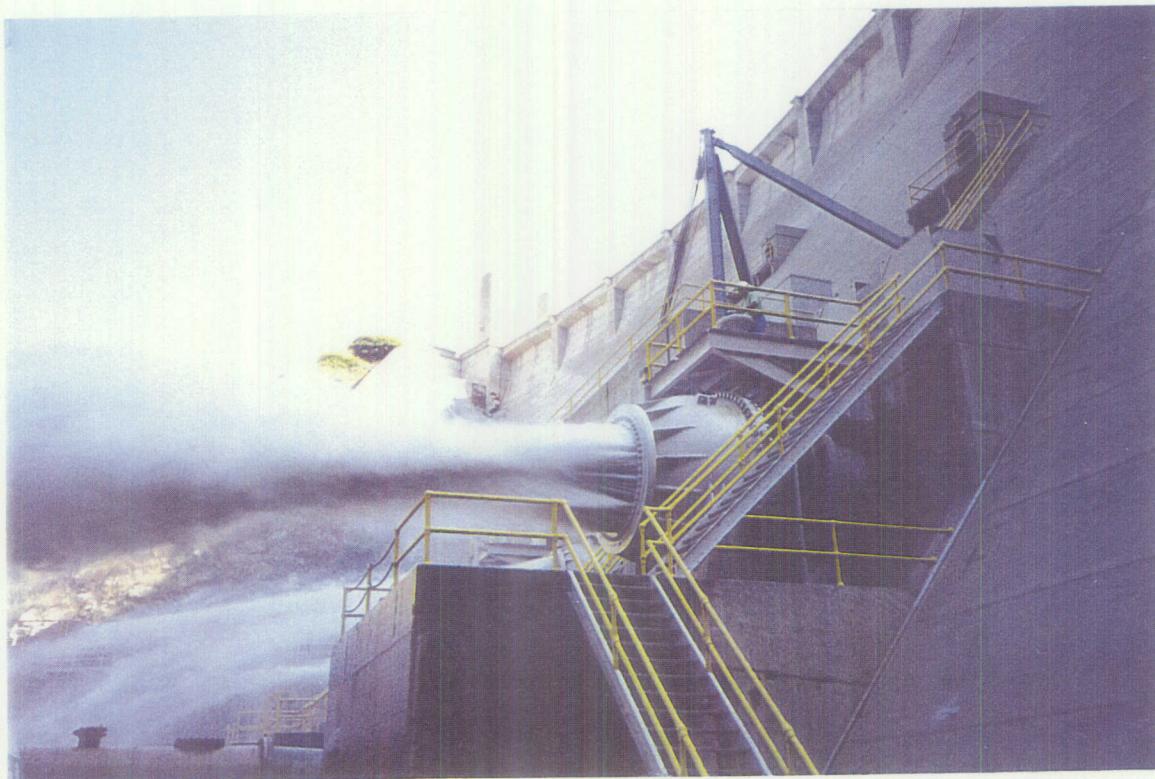
Photo 10 - Morris Dam - Needle Valve 1 - View of needle valve discharge under full head.
07/01/98

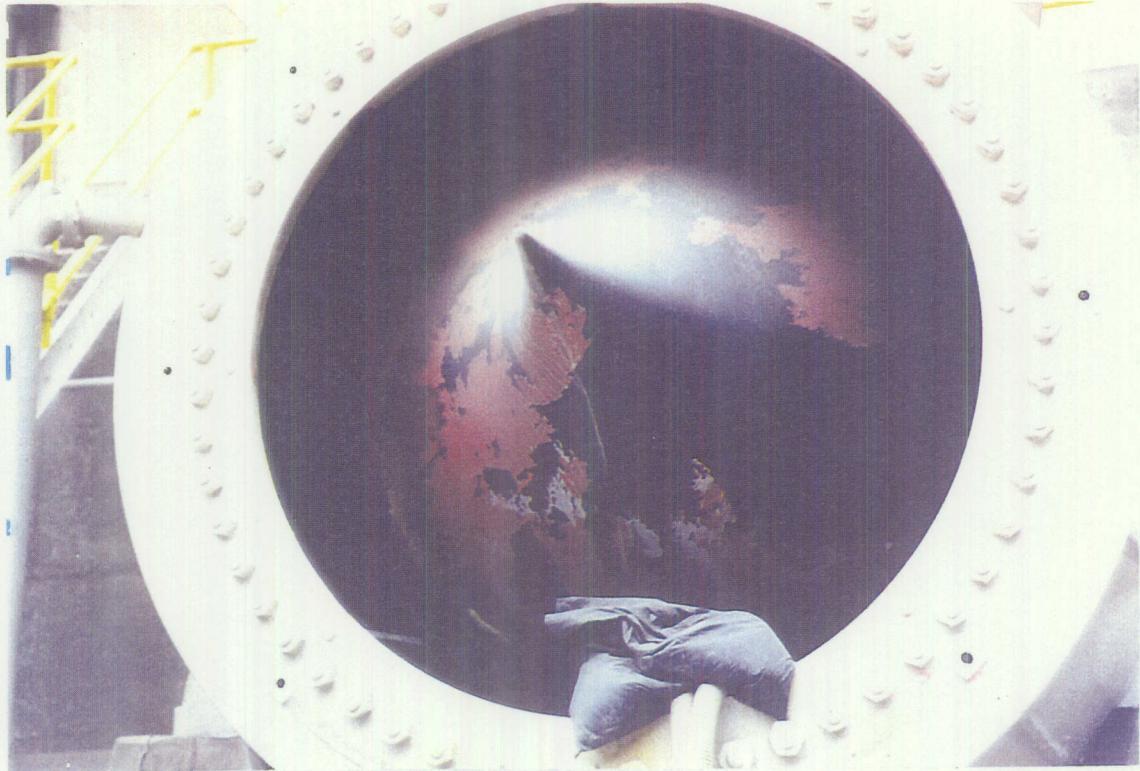
Photo 11- Morris Dam - Needle Valve 1 - View of needle and downstream flange.
09/29/98

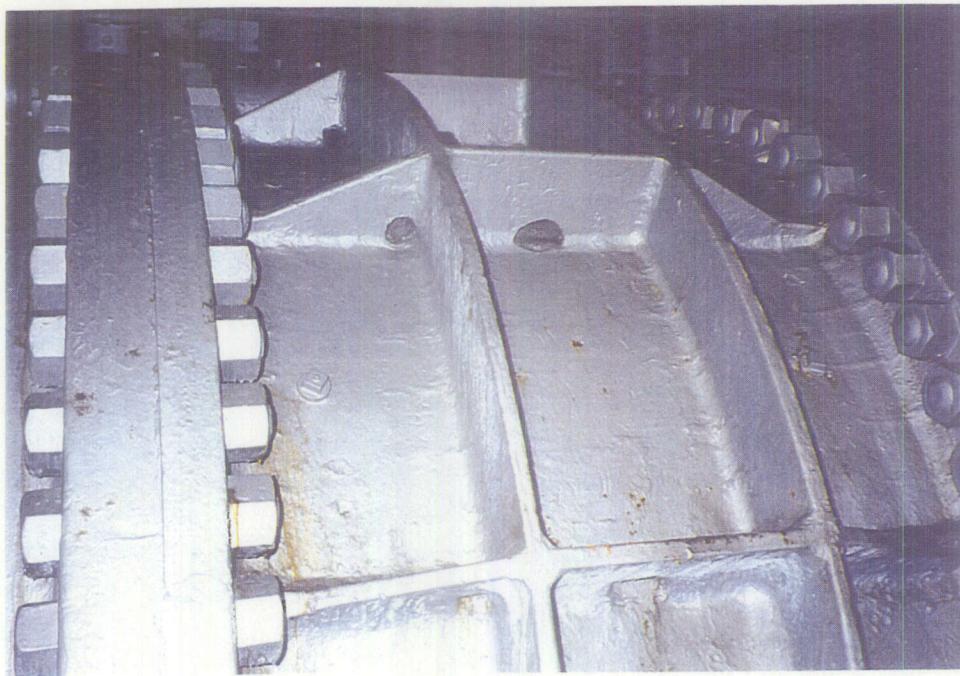
Photo 1 - Morris Dam - Butterfly Valve 1A - View of body and upstream flange.
07/01/98

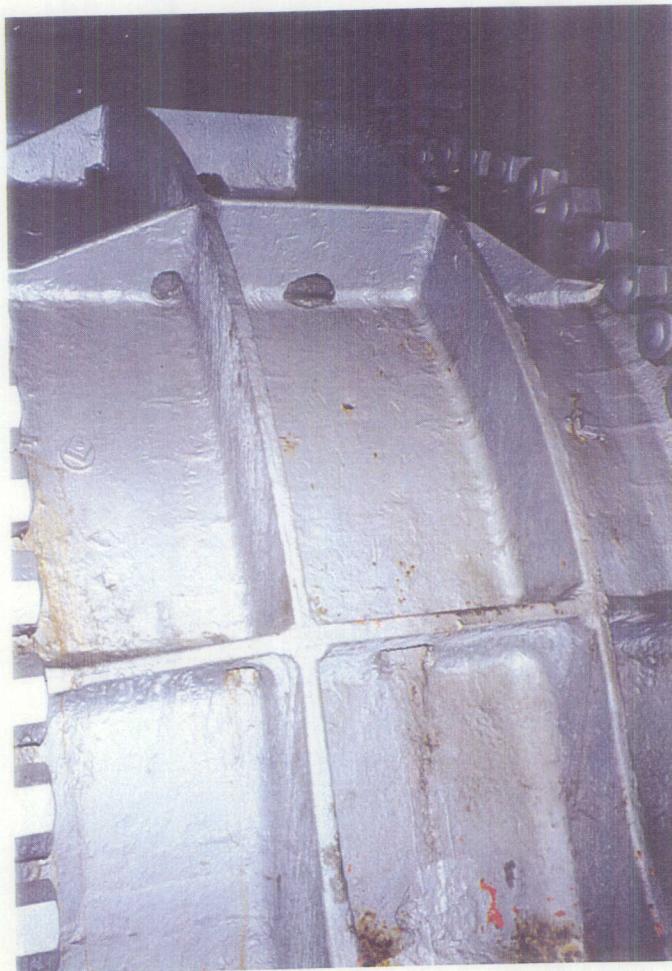
Photo 2 - Morris Dam - Butterfly Valve 1A - View of valve body.
07/01/98

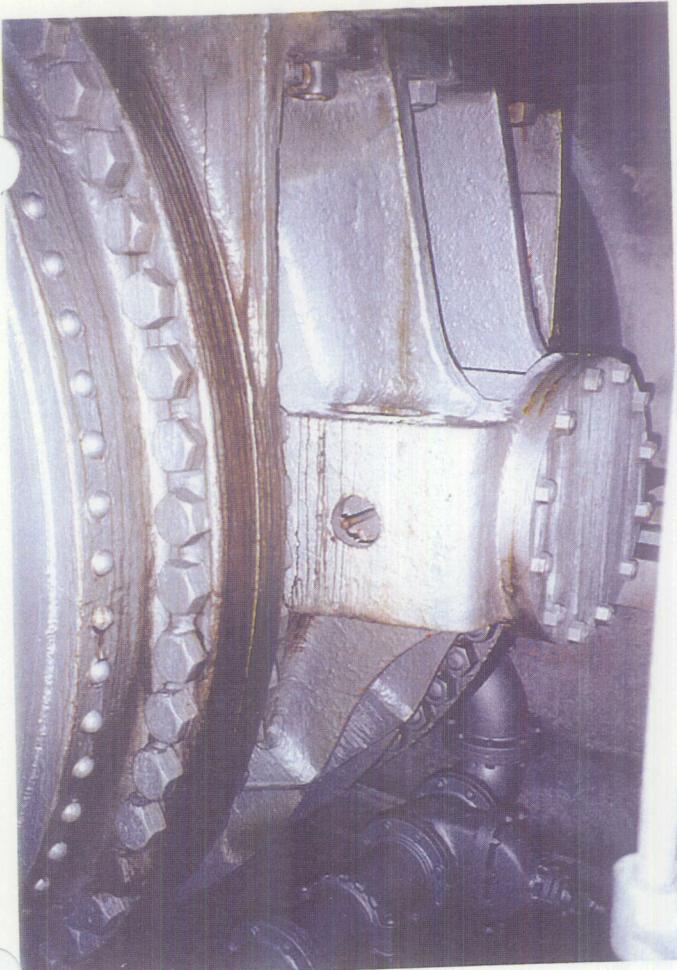
Photo 3 - Morris Dam - Butterfly Valve 1A -
View of valve trunnion housing. 07/01/98

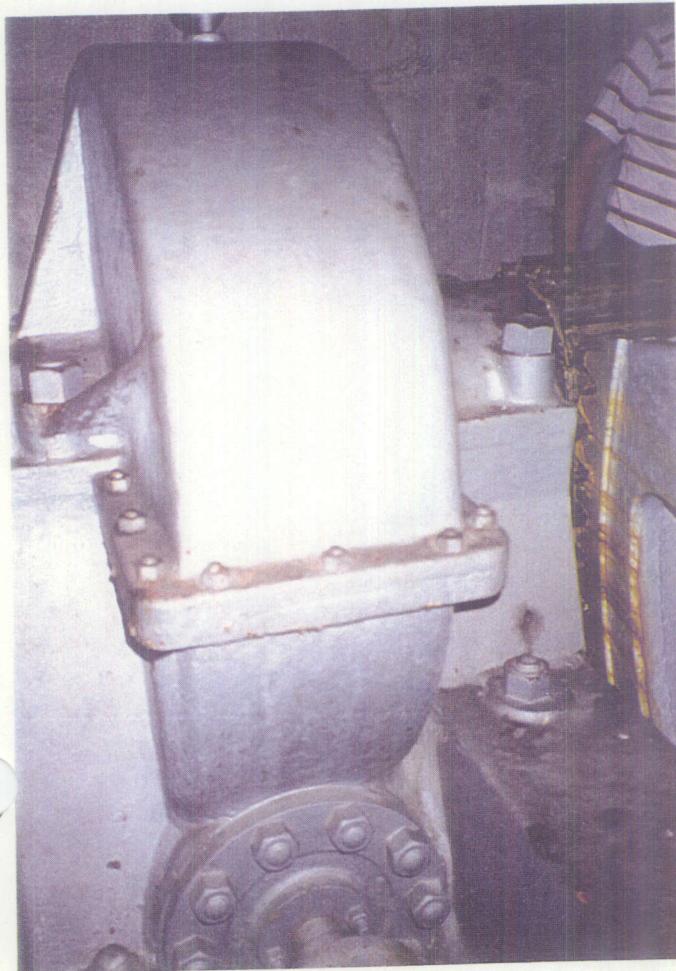
Photo 4 - Morris Dam - Butterfly Valve 1A -
View of valve gear housing. 07/01/98

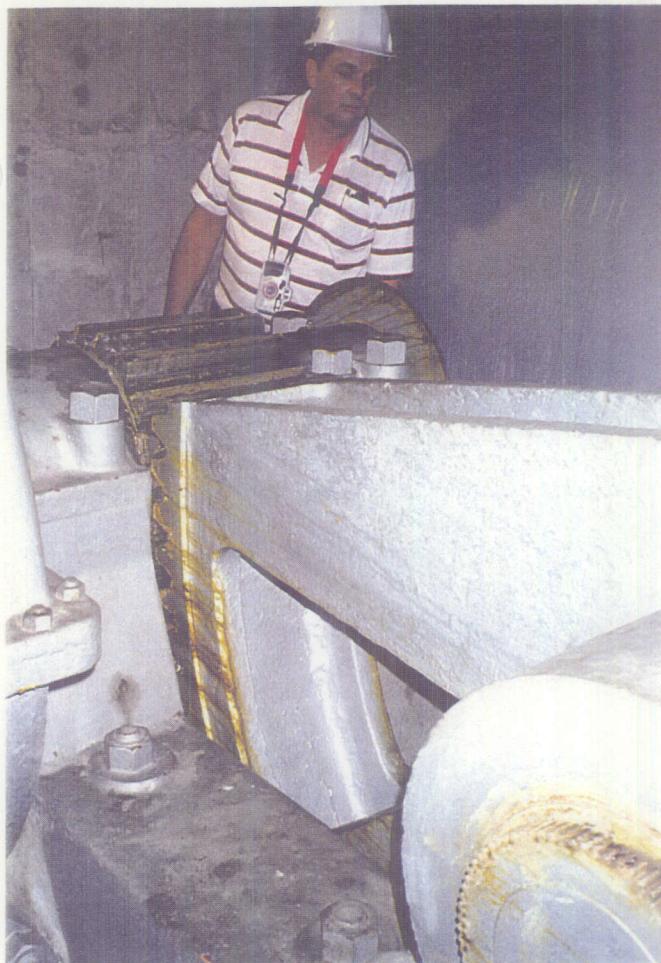
Photo 5 - Morris Dam - Butterfly Valve 1A -
View of valve spur gear operating arm.

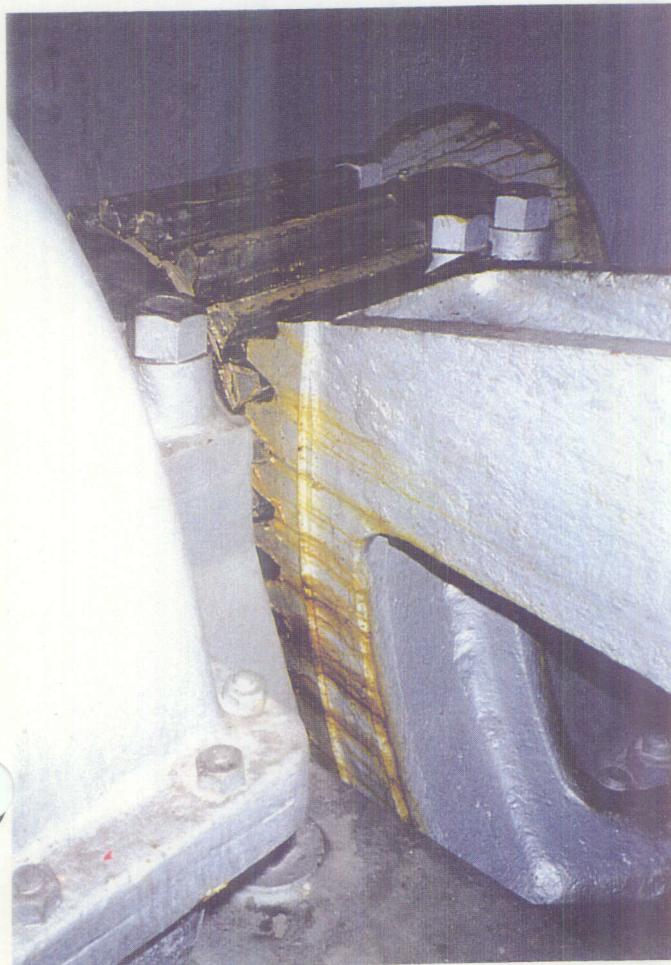
Photo 6 - Morris Dam - Butterfly Valve 1A -
View of valve spur gear operating arm.

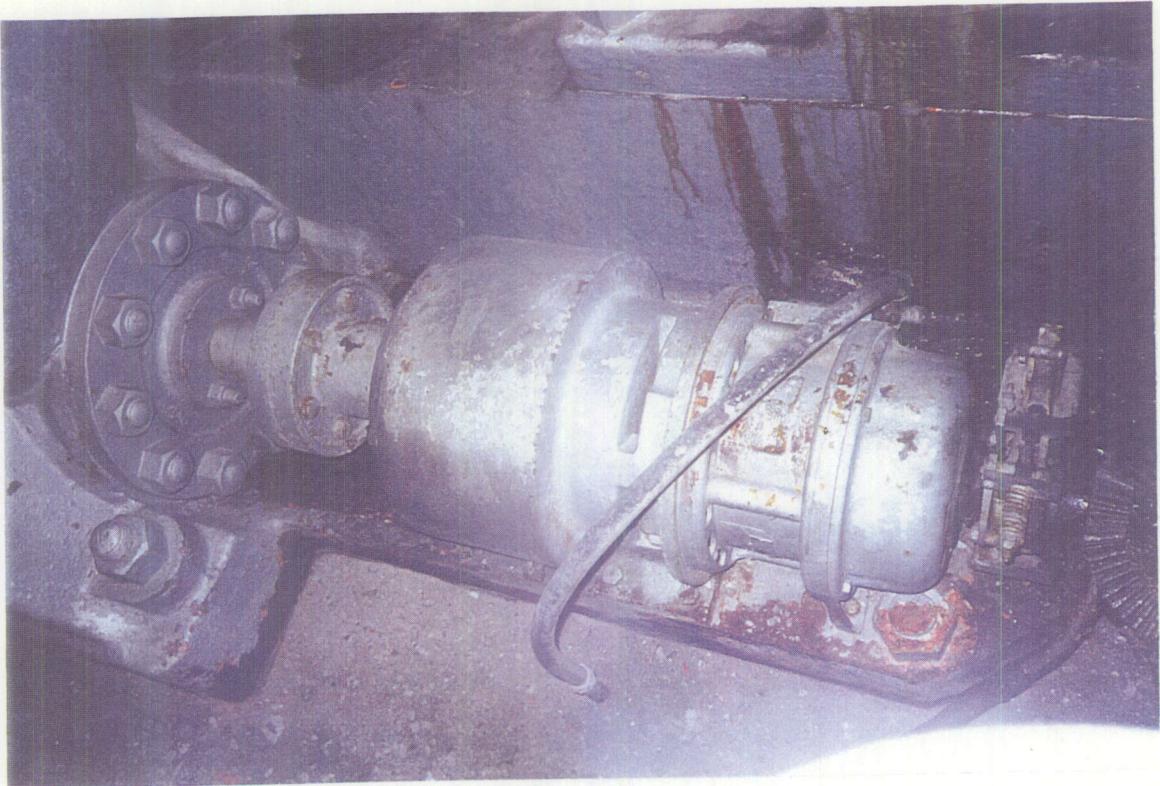
Photo 7 - Morris Dam - Butterfly Valve 1A - View of valve operator electric motor.
07/01/98

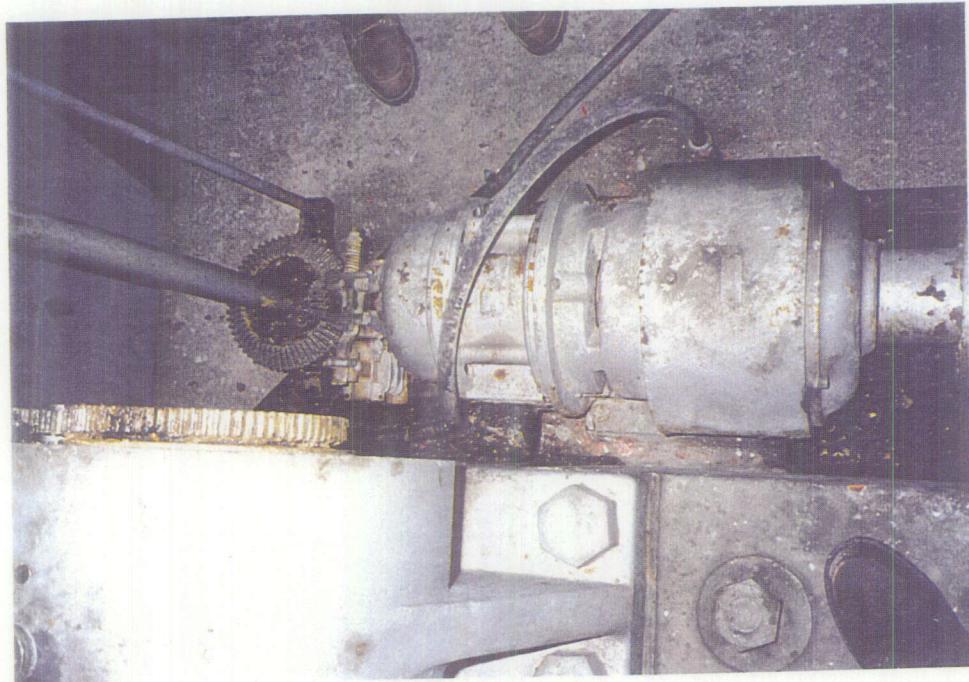
Photo 8 - Morris Dam - Butterfly Valve 1A - View of valve operator
electric motor.
07/01/98

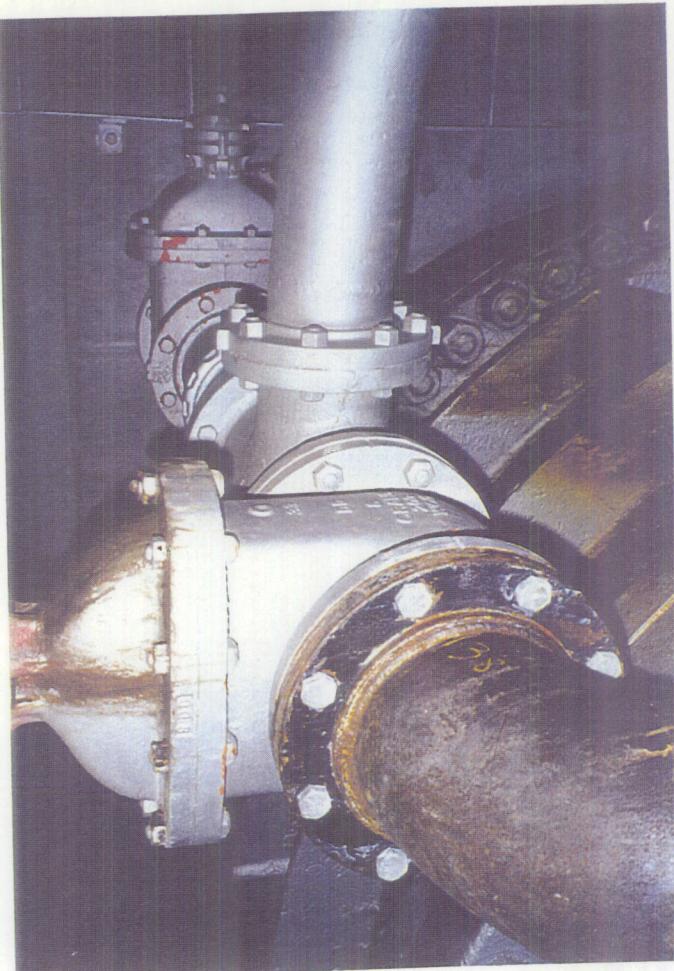
Photo 9 - Morris Dam - Butterfly Valve 1A -
View of valve bypass piping and valves.

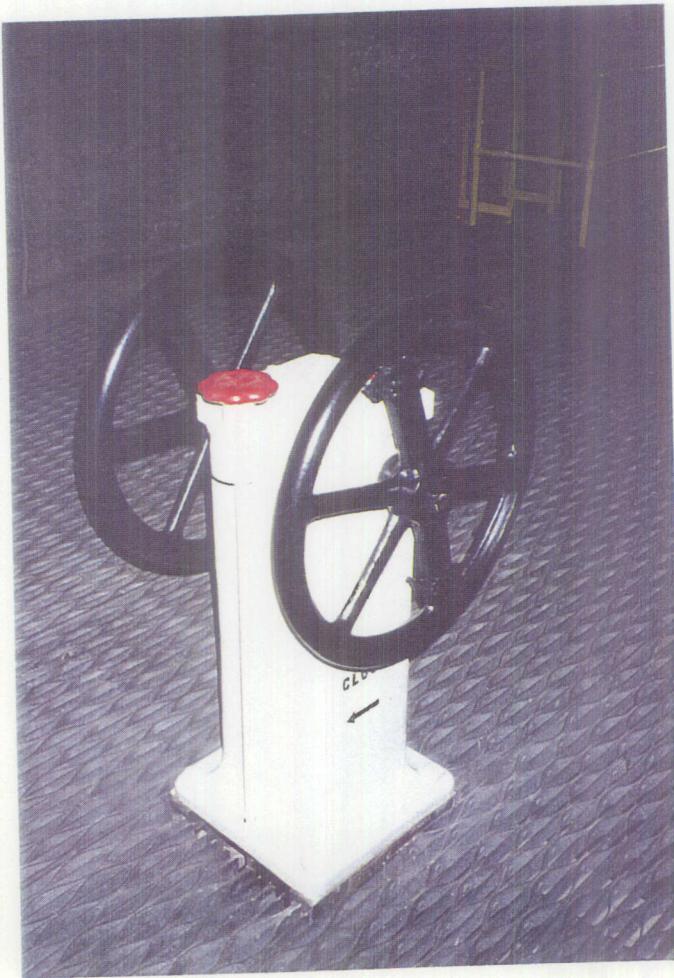
Photo 10 - Morris Dam - Butterfly Valve 1A
- View of valve operating handwheel.

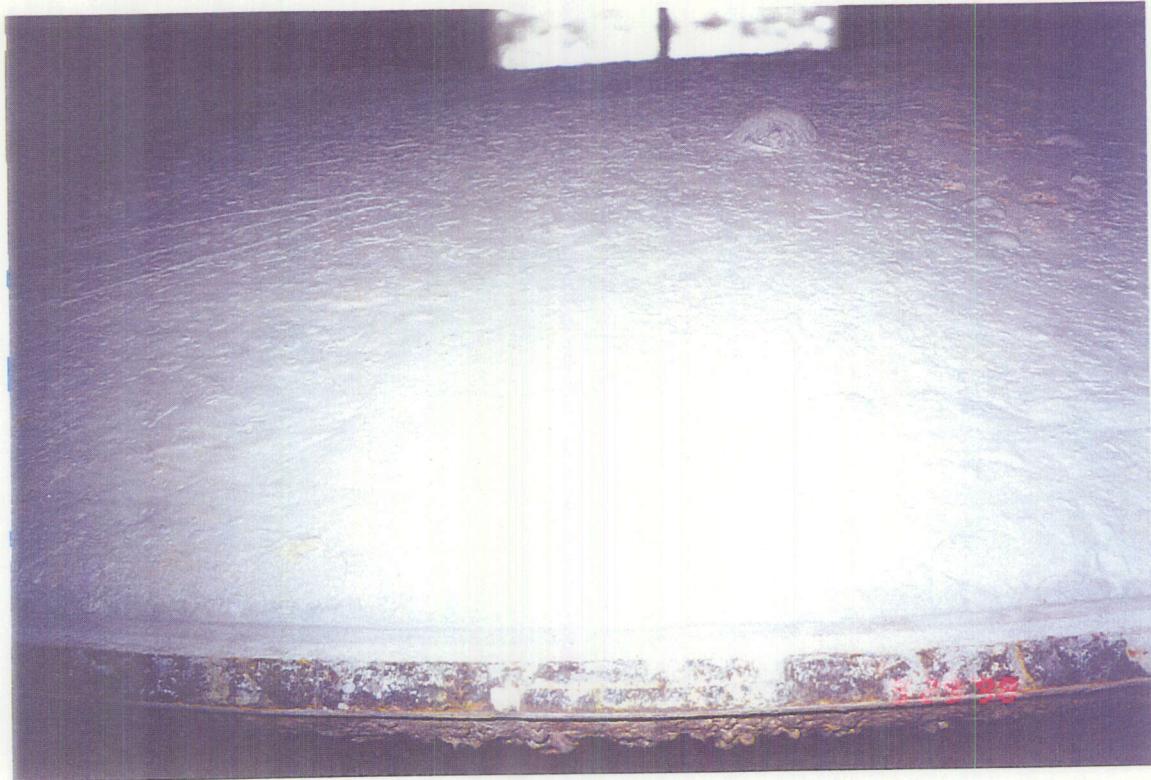
Photo 11- Morris Dam - Butterfly Valve 1A - View of upstream face of valve disc and seal.

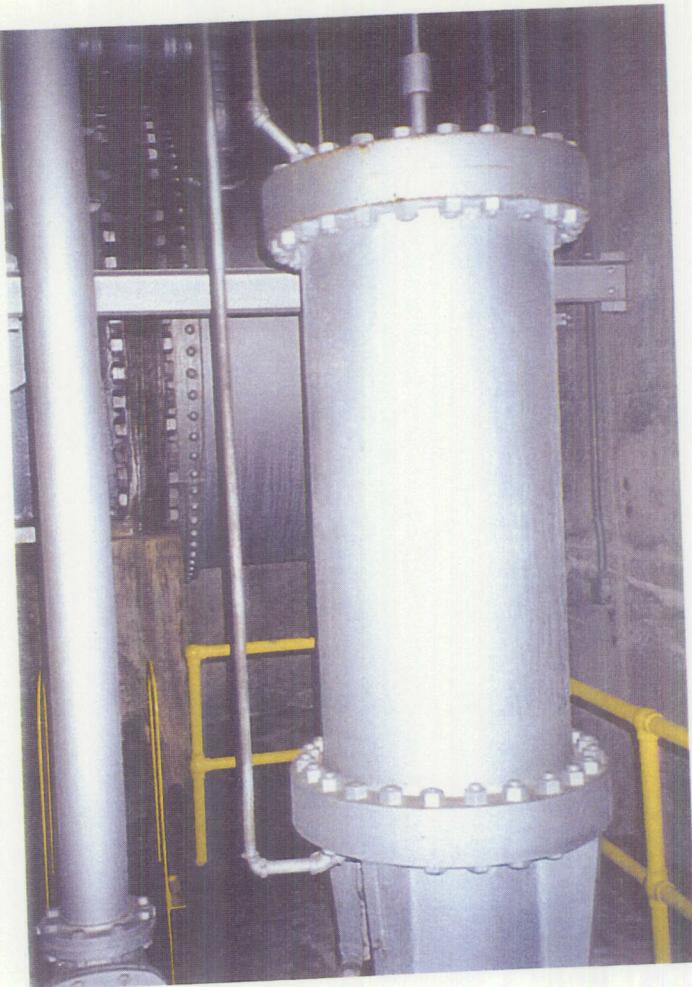
Photo 1 - Morris Dam - Slide Gate
2A - View of hoist and bonnet cover.
07/01/98

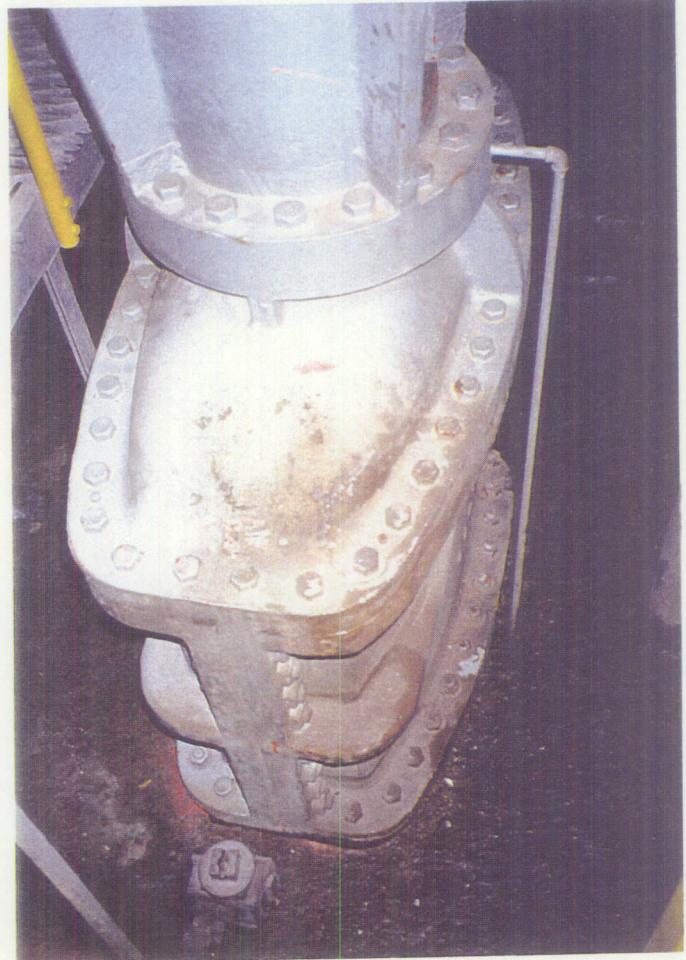
- ◆ Valve lower body is embedded in concrete.
- ◆ It was reported by dam tender that when valve was operated unbalanced (opened) that the vibration was so severe that the bypass filling line valve cracked and had to be replaced with a butterfly valve. (Noticed that gates had been operating with filling line open.)
- ◆ Downstream needle valve 2 has been removed and replaced with a gate valve and extension pipe for sluicing.

Photo 2 - Morris Dam - Slide Gate 2A - View of
bonnet cover and body. Note lower body
embedded in concrete. 07/01/98

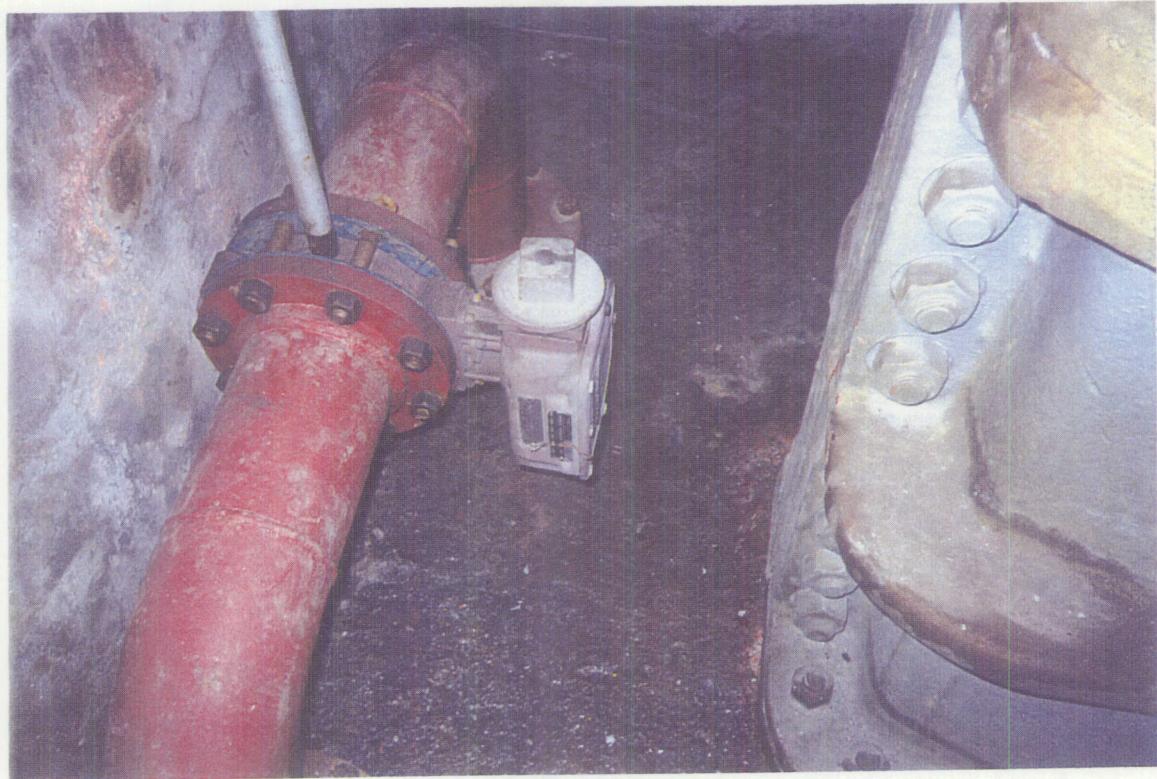
Photo 3 - Morris Dam - Slide Gate 2A - View of bypass pipe and bypass butterfly valve.
07/01/98

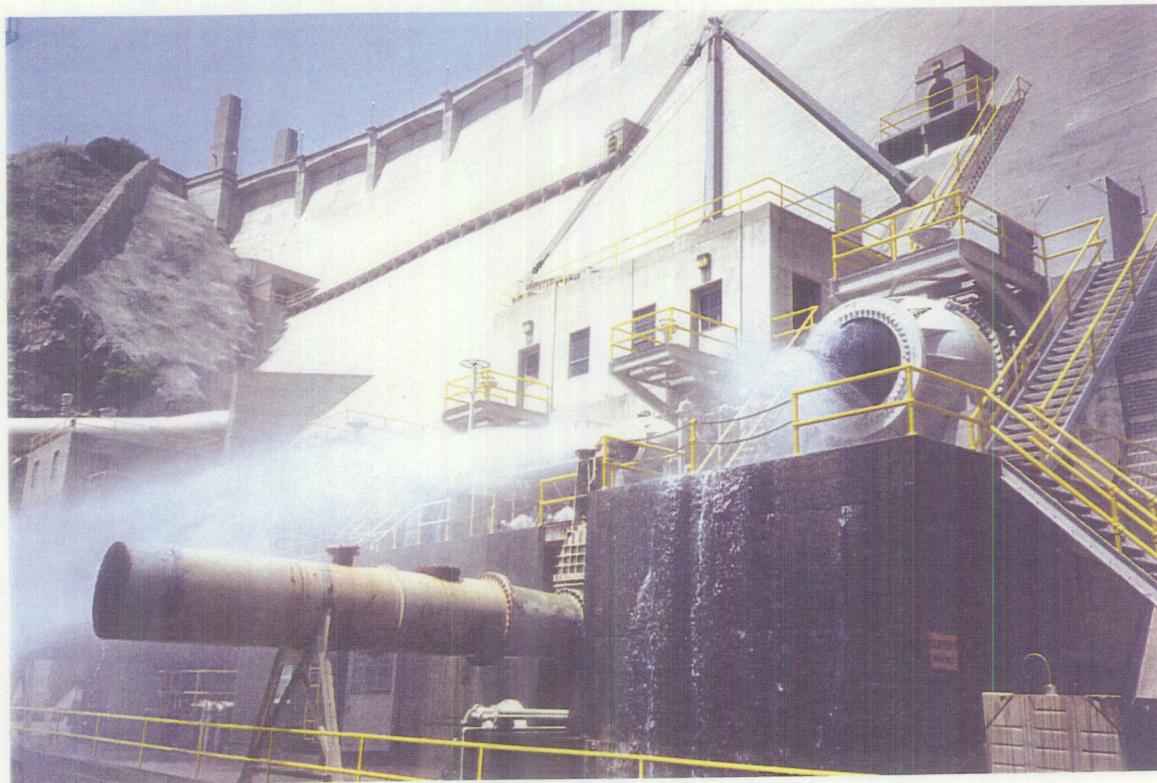
Photo 1 - Morris Dam - Valve 2 (removed) - View showing pipe extension on outlet used
for sluicing.
07/01/98

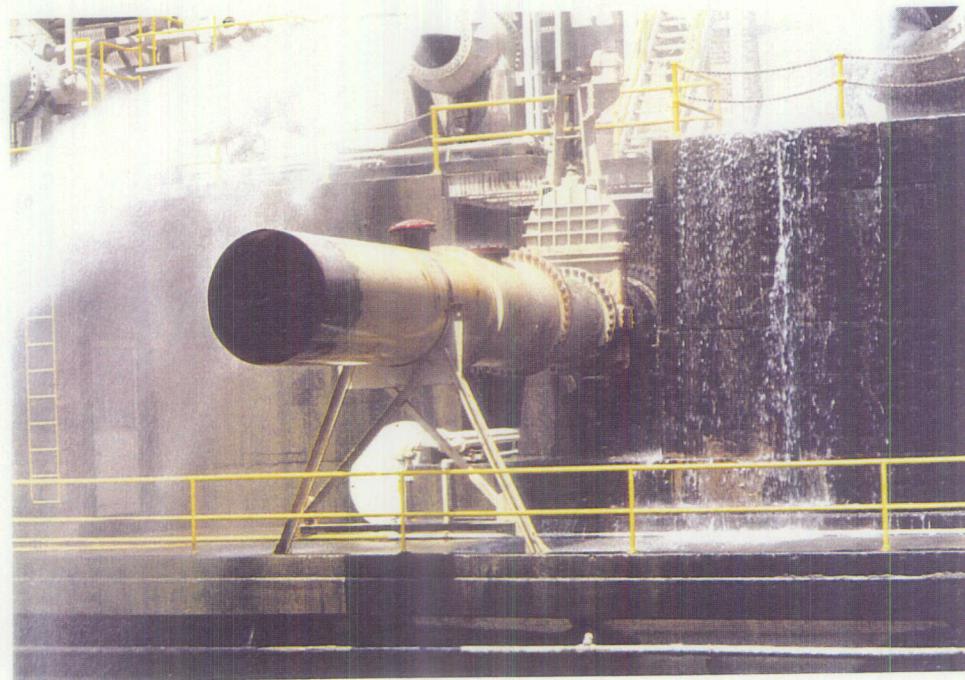
Photo 2 - Morris Dam - Valve 2 (removed) - View showing pipe extension
and gate valve on outlet used for sluicing.
07/01/98

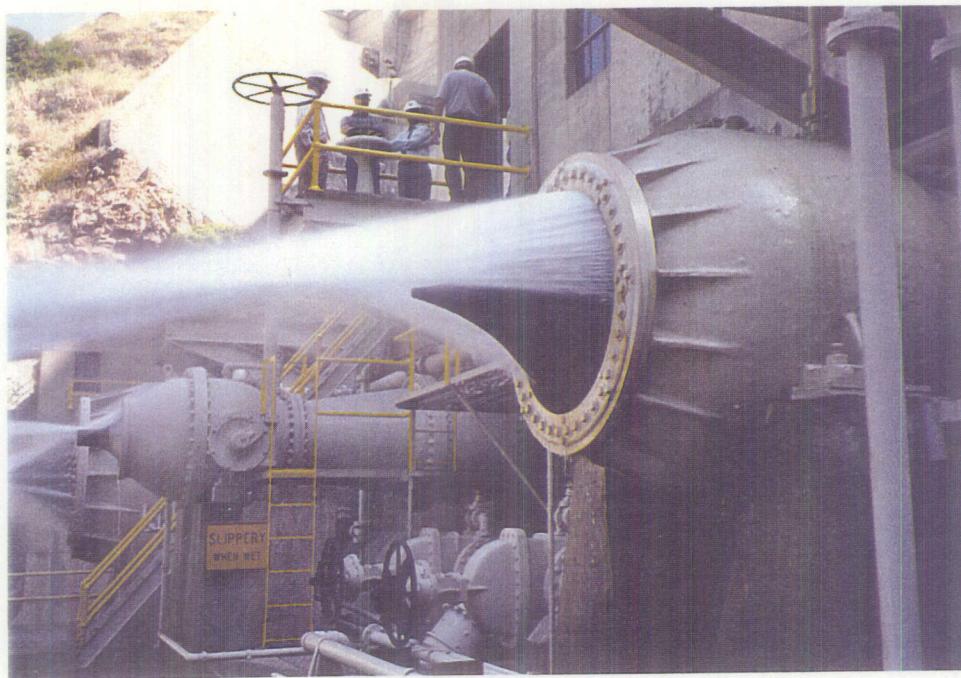
Photo 1 - Morris Dam - Needle Valve 3 - View showing needle valve body and leakage at full head. 07/01/98

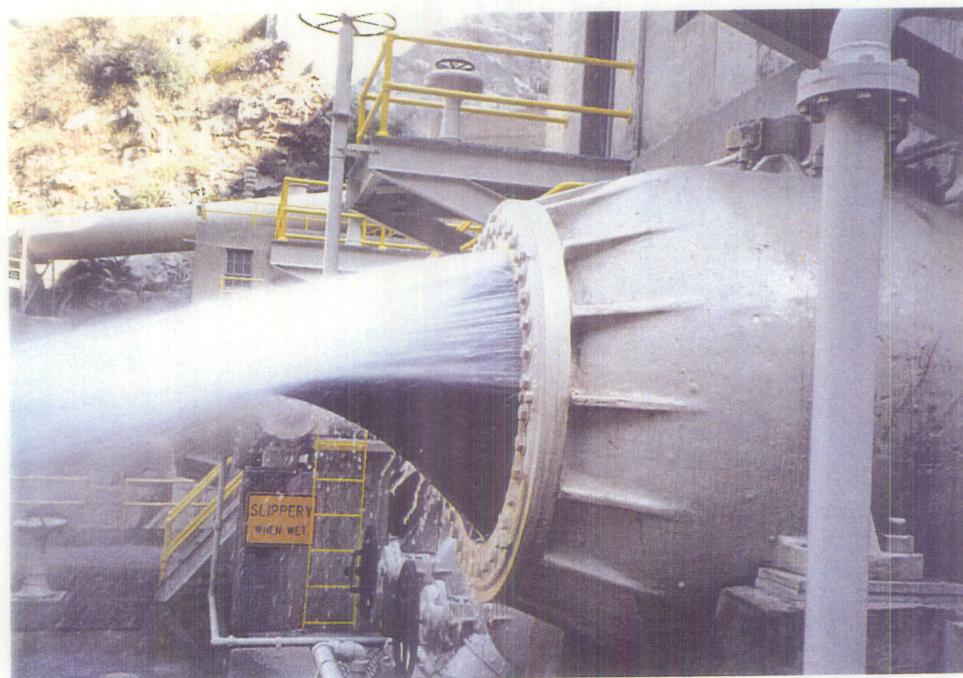
Photo 2 - Morris Dam - Needle Valve 3 - View showing needle valve body and leakage at full head. 07/01/98

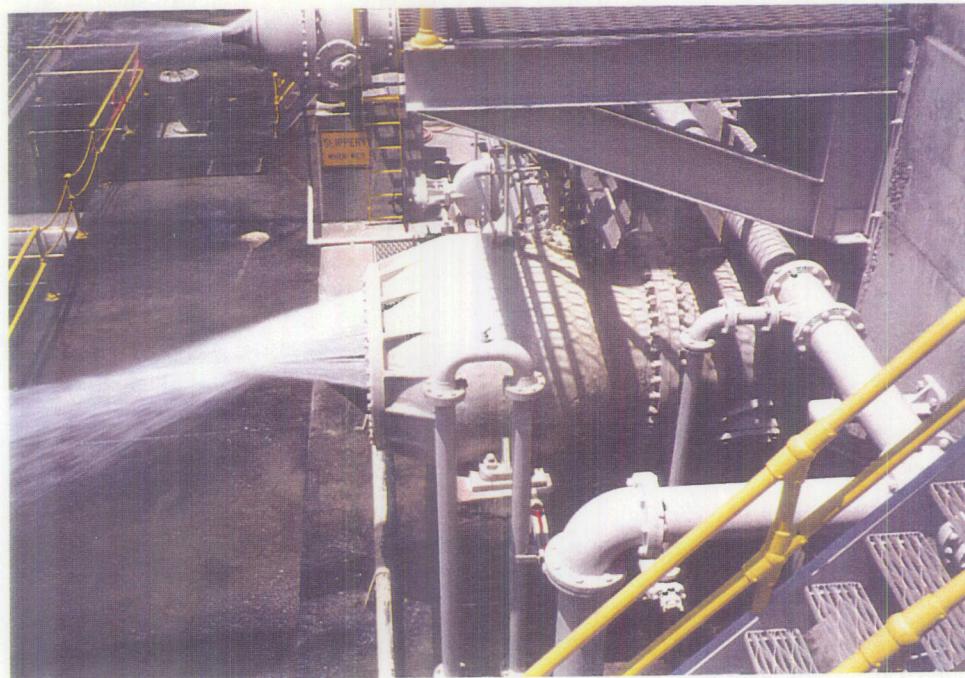
Photo 5 - Morris Dam - Needle Valve 3 - View showing needle valve body, piping, and leakage at full head. 07/01/98

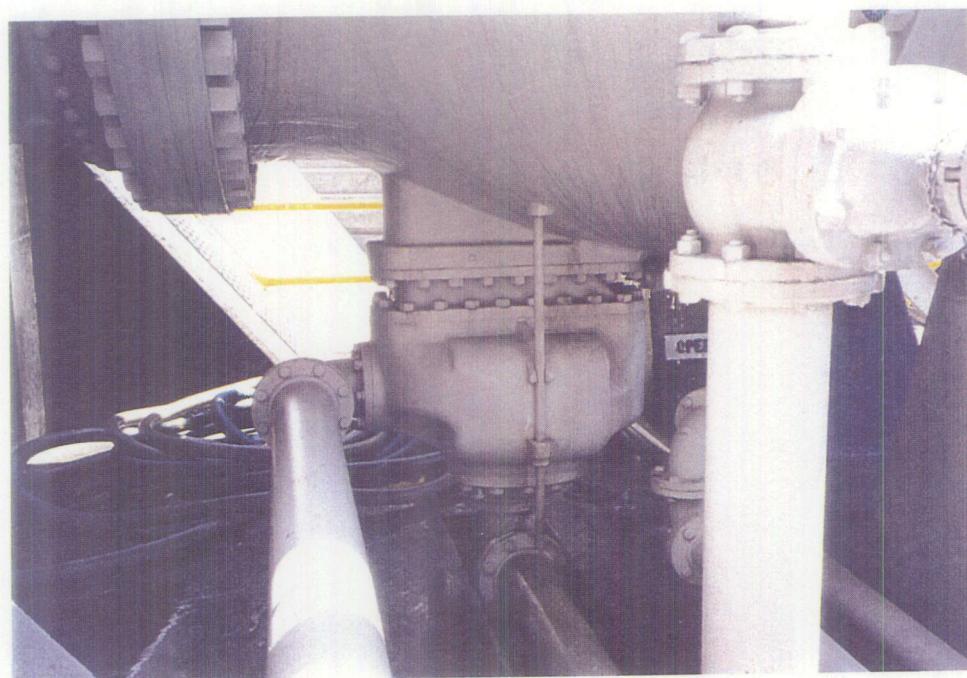
Photo 6 - Morris Dam - Needle Valve 3 - View showing needle valve paradox valve and piping. 07/01/98

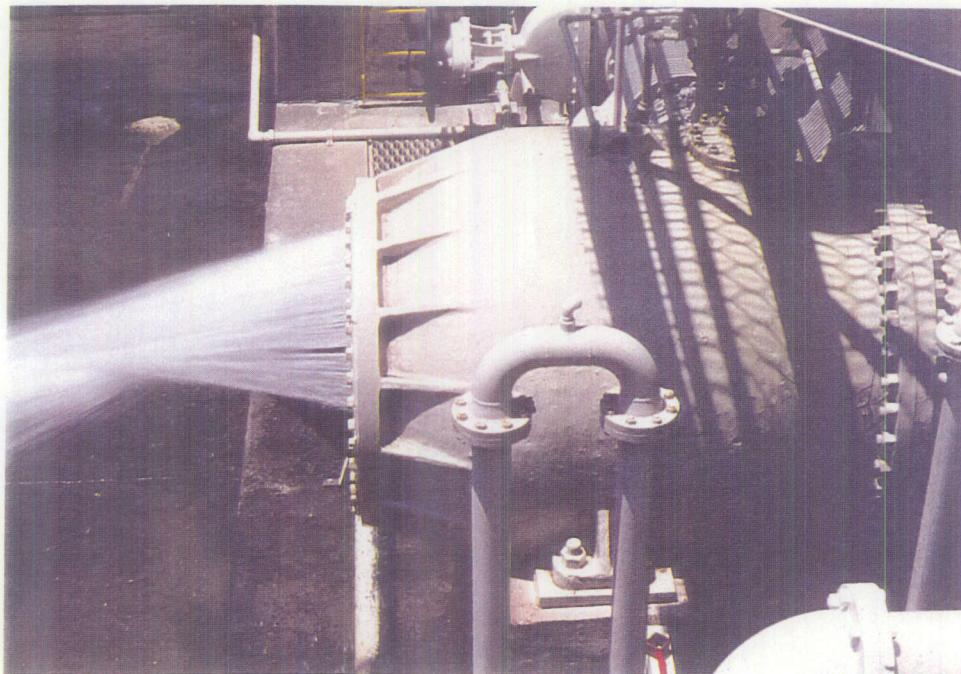
Photo 3 - Morris Dam - Needle Valve 3 - View showing needle valve body, gooseneck piping, and leakage at full head. 07/01/98

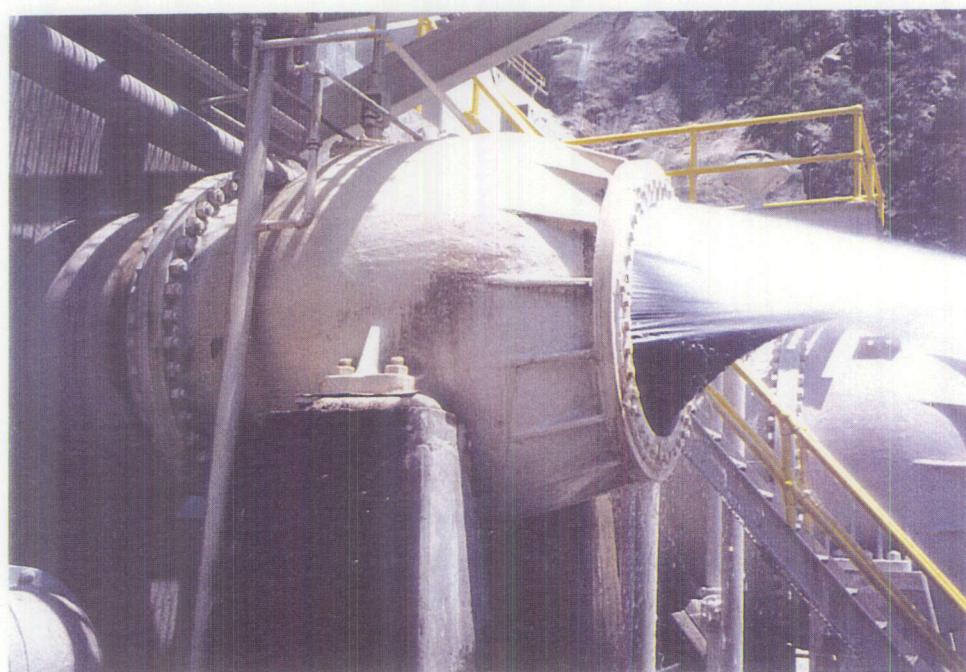
Photo 4 - Morris Dam - Needle Valve 3 - View showing needle valve body, pedestal, and leakage at full head. 07/01/98
