EQUIPMENT INSPECTION / EVALUATION REPORT

MORRIS DAM INLET/OUTLET WORKS
MODERNIZATION
County of Los Angeles
Department of Public Works

MECHANICAL EXAMINATION REPORT

Morris Dam Inlet/Outlet Works Modernization

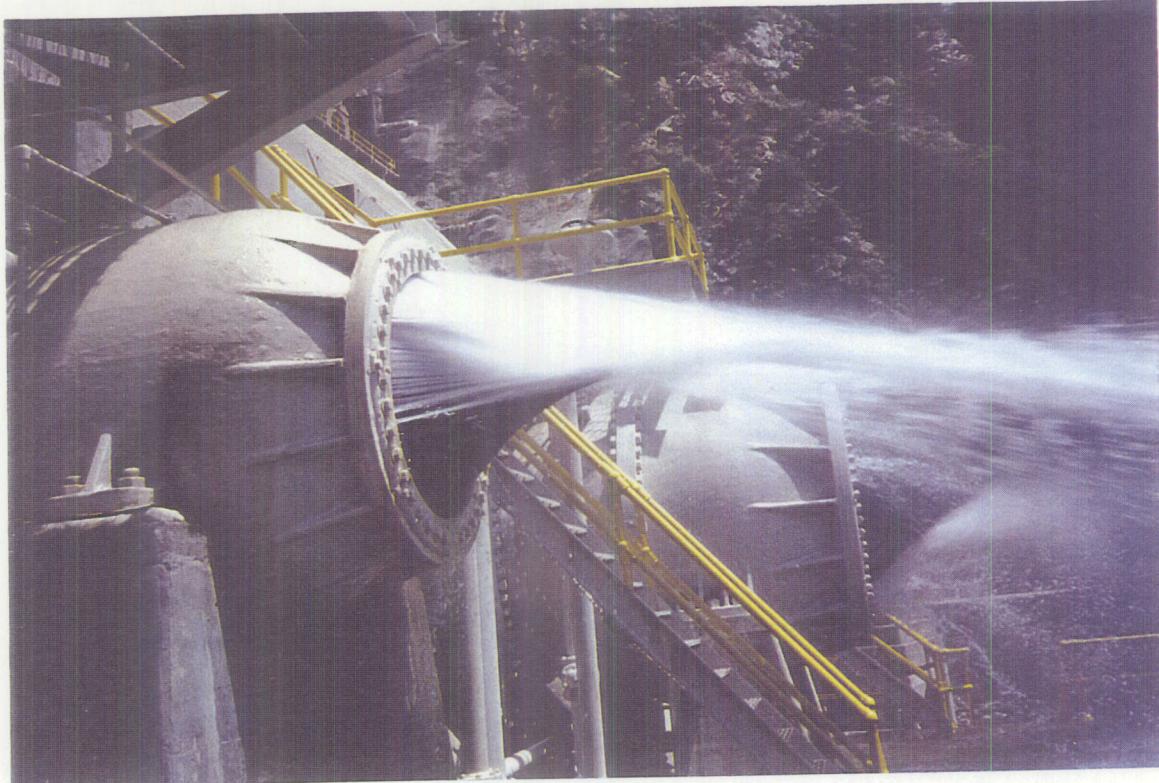
Photo 7 - Morris Dam - Needle Valve 3 - View showing needle valve body, pedestal, and leakage at full head.
07/01/98

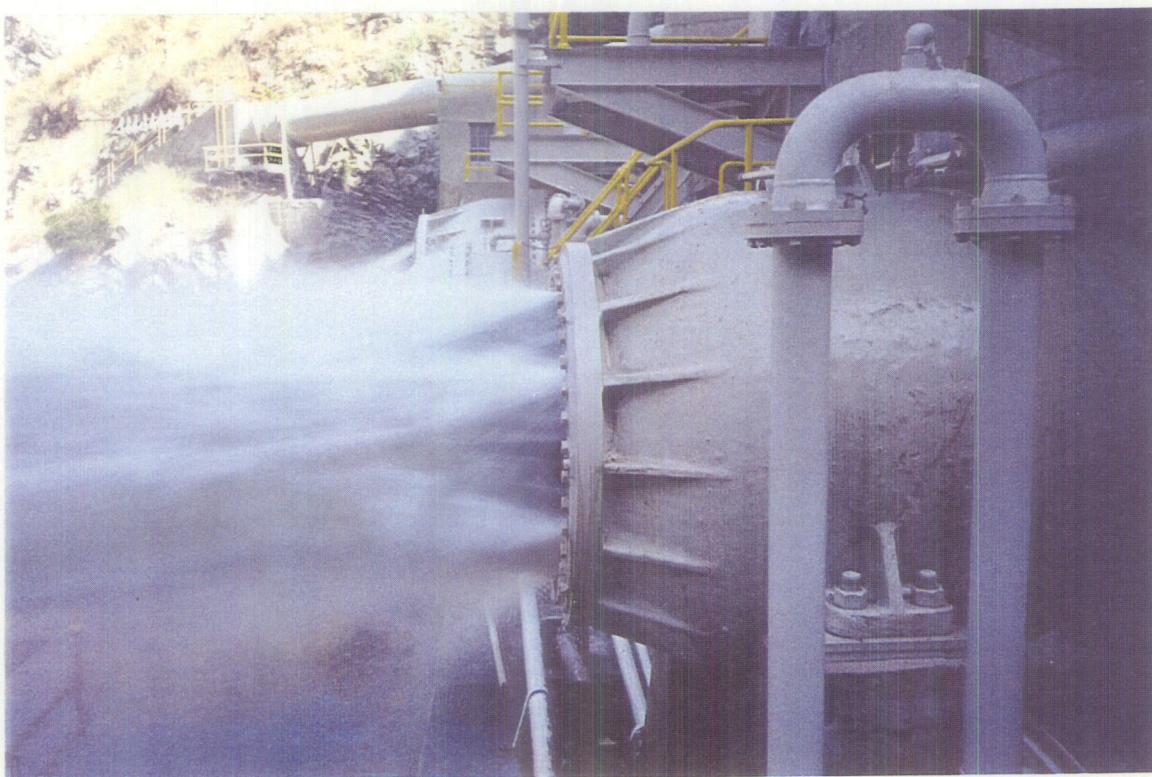
Photo 8 - Morris Dam - Needle Valve 3 - View showing needle valve gooseneck piping, and discharge at full head.
07/01/98

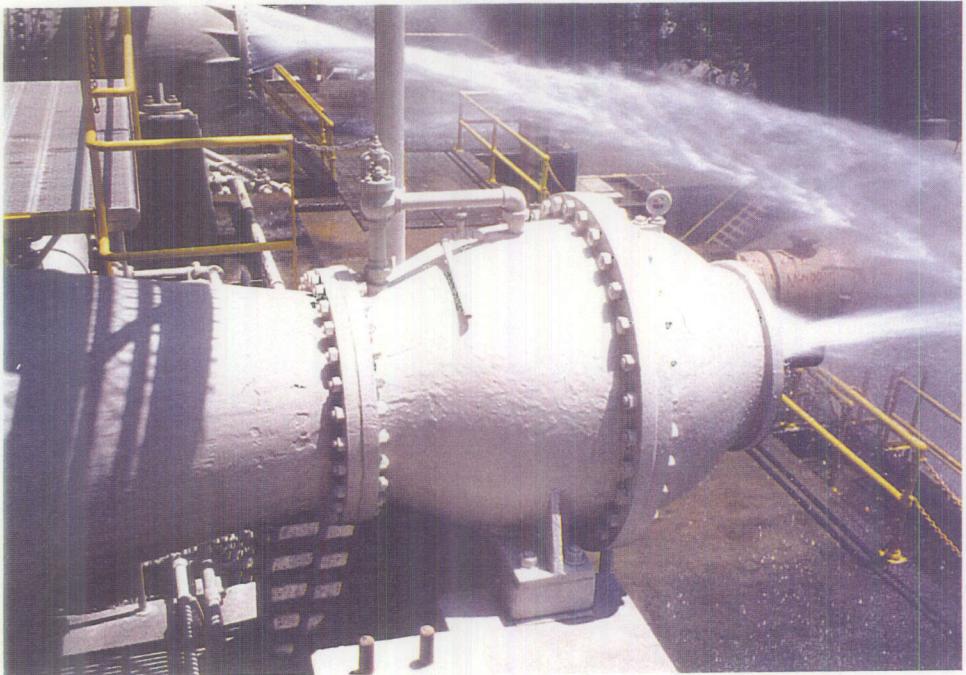
Photo 1 - Morris Dam - Pelton Needle Valve 4 - View showing needle valve body and leakage at full head. 07/01/98

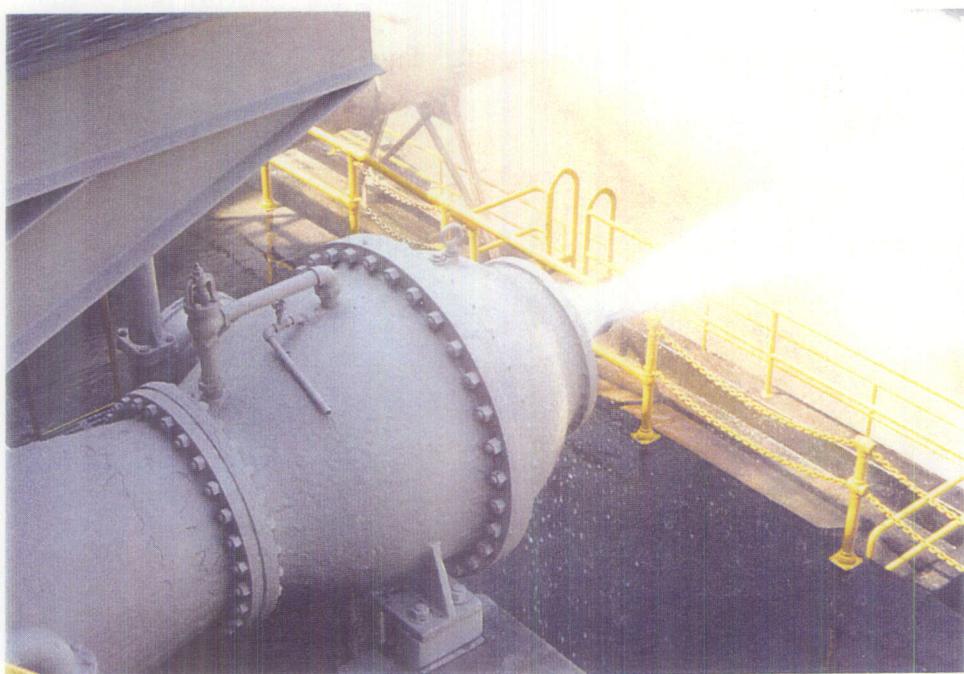
Photo 2 - Morris Dam - Pelton Needle Valve 4 - View showing needle valve body and leakage at full head. 07/01/98

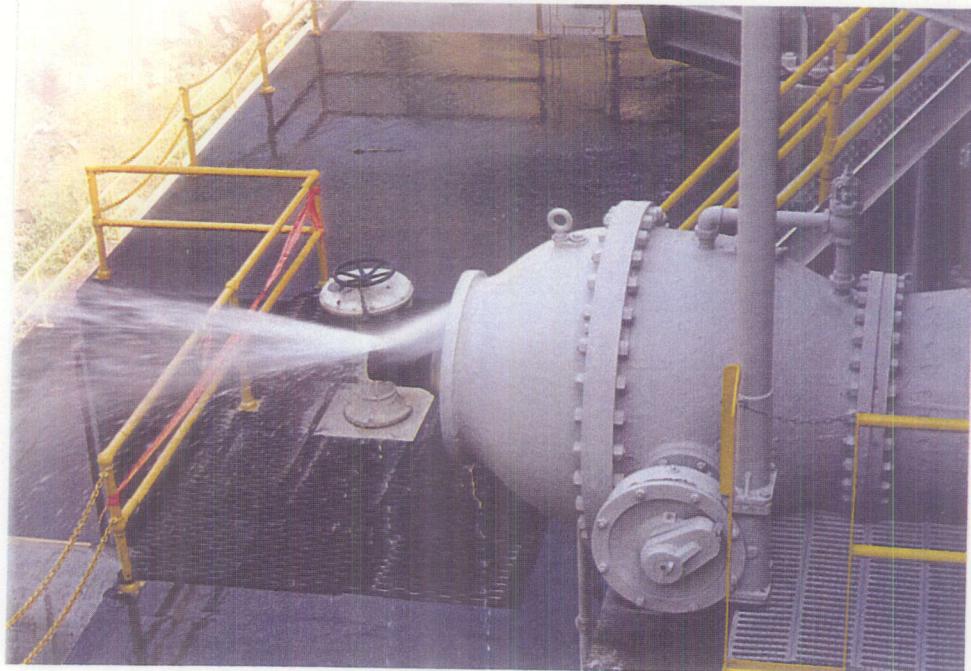
Photo 3 - Morris Dam - Pelton Needle Valve 4 - View showing needle valve body and leakage at full head.
07/01/98

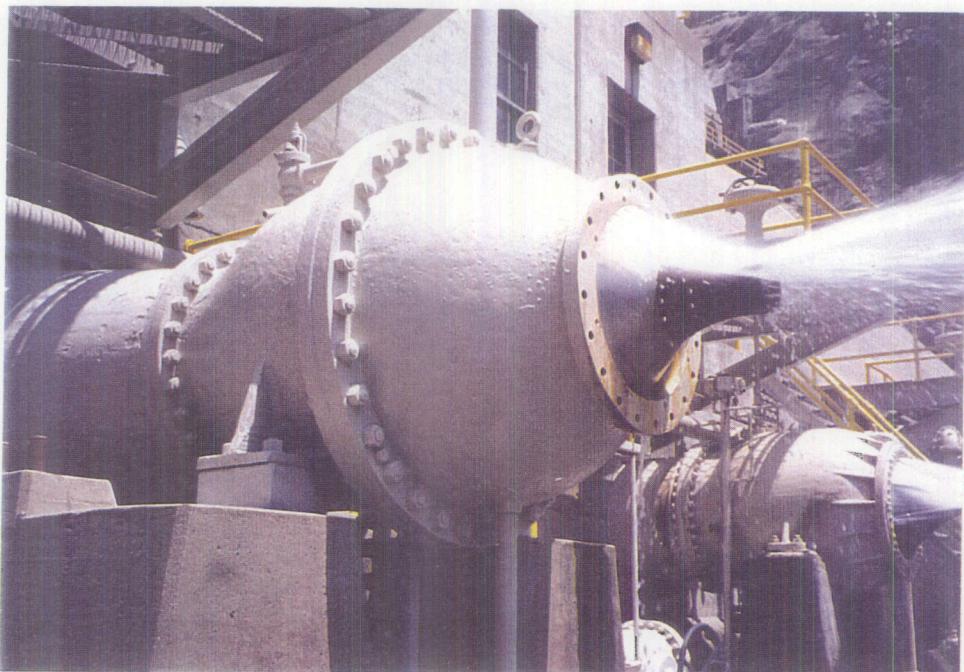
Photo 4 - Morris Dam - Pelton Needle Valve 4 - View showing needle valve body and leakage at full head.
07/01/98

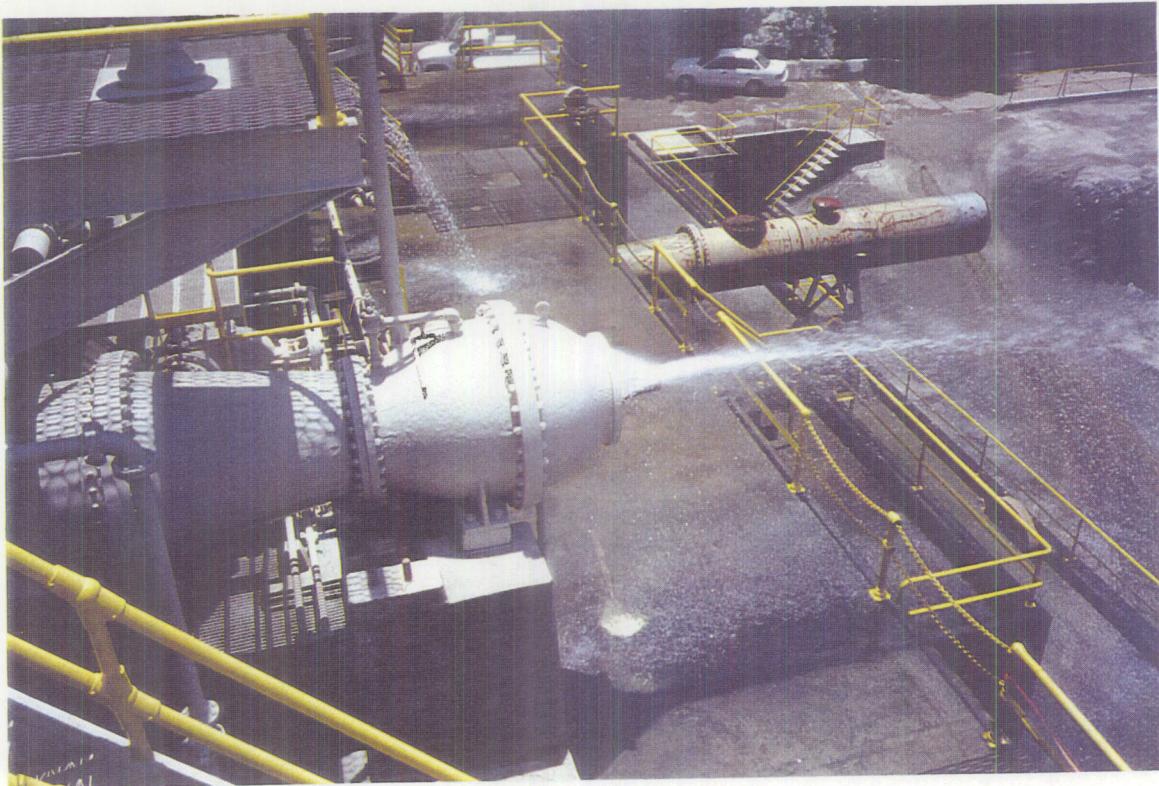
Photo 5 - Morris Dam - Pelton Needle Valve 4 - View showing needle valve body and leakage at full head.
07/01/98

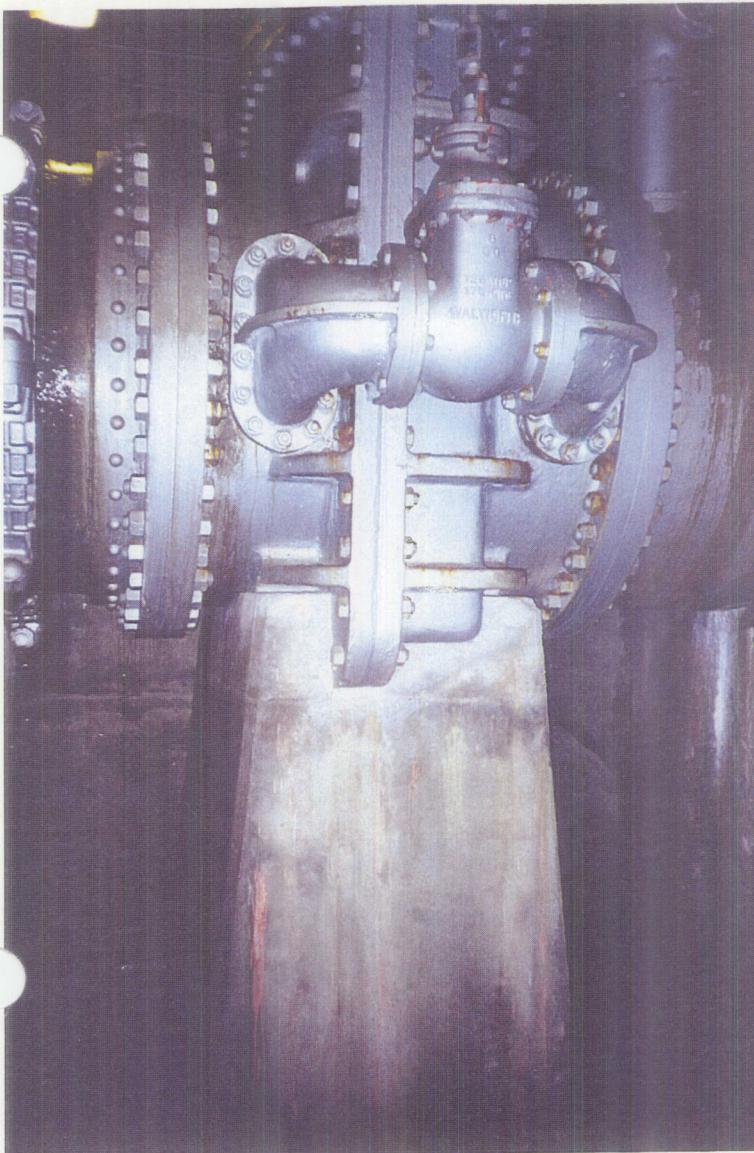
Photo 3 - Morris Dam - Slide Gate
4A - View of gate body, bypass valve
and pedestal. Note bottom gate body
flange embedded in pedestal.

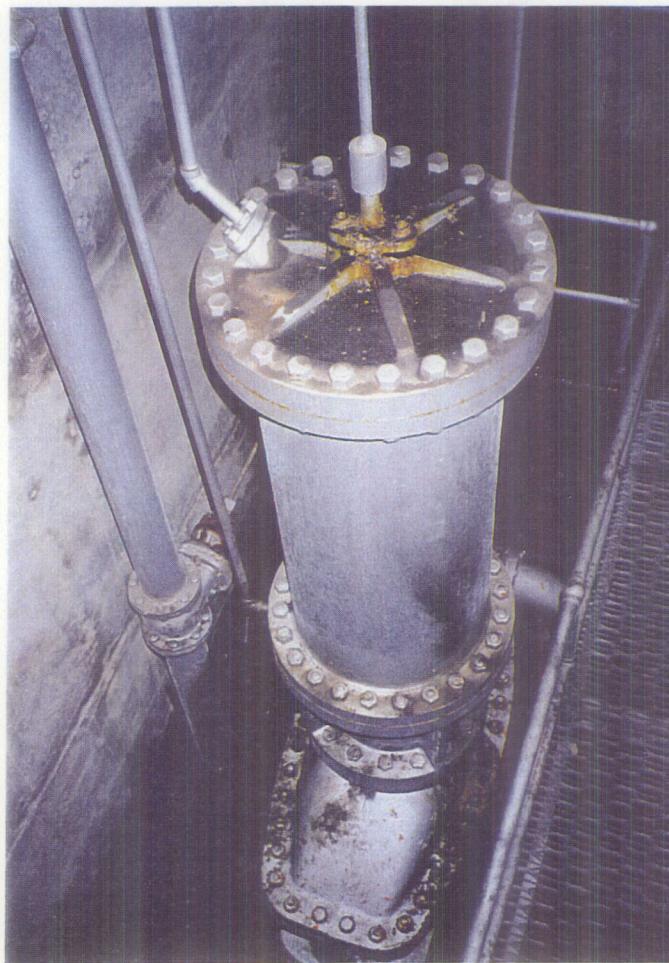
Photo 2. - Morris Dam -
Slide Gate 5A - View of
slide gate cylinder and
bonnet cover. Note body of
gate embedded. 07/01/98

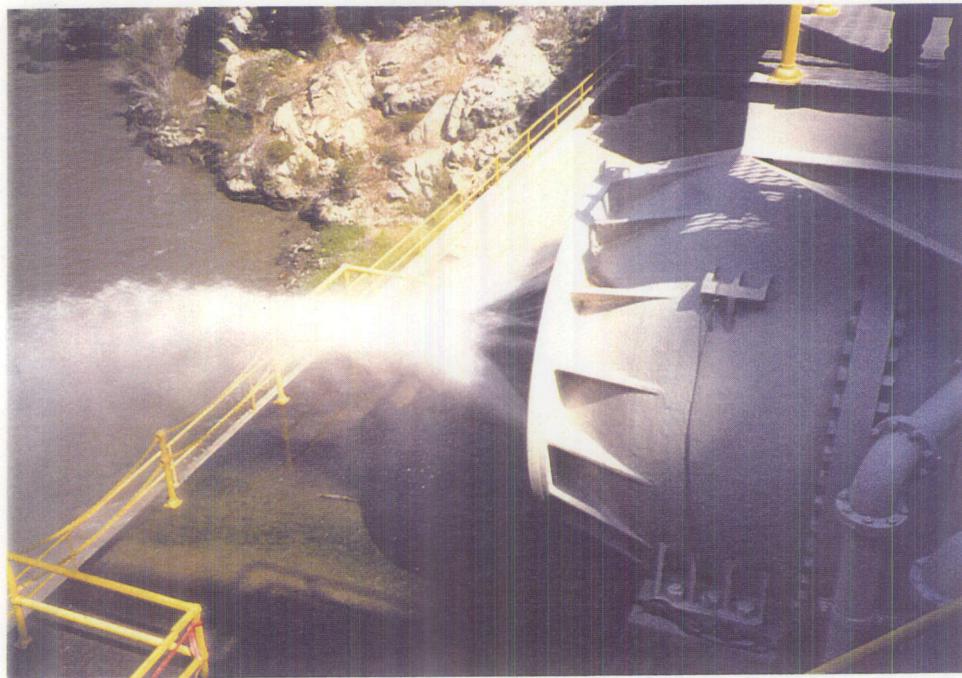
Photo 1 - Morris Dam - Needle Valve 6 - View showing needle valve
leakage at full head.
07/01/98

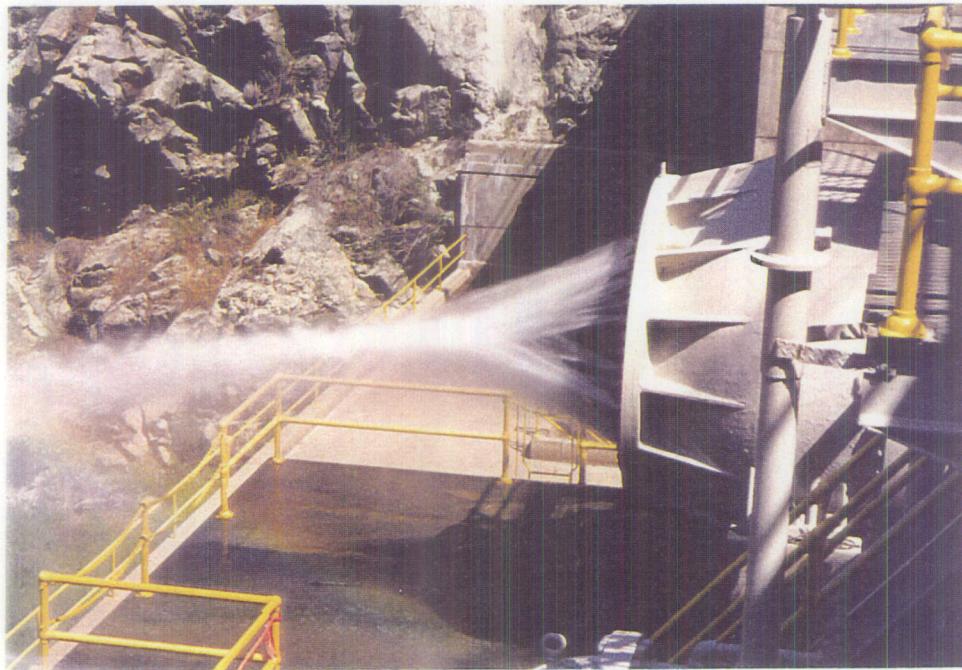
Photo 2 - Morris Dam - Needle Valve 6 - View showing needle valve
leakage at full head.
07/01/98

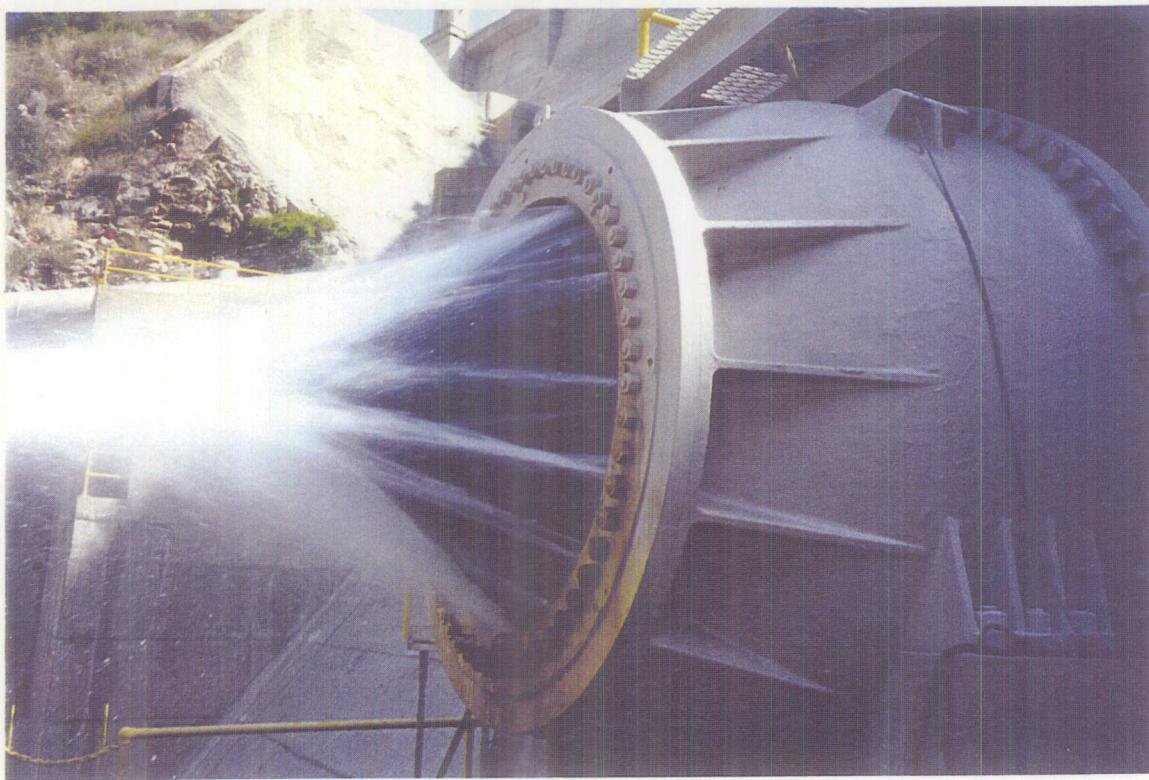
Photo 3 - Morris Dam - Needle Valve 6 - View showing needle valve leakage at full head.
07/01/98

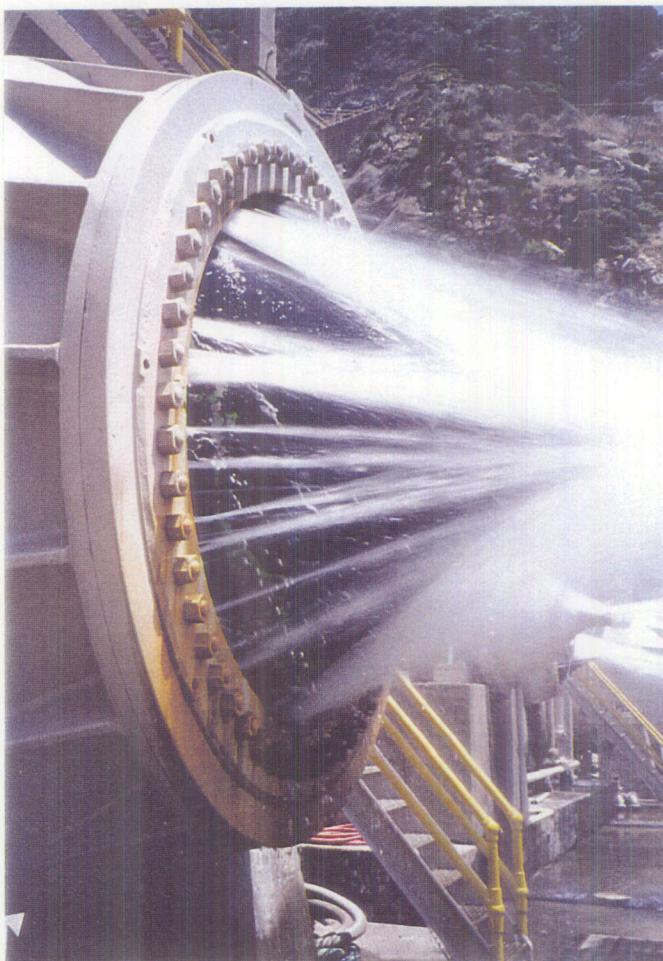
Photo 4 - Morris Dam - Needle
Valve 6 - View showing needle
valve leakage at full head.
07/01/98

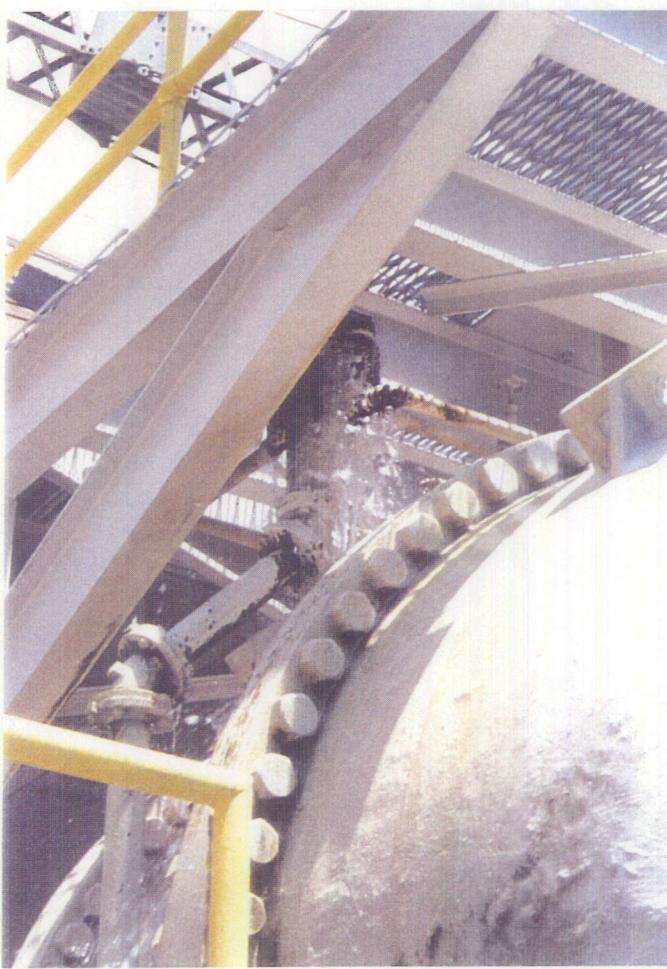
Photo 6 - Morris Dam -
Needle Valve 6 - View
showing needle valve
body flange and air vent
manifold. Note leakage
from manifold.

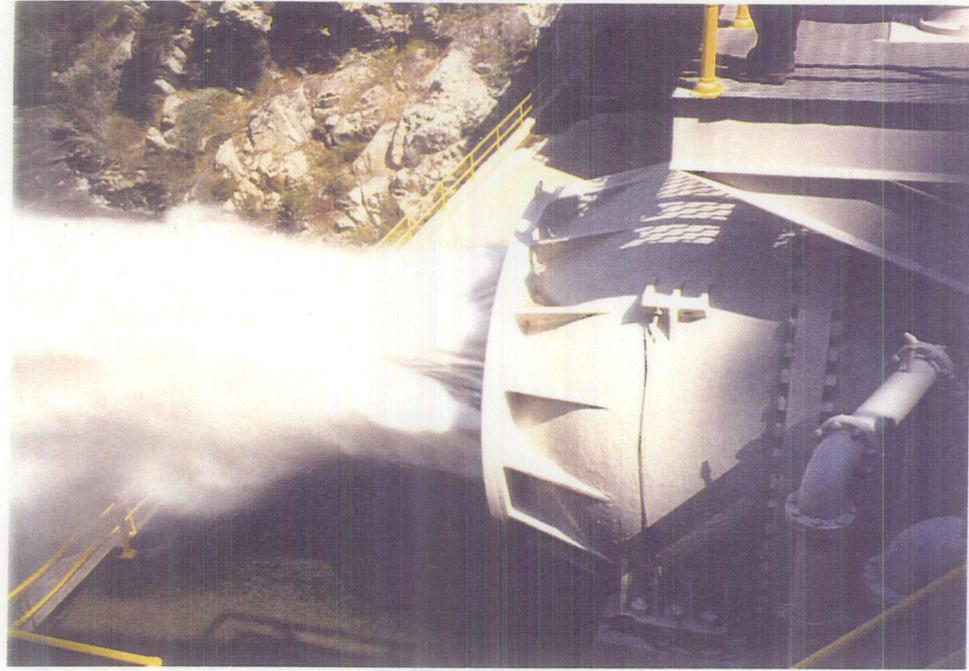
Photo 9 - Morris Dam - Needle Valve 6 - View showing needle valve discharge at full head.
07/01/98

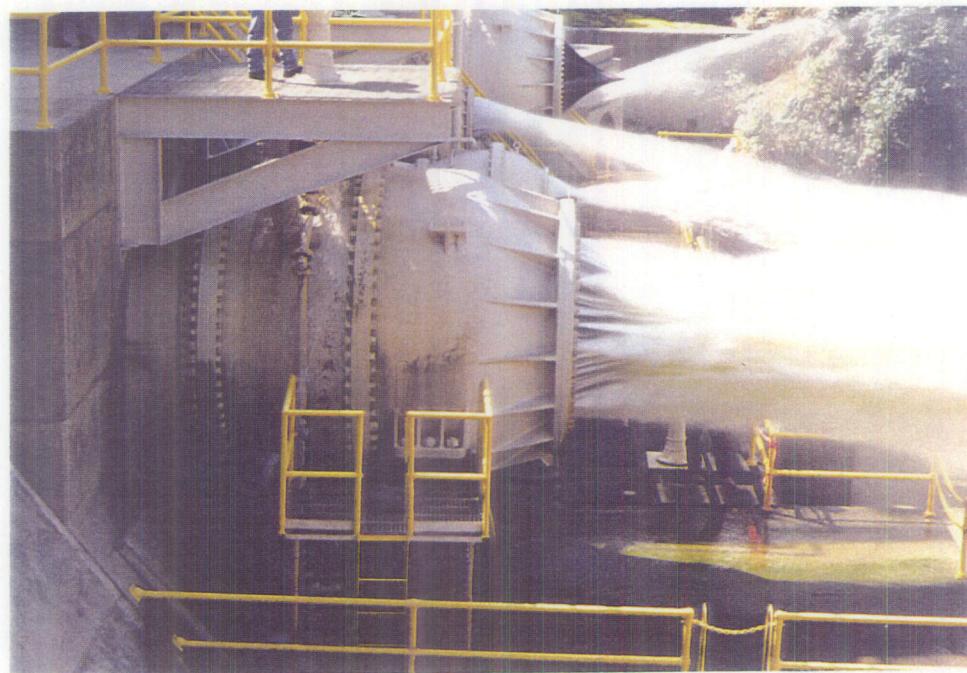
Photo 10 - Morris Dam - Needle Valve 6 - View showing needle valve discharge at full head.
07/01/98

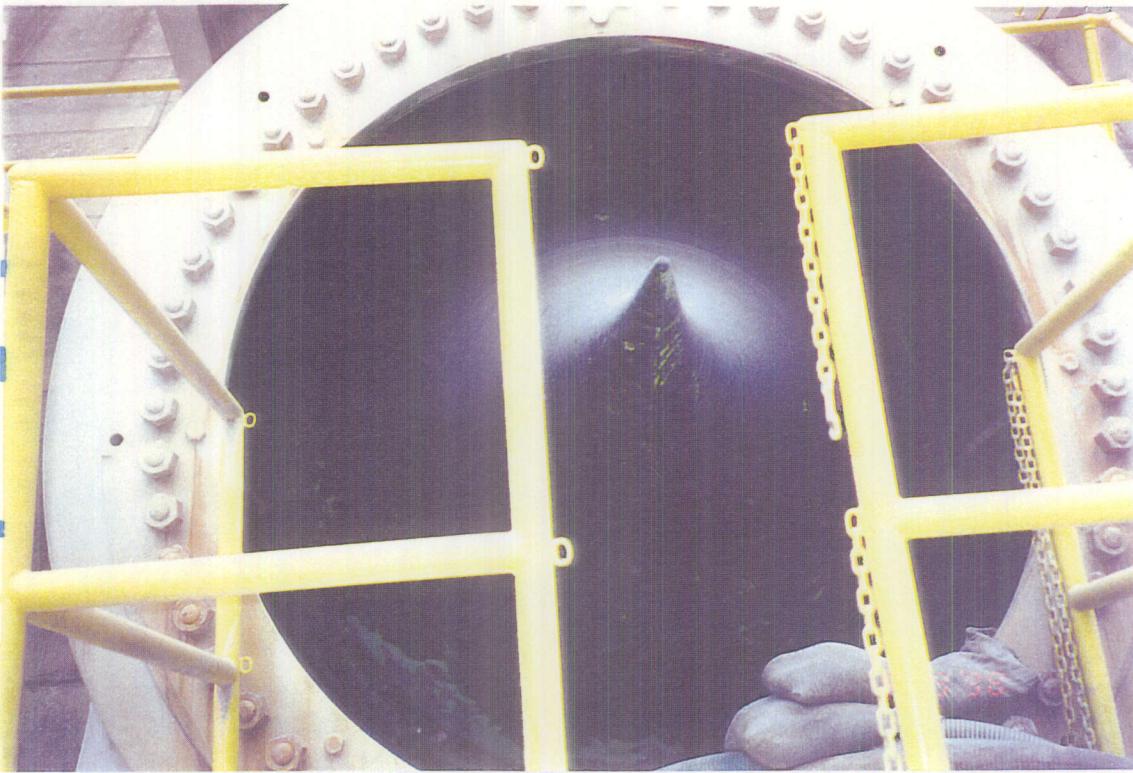
Photo 11- Morris Dam - Needle Valve 6 - View of needle and downstream flange.
09/29/98

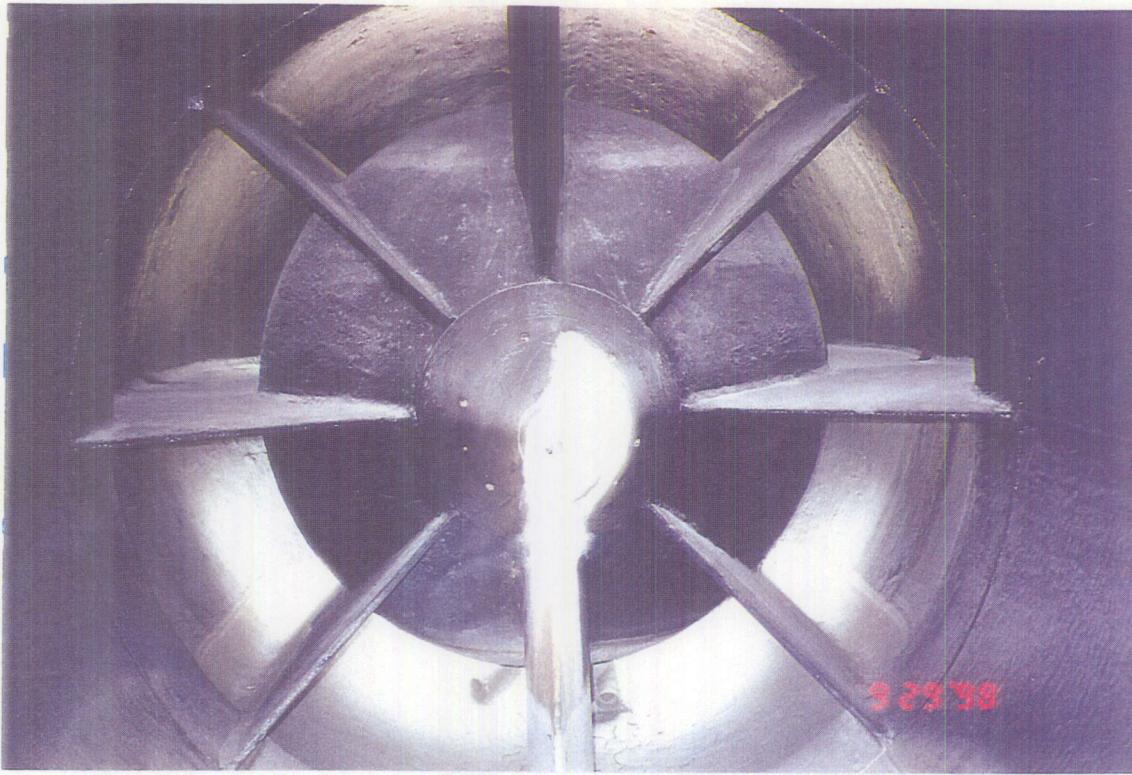
Photo 13- Morris Dam - Needle Valve 6 - View looking downstream of body tip, valve body, and splitters.

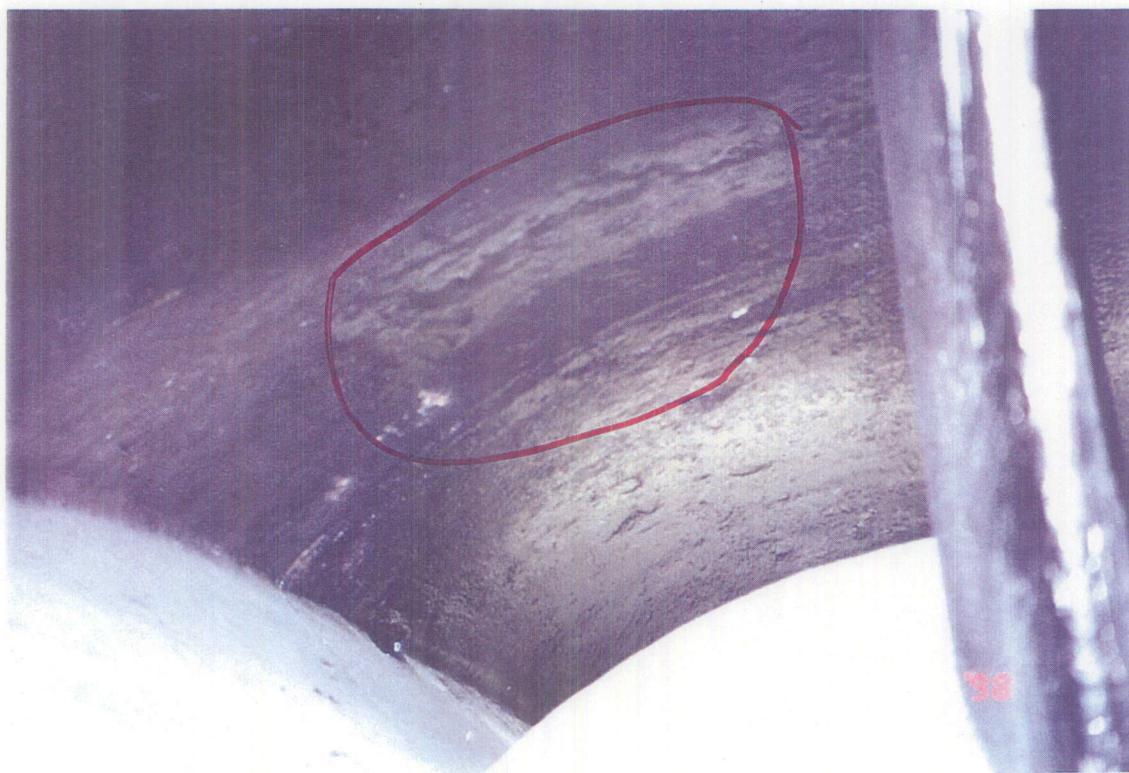
Photo 14 - Morris Dam - Needle Valve 6 - View of area 6" x 24" x ½ deep of material loss 36" downstream of upstream flange between 1030 and 12 o'clock splitters

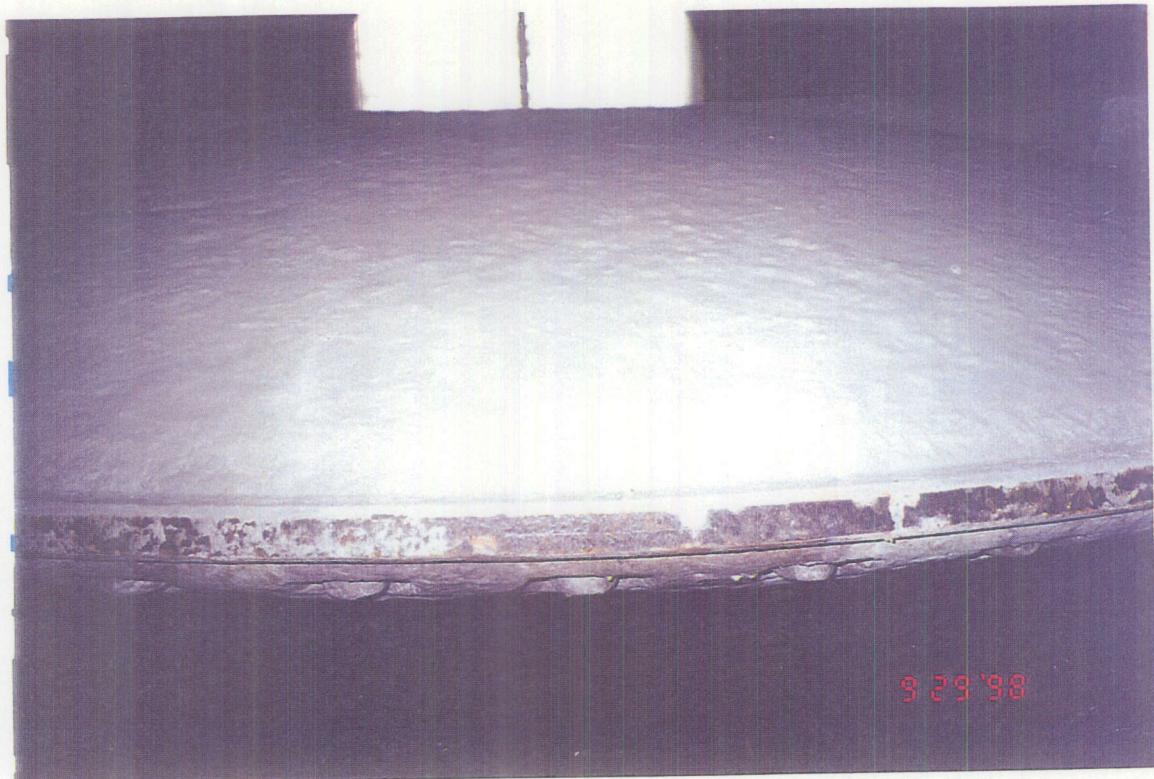
Photo 1 - Morris Dam - Butterfly Valve 6A - View looking upstream of downstream surface of disc.

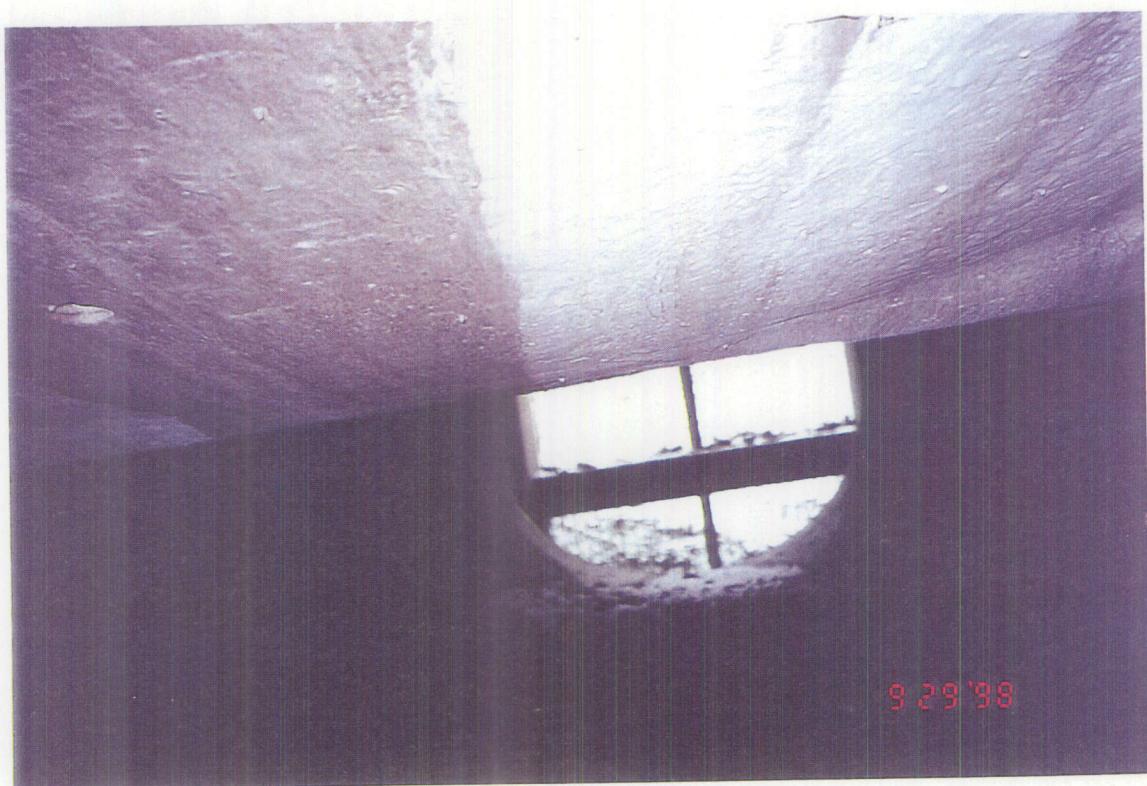
Photo 2 - Morris Dam - Butterfly Valve 6A - View looking upstream of upstream surface of disc.

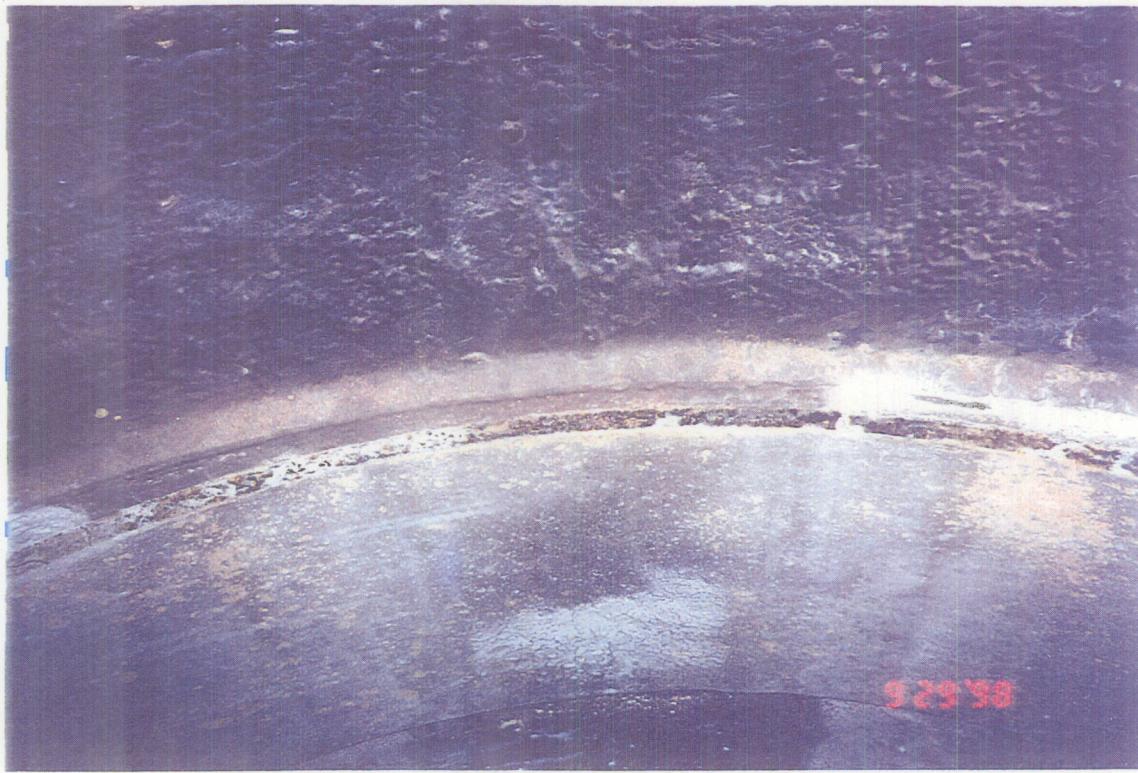
Photo 3- Morris Dam - Butterfly Valve 6A - View looking downstream of body disc seat at pipe crown.

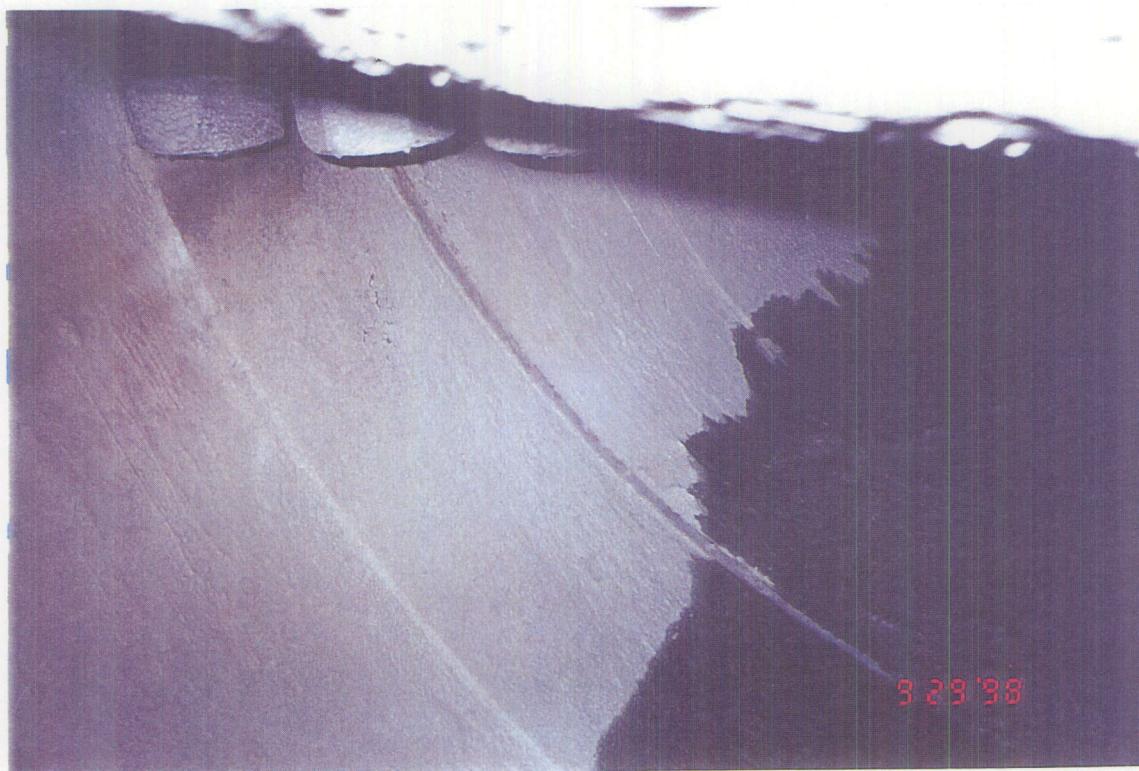
Photo 4 - Morris Dam - Butterfly Valve 6A - View looking downstream of body disc seat at pipe invert.

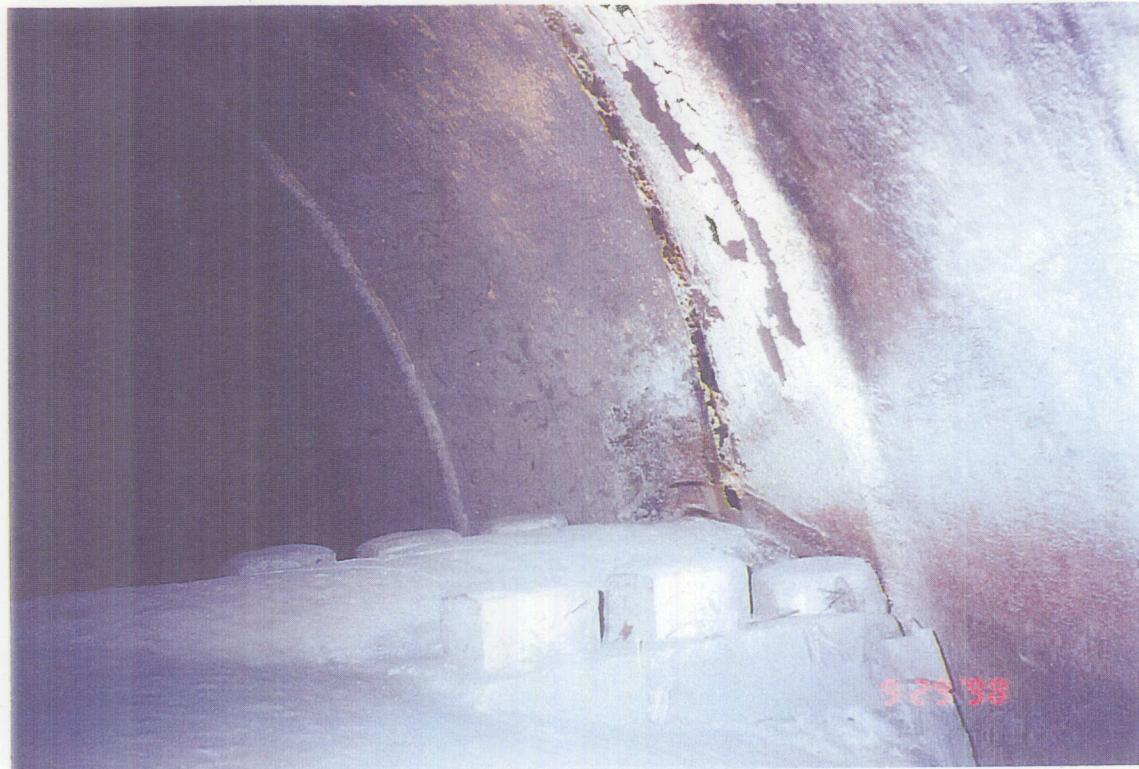
Photo 5- Morris Dam - Butterfly Valve 6A - View looking upstream of downstream surface of right disc trunnion.

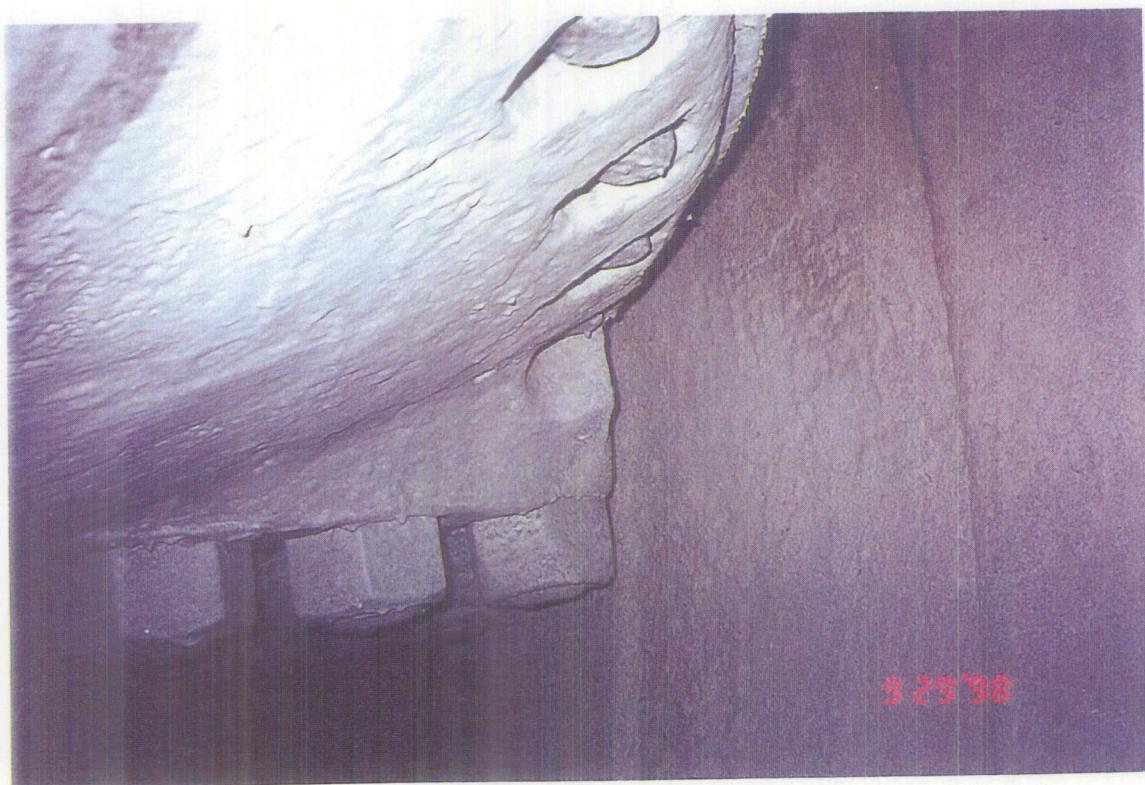
Photo 6 - Morris Dam - Butterfly Valve 6A - View looking upstream of upstream surface of right disc trunnion.

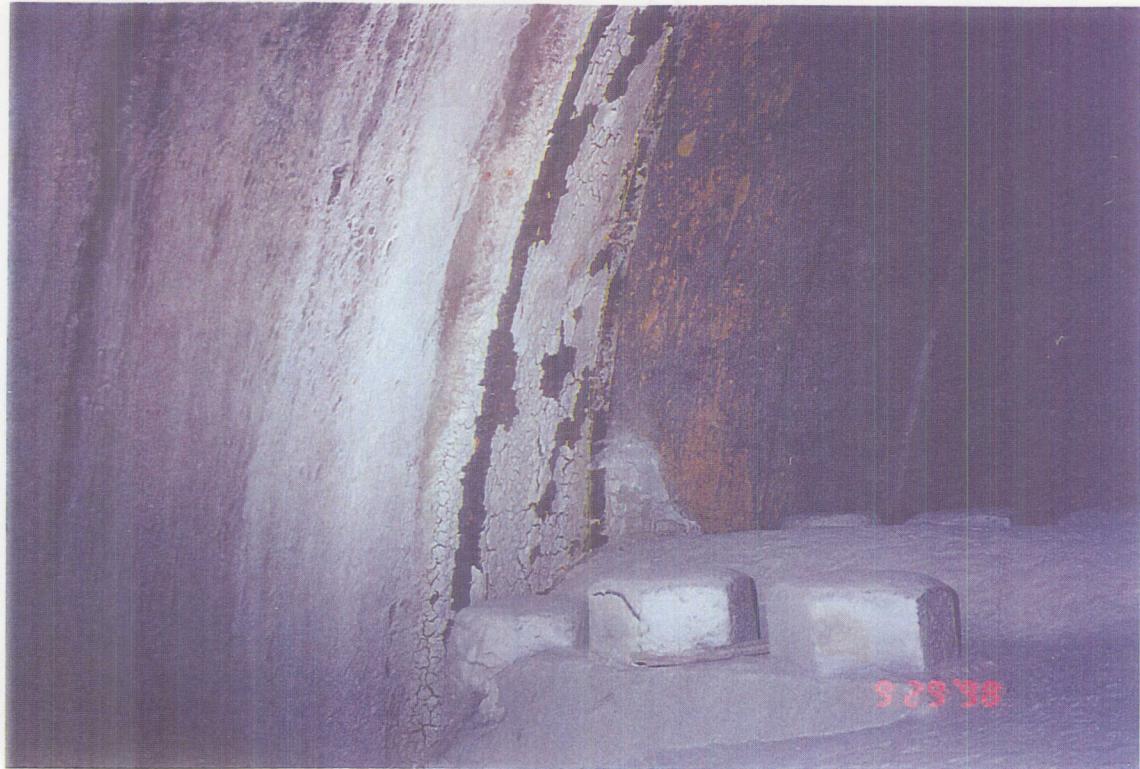
Photo 7- Morris Dam - Butterfly Valve 6A - View looking upstream of downstream surface of left disc trunnion.

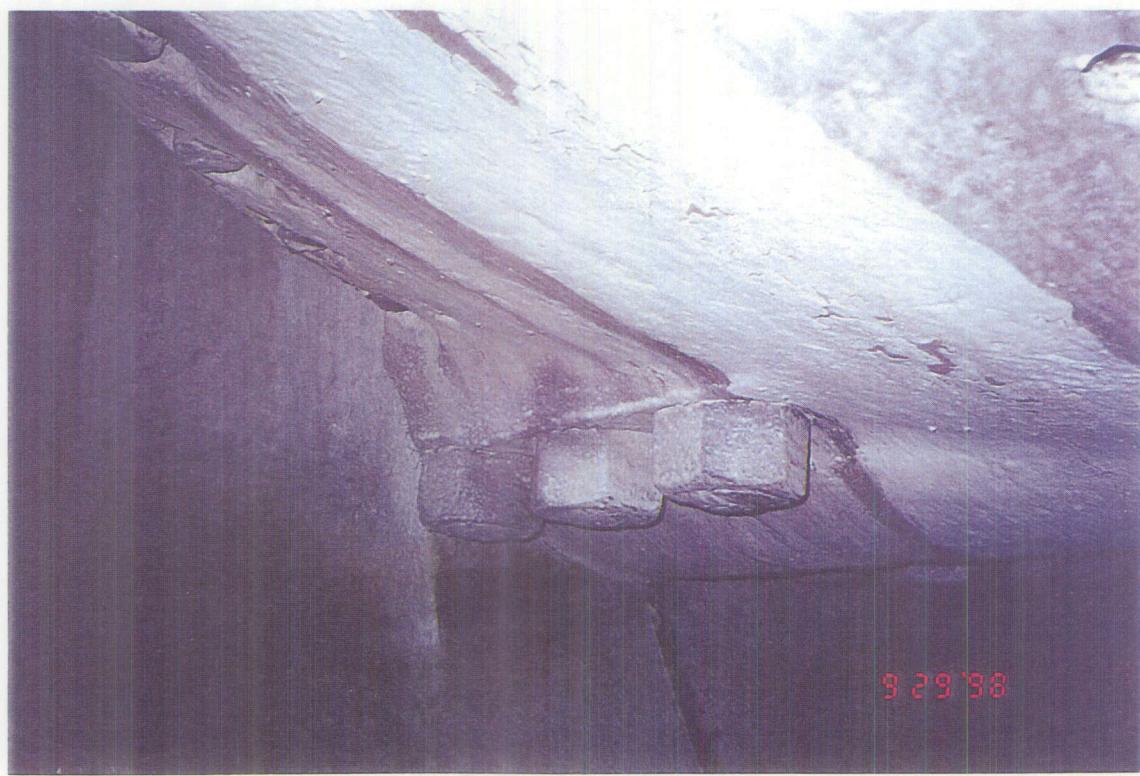
Photo 8 - Morris Dam - Butterfly Valve 6A - View looking upstream of upstream surface of left disc trunnion.

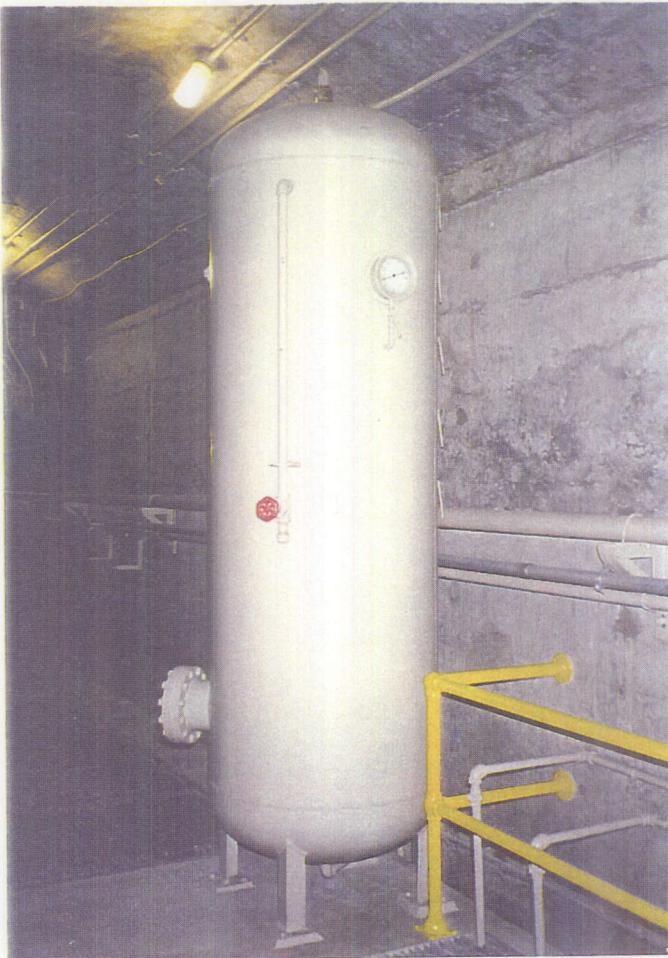
Photo 11 - Morris Dam - Miscellaneous Piping - View of abandoned accumulator tank in gate chamber. 06/30/98
