EQUIPMENT INSPECTION / EVALUATION REPORT

MORRIS DAM INLET/OUTLET WORKS
MODERNIZATION
County of Los Angeles
Department of Public Works

MECHANICAL EXAMINATION REPORT

Morris Dam Inlet/Outlet Works Modernization

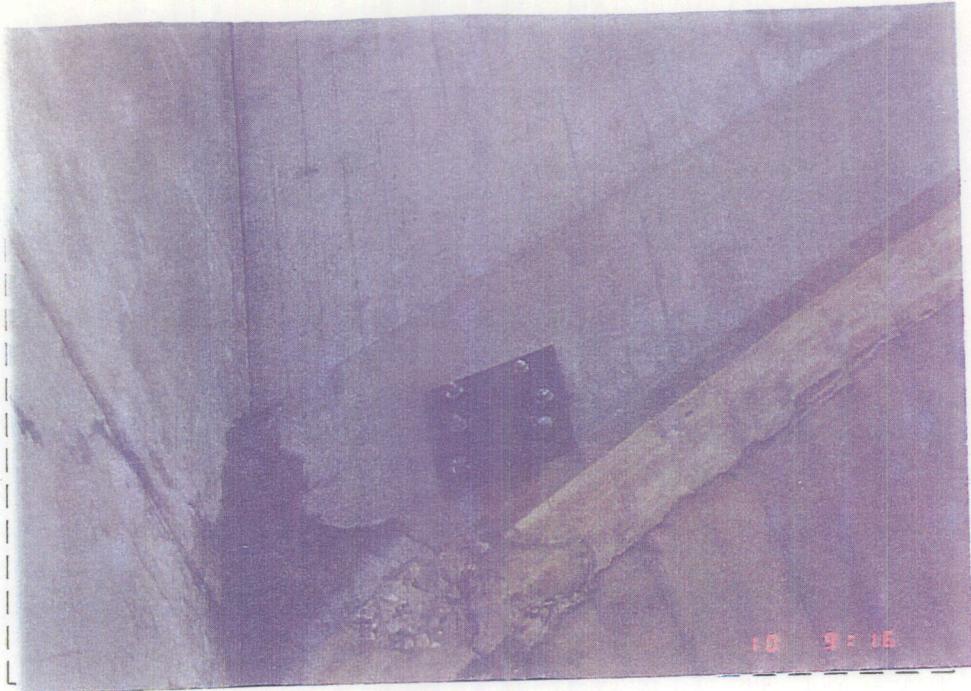
Photo 3. - Morris Dam - 70' x 18' Drum Gates - Gate bay #1, View upwards towards temporary bracket on face of spillway bridge for hydraulic ram. - Sept 10, 1998.

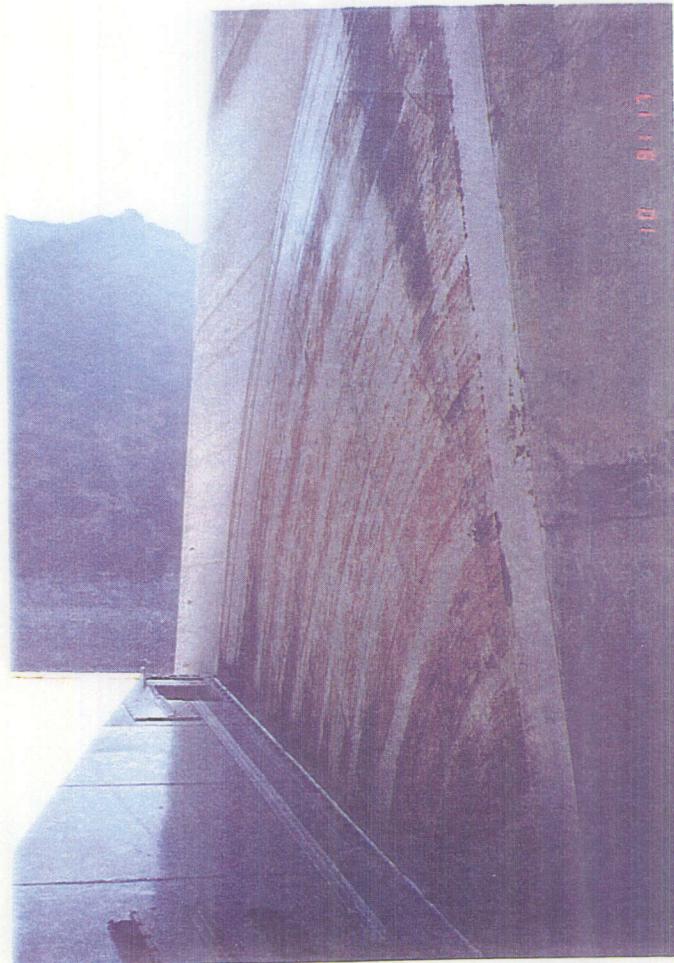
Photo 4. - Morris Dam - 70' x 18' Drum Gates - Gate #1, downstream faceplate, left side. View of wallplate and damaged hollow bulb seal. - Sept 10, 1998.

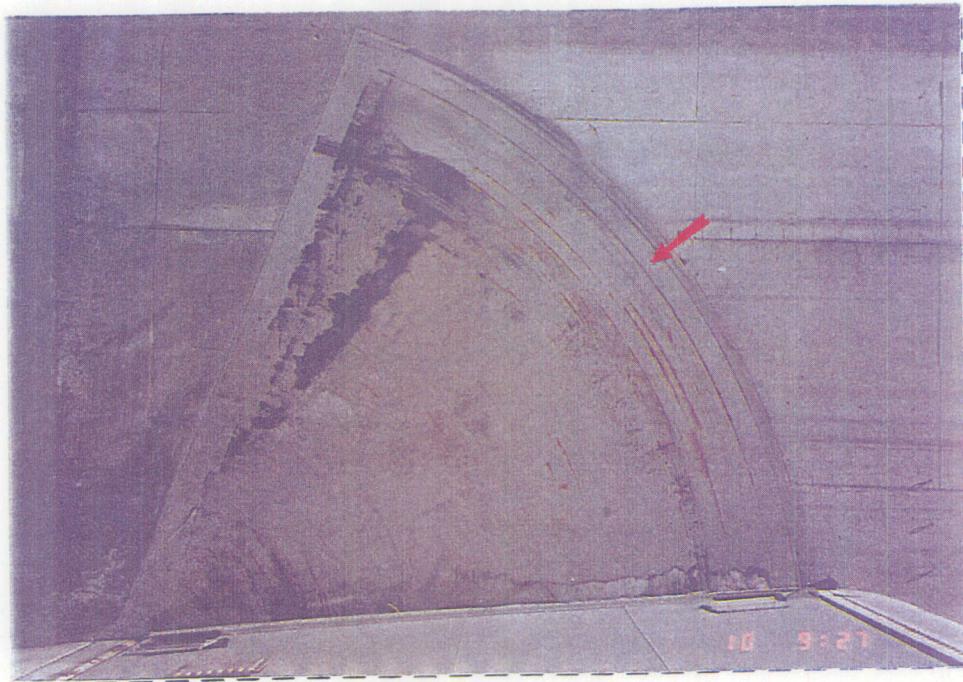
Photo 6. - Morris Dam - 70' x 18' Drum Gates - Gate #1, downstream faceplate, right side. View of embedded wallplate. Note - the pair of concentric gouge marks (arrow) in wallplate can be seen near the upstream edge of wallplate. - Sept 10, 1998.

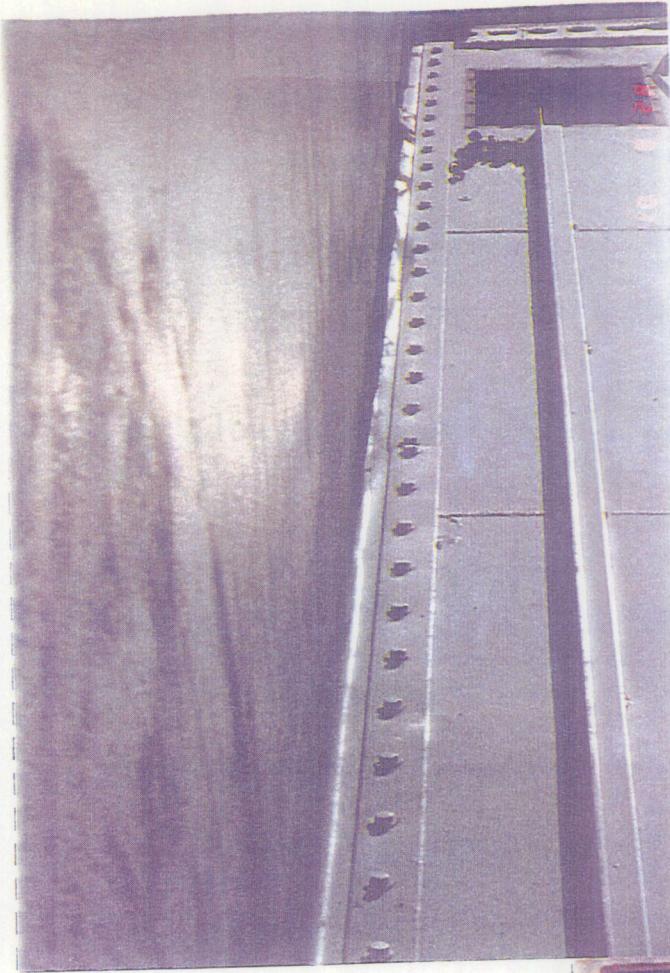
Photo 7. - Morris Dam - 70' x 18' Drum Gates
- Gate #1, downstream faceplate, right side.
View of damaged hollow bulb seal and
embedded wallplate. View is from hinge
looking upstream. - Sept 10, 1998.

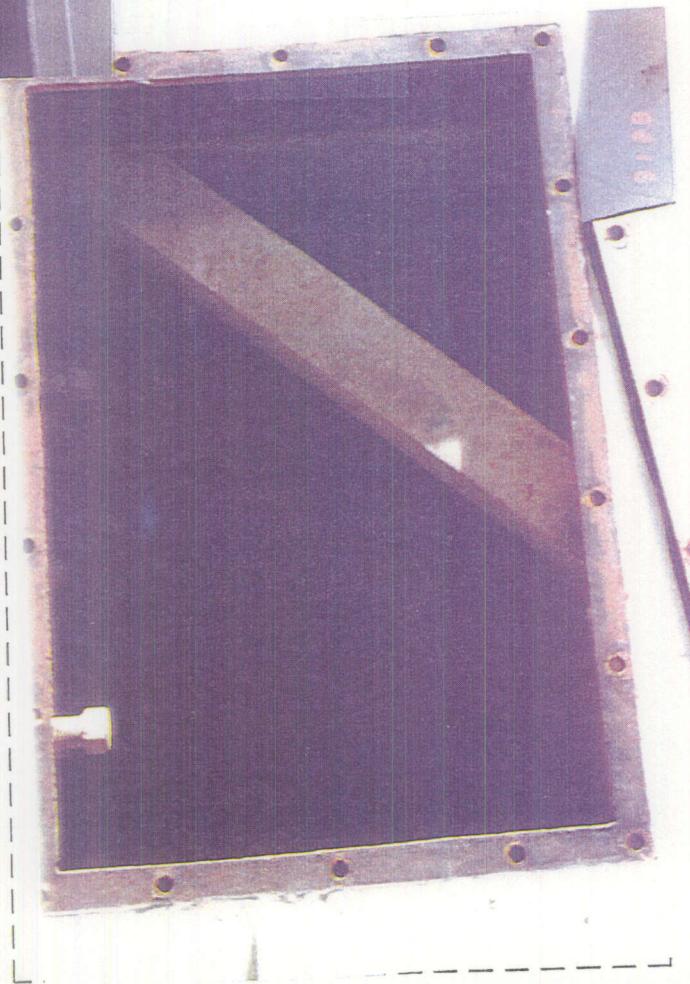
Photo 8. - Morris Dam - 70' x 18'
Drum Gates - Gate #1, downstream
faceplate, right side. View of inside
hatchway seen in Photo #7. View of
bracing supporting the cantilever
portion of the upstream faceplate. -
Sept 10, 1998.

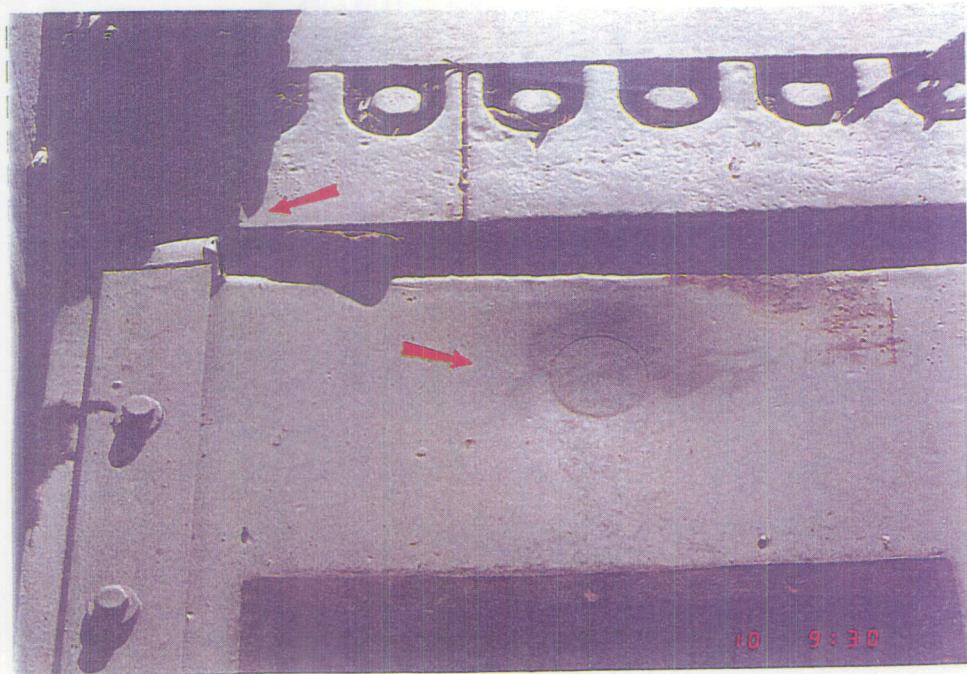
Photo 10. - Morris Dam - 70' x 18' Drum Gates - Gate #1, View immediately upstream of hatch (Photo 8). Right pointing arrow shows local buckling caused by hydraulic ram used to unwedge gate. Left pointing arrow shows edge of shield guard which is interfering with the small 1/4" thick bar just to the left. - Sept 10, 1998.

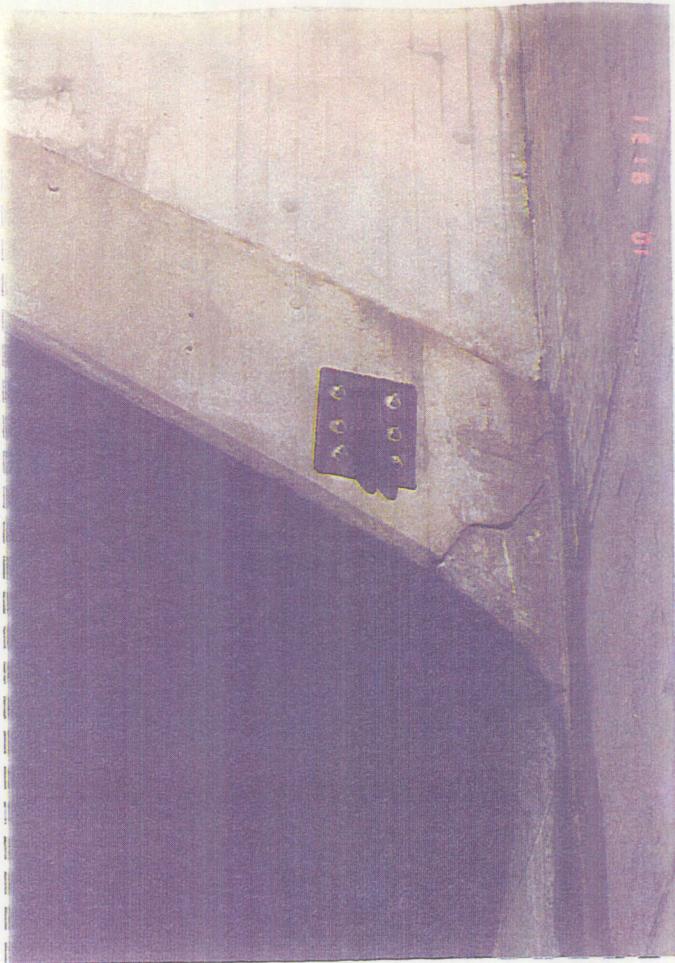
Photo 11. - Morris Dam - 70' x 18' Drum Gates - Gate #1, View from downstream faceplate looking up towards spillway bridge at bracket used for ram. Note concrete cracking at intersection of bridge of pier wall.
- Sept 10, 1998.

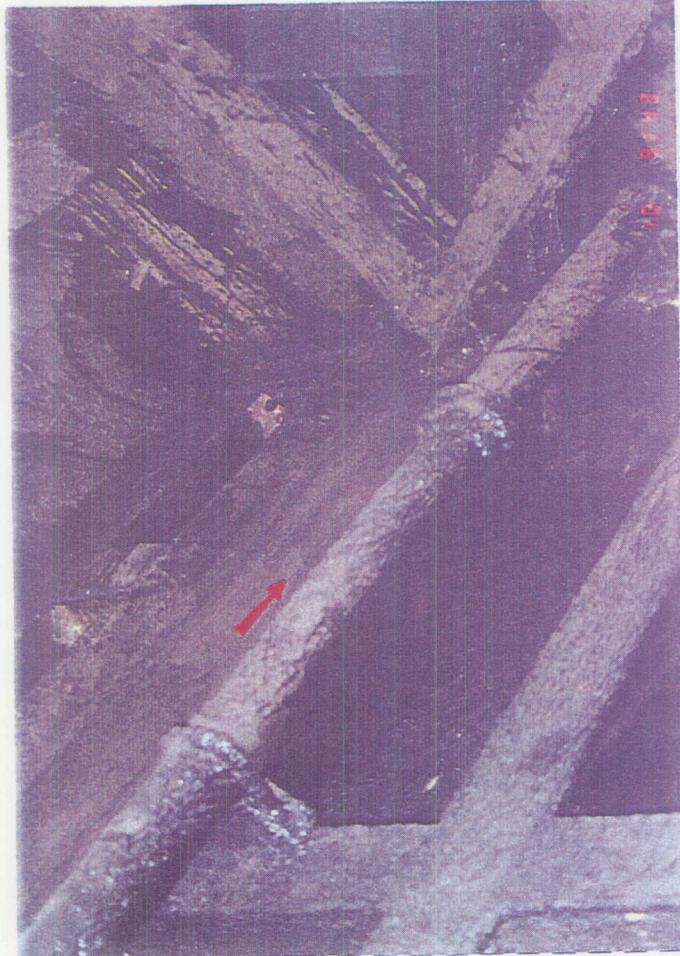
Photo 12. - Morris Dam - 70' x 18' Drum Gates - Gate #1, right side of gate. View inside gate hatch. Arrow parallel to 3" ejector piping points towards bottom of gate (when in the closed position). Note coal tar enamel on structural members. - Sept 10, 1998.

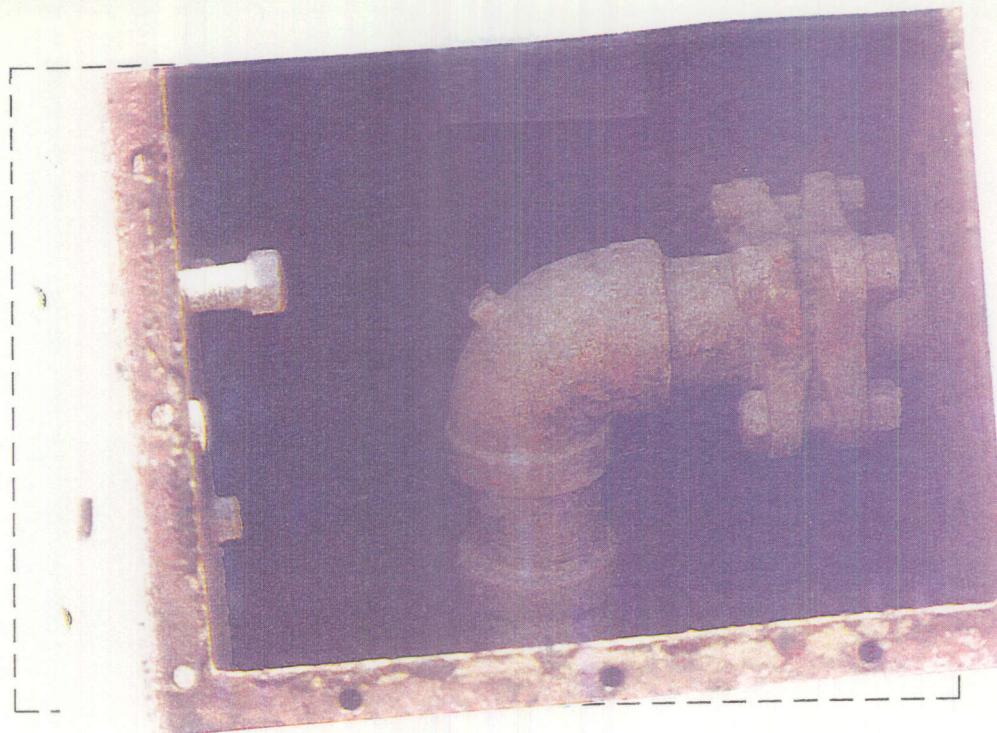
Photo 13. - Morris Dam - 70' x 18' Drum Gates - Gate #1, right side of gate. View of ejector piping exiting gate from the right and plumbed to the hinge at the bottom. - Sept 10, 1998.

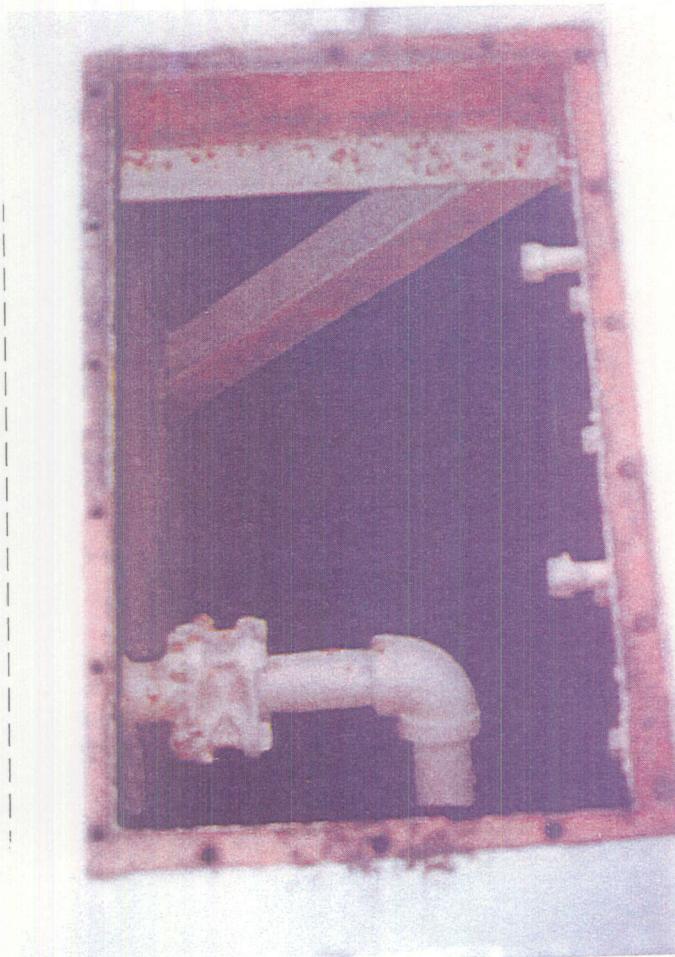
Photo 14. - Morris Dam - 70' x 18' Drum Gates - Gate #2, left side of gate. View of ejector piping exiting gate from the left and plumbed to the hinge at the bottom. Note brace for cantilevered portion of downstream faceplate. - Sept 10, 1998.

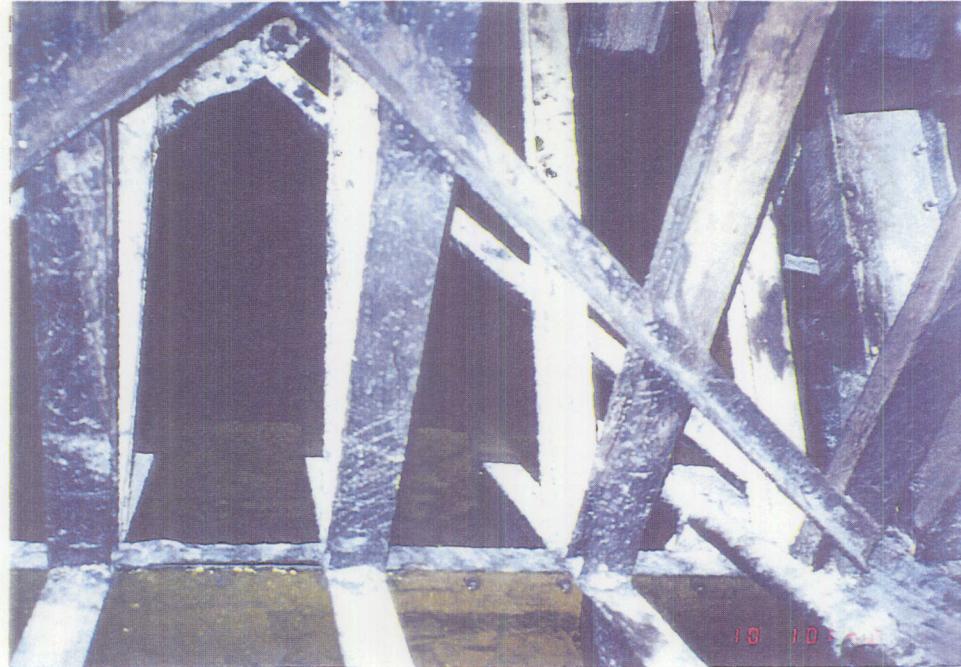
Photo 15. - Morris Dam - 70' x 18' Drum Gates - Gate #2, left side of gate. View inside hatch, looking down towards bottom of gate. Note water ponding in webs of structural members. Gate #2 contained approx 3' of water. - Sept 10, 1998.

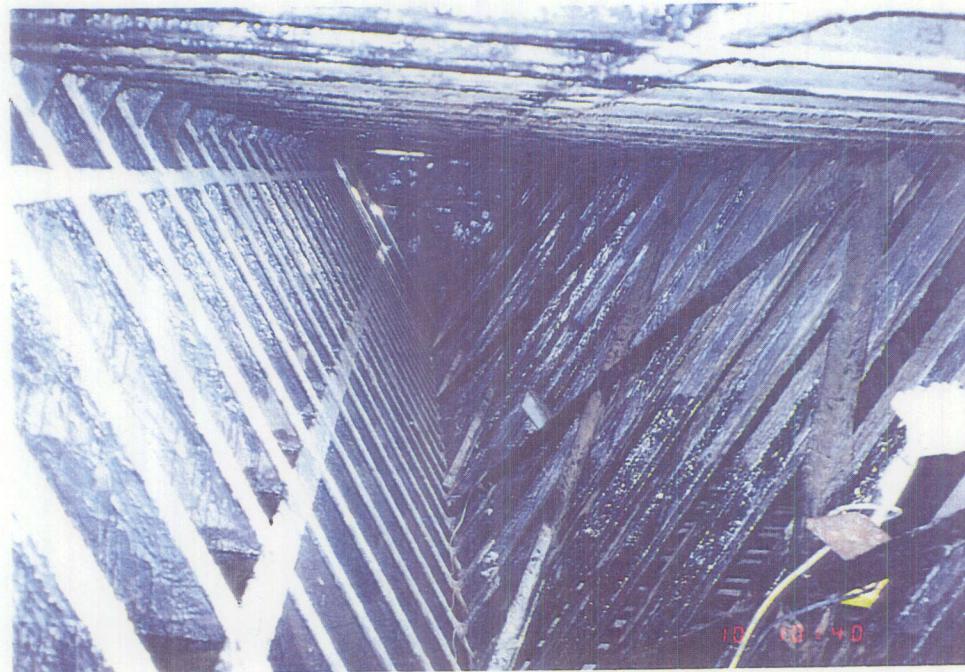
Photo 16. - Morris Dam - 70' x 18' Drum Gates - Gate #2, View from hatchway looking from left side of gate looking 70' towards right side of gate. Top of photo are structural members for d/s face, left side photo are members for bottom face, and right side of photo are members for upstream face. - Sept 10, 1998.

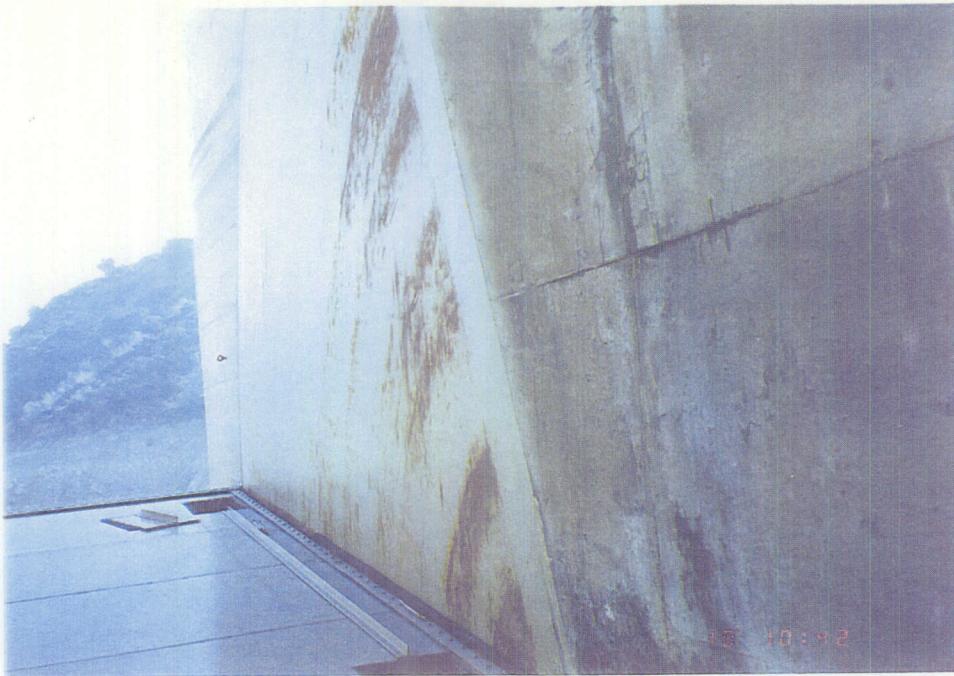
In any case, the present hollow, music-note, side seals located on the edges upstream and downstream faceplates do not appear to have been the best choice. Many seal segments are damaged, torn, and missing, perhaps for the following reasons:

Photo 17. - Morris Dam - 70' x 18' Drum Gates - Gate #2 - downstream faceplate, left side of gate. View of wallplate and end seal. Note missing portion of end seal. - Sept 10, 1998.

The seals should be replaced; however, rather than replacing the seals, in-kind with similar hollow bulb, music-note seals, the seal design should be reconsidered for both material and sizes and possibly the geometry. At a minimum, if the music-note seal concept is retained; a solid bulb, Teflon-clad, neoprene material, and smaller bulb should be considered.

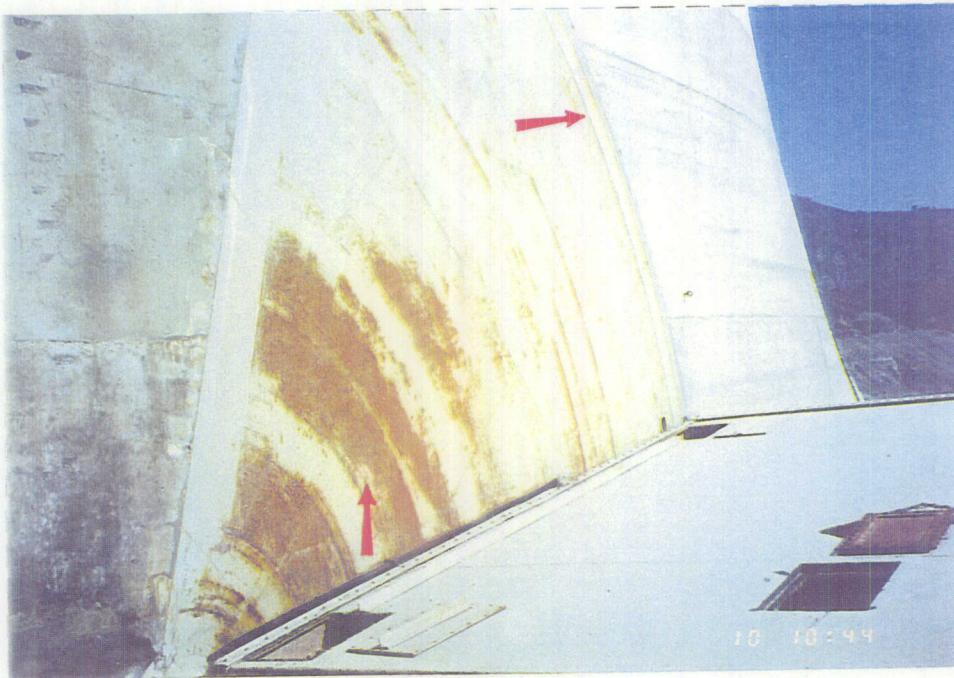
Photo 18. - Morris Dam - 70' x 18' Drum Gates - Gate #2 - downstream faceplate, right side of gate. View of wallplate and end seal. Note missing portion of end seal. Right arrow points to pair of concentric gouge marks. Up arrow points to arcs scrapped by seal guard. - Sept 10, 1998.

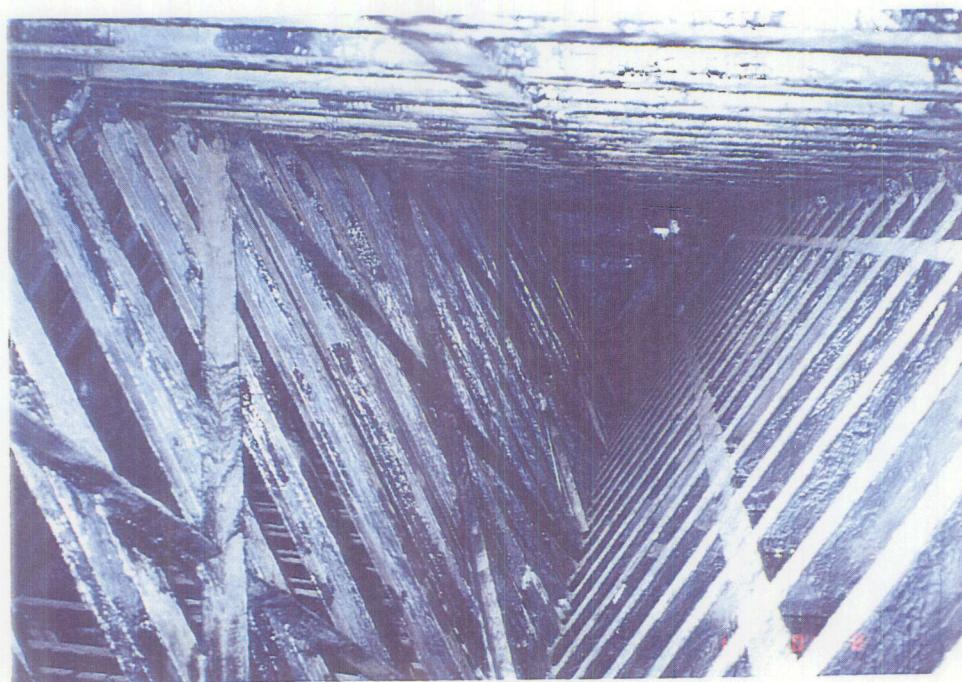
Photo 20. - Morris Dam - 70' x 18' Drum Gates - Gate #2, View from hatchway (Photo 18) from right side of gate looking 70' towards left side of gate. Top of photo are structural members for d/s face, left side photo are mid-bracing members, right side of photo are bottom face members. - Sept 10, 1998.

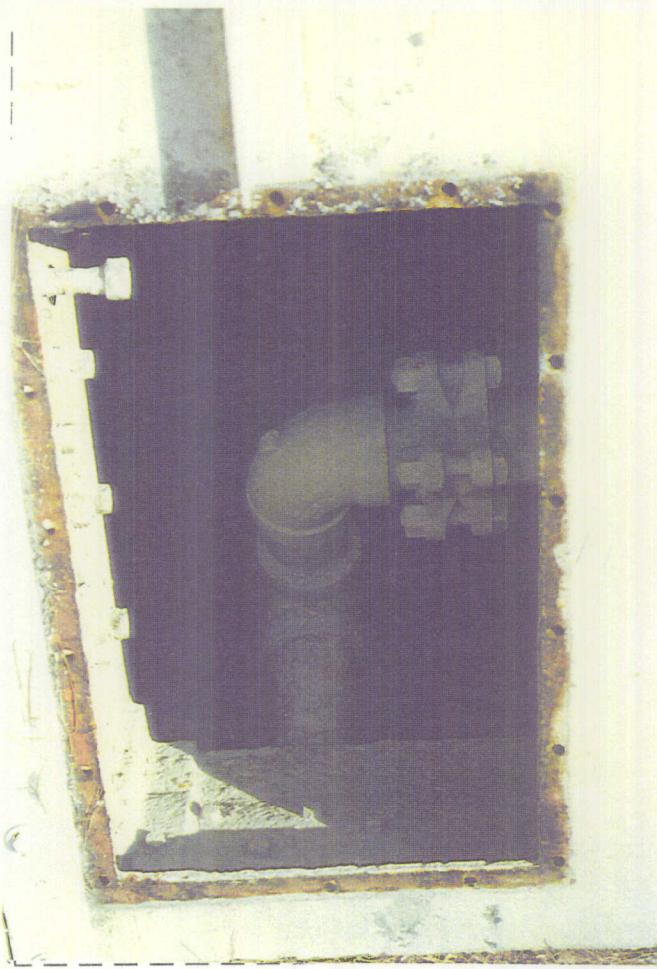
Photo 21. - Morris Dam - 70' x 18' Drum Gates - Gate #2, right side. View of ejector piping though hatchway (Photo 18). - Sept 10, 1998.

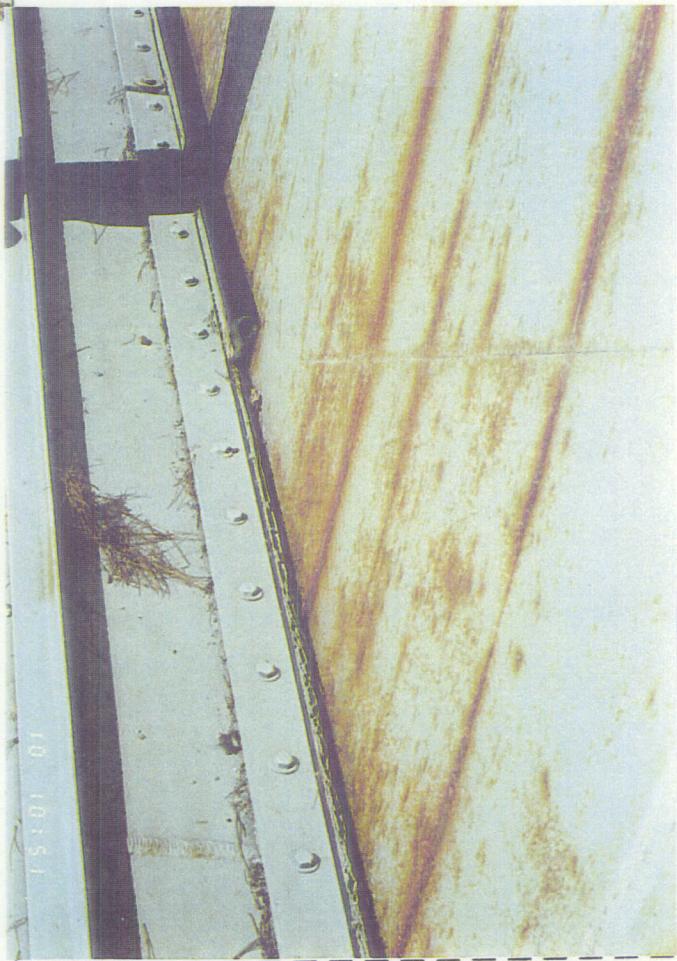
- The hollow bulb, although theoretically capable of providing more effective sealing due to its flexibility, in fact, may be too flexible and flimsy, and is a contributing factor to the premature material failure.

- The seal bulb appears oversized for the space available for installation, and hence requires the bulb and stem to rotate and deflect excessively resulting in unnecessary stresses, also leading to early failure.

Photo 22. - Morris Dam - 70' x 18' Drum Gates - Gate #2, Right side of gate. View of missing seal (Photo 18). Note oversized hollow bulb seal with excessive stem deflection. Seals are circa '60s retrofit from original seals. Seals bulbs are not oriented/installed for effective sealing. - Sept 10, 1998.

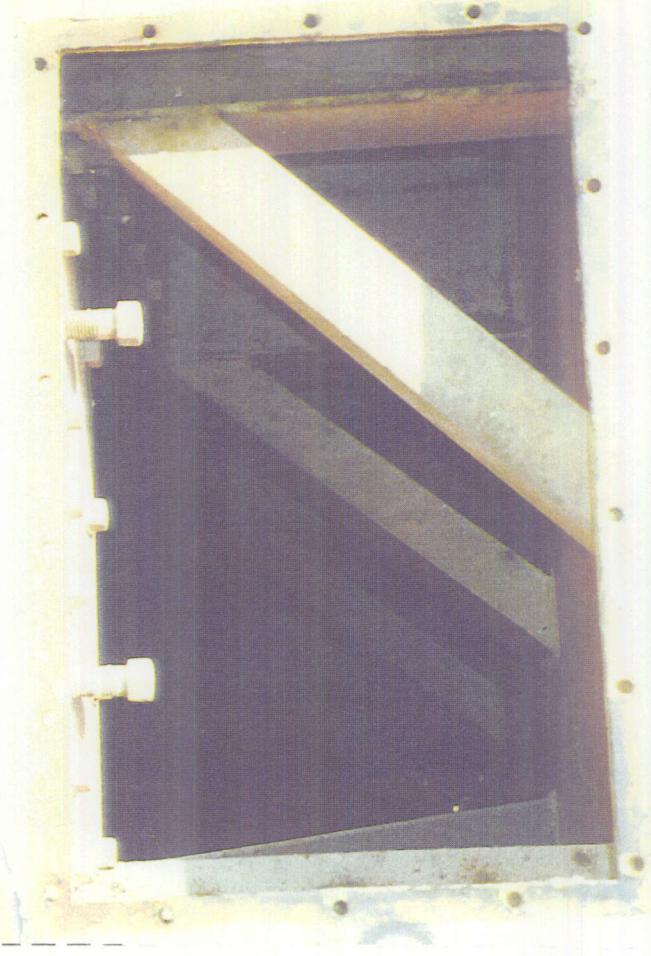
Photo 23. - Morris Dam - 70' x 18' Drum Gates - Gate #2, Right side of gate. Bracing for cantilevered portion of upstream faceplate, and portions of horizontal stiffener beams. - Sept 10, 1998.

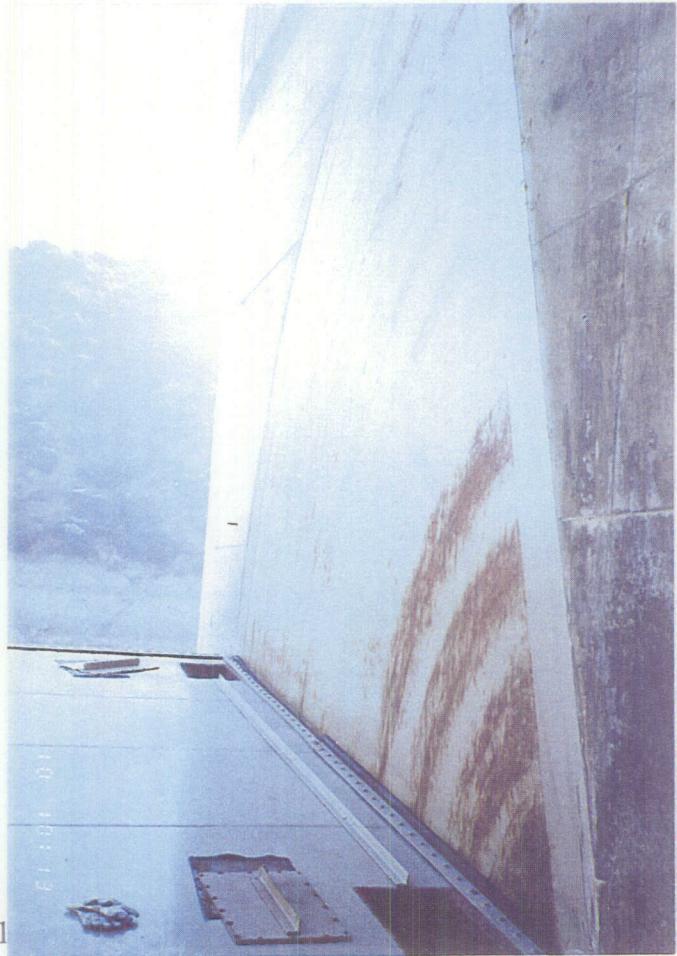
Photo 24. - Morris Dam - 70' x 18' Drum Gates - Gate #3, Left side of gate. Wallplate and end seals with missing portion. Note rust "arcs" due to scrapping by seal guards. - Sept 10, 1998.

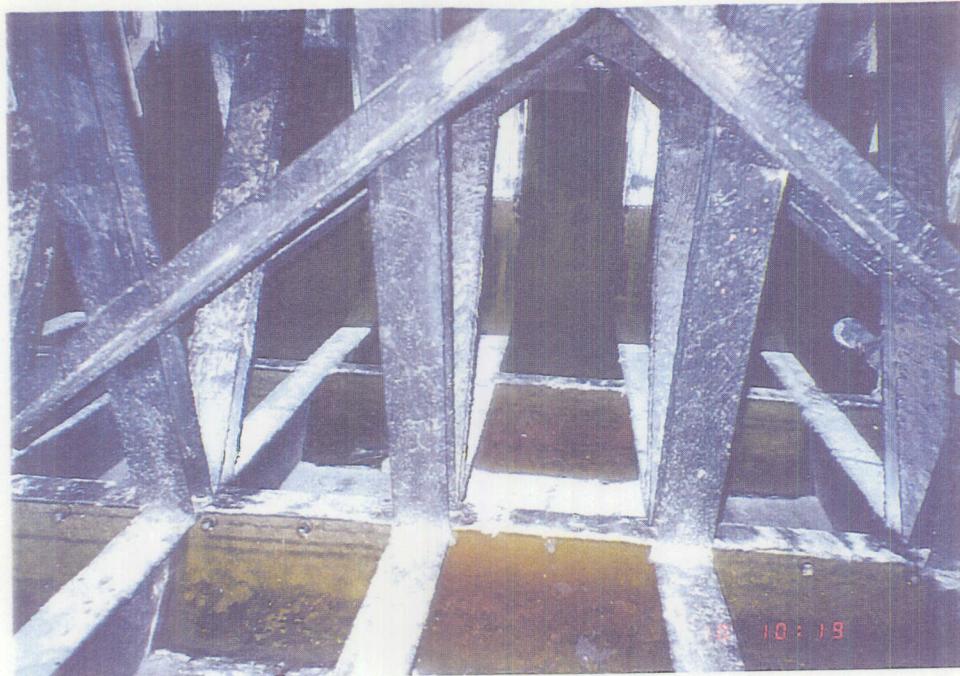
Photo 25. - Morris Dam - 70' x 18' Drum Gates - Gate #3, Left side of gate. View inside gate through hatch (Photo 24) looking along bottom faceplate. Note ponding water in webs of beams, and depth of water (approx 5'), and coal tar coating on structural members.
- Sept 10, 1998.

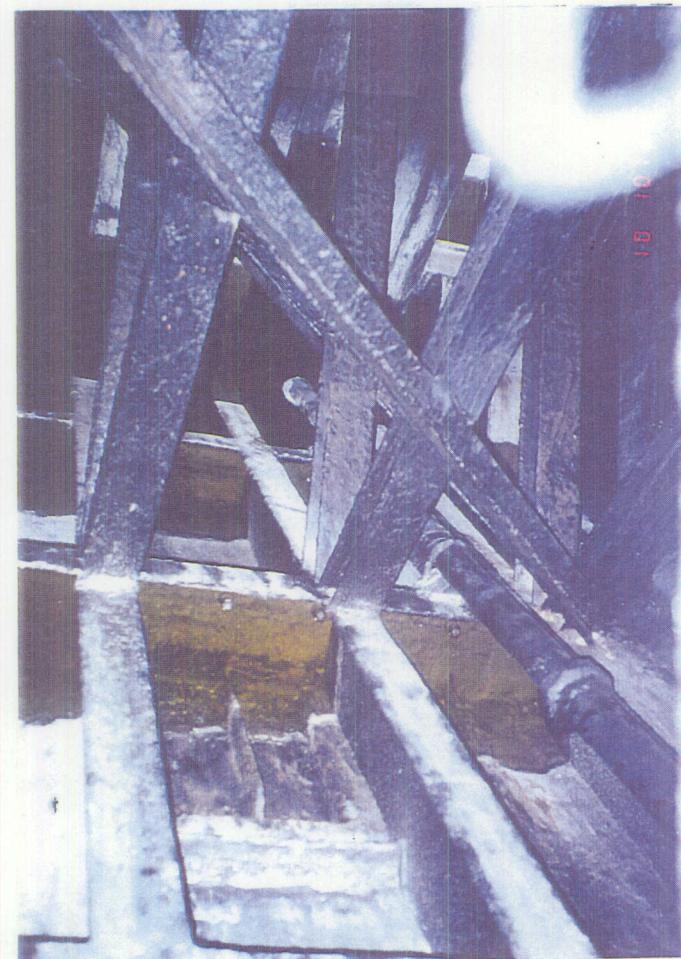
Photo 26. - Morris Dam - 70' x 18' Drum Gates - Gate #3, Left side of gate. View inside gate through hatch (Photo 24).
Note 3" ejector piping on right (piping is plumbed towards bottom of gate), and mid-bracing at top of photo. - Sept 10, 1998.

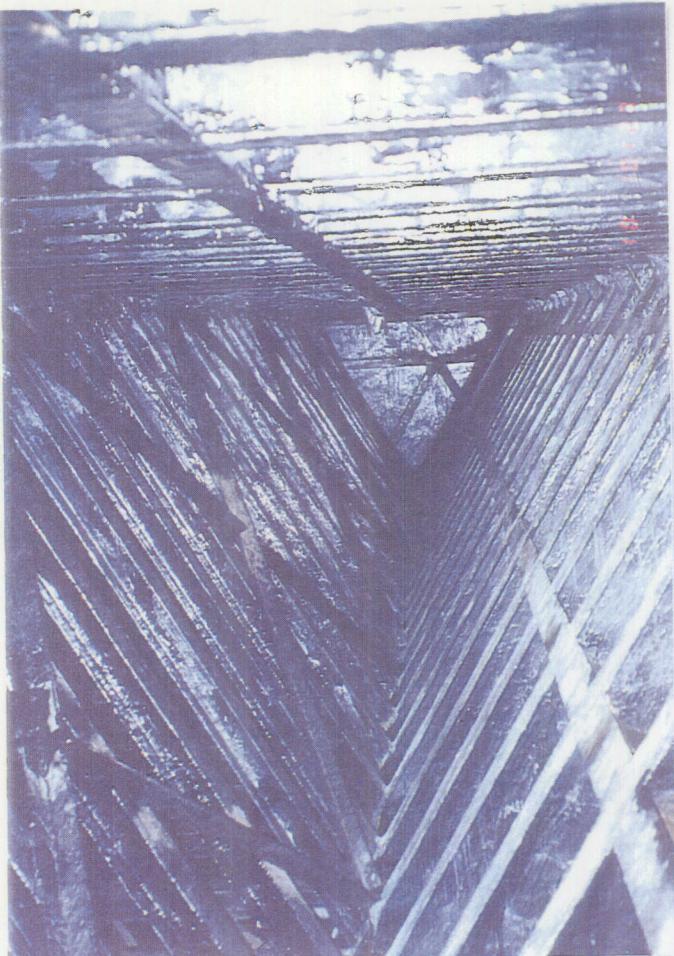
Photo 27. - Morris Dam - 70' x 18' Drum Gates - Gate #3, View from right side of gate, looking 70' towards left side of gate. Top of photo are members for downstream face, left side of photo are the internal braces, right side of photo are structural members for bottom faceplate. - Sept 10, 1998.

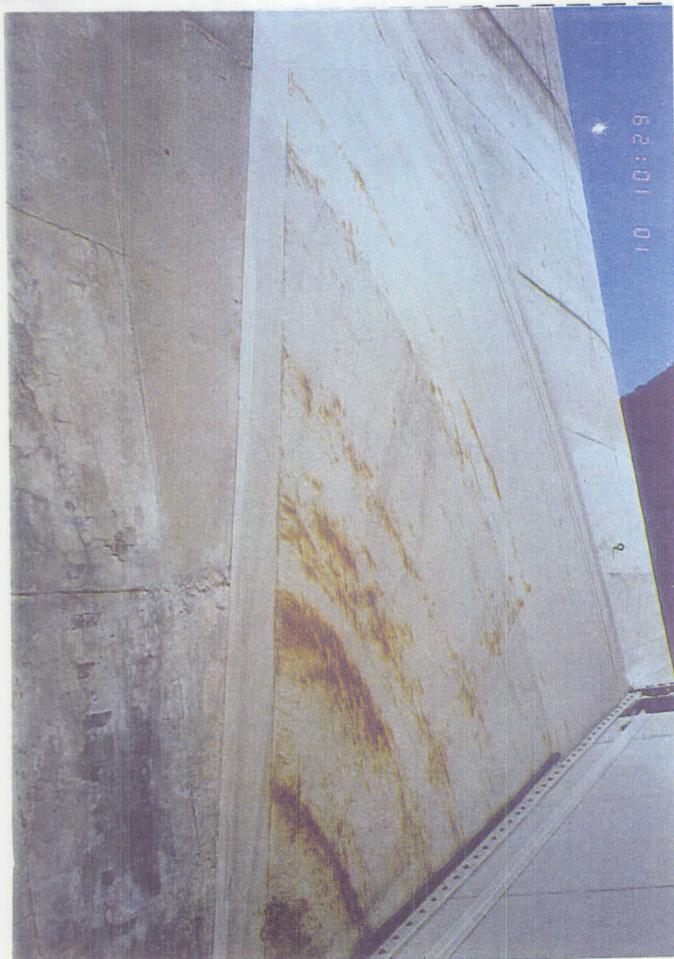
Photo 28. - Morris Dam - 70' x 18' Drum Gates - Gate #3, right side of gate. Wallplate and end seal with missing portion (Photo 29) - Sept 10, 1998.

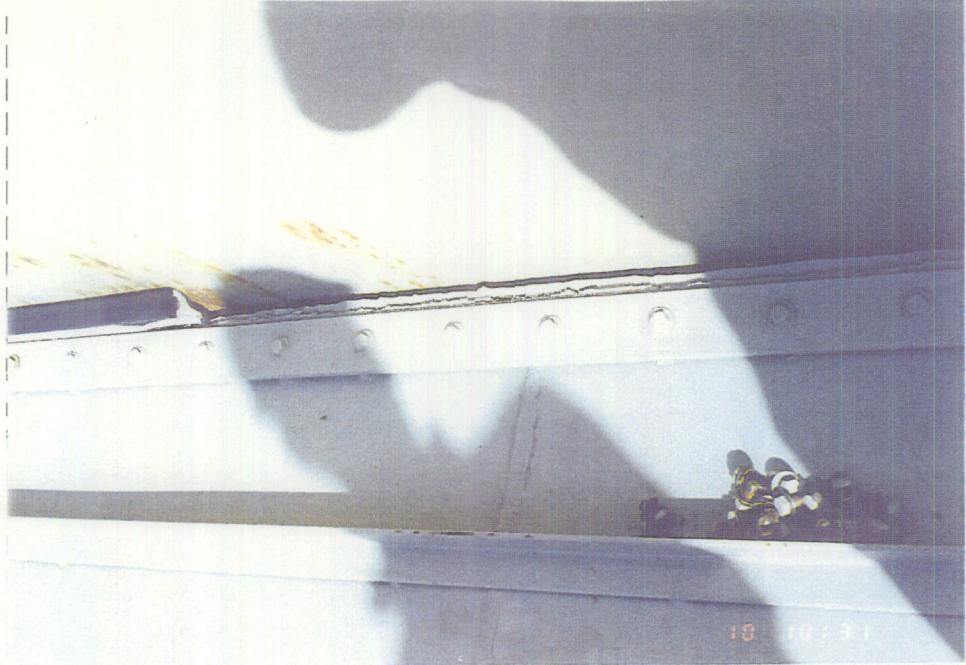
Photo 29. - Morris Dam - 70' x 18' Drum Gates - Gate #3, right side of gate. Missing portion of sea (Photo 28) - Sept 10, 1998.

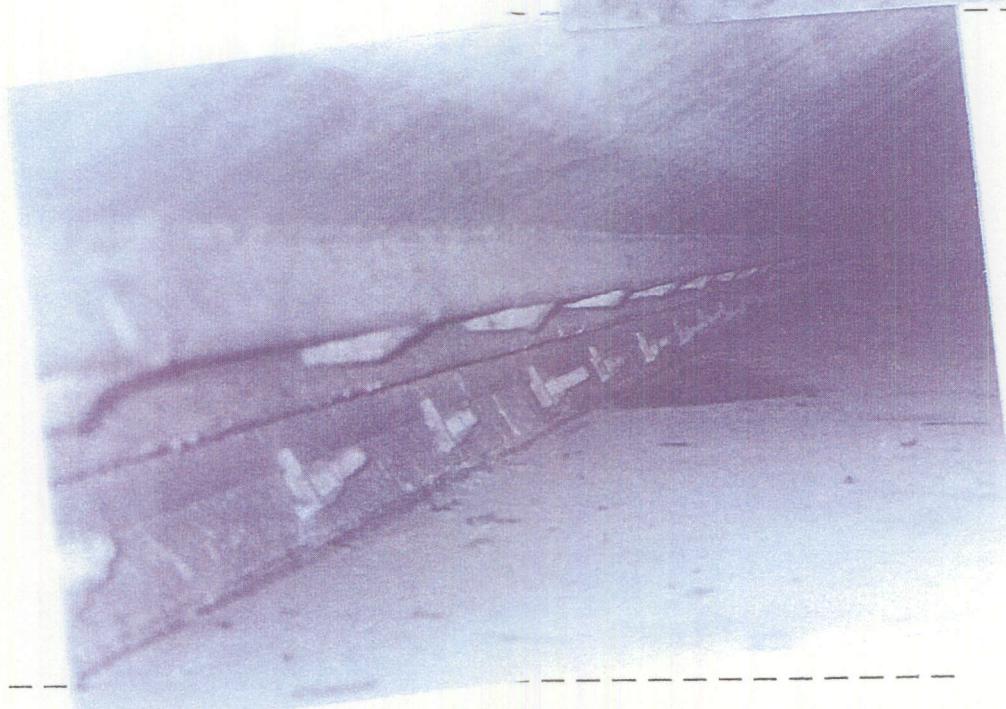
Photo 4 - Morris Dam - 70' x 18' Drum Gate #1 (east) - Upstream of dry gate chamber, gate lowered and resting on rail (at bottom) bottom edge of upstream faceplate, looking towards right side of gate along the stop angle. Note the 5" wide band where high velocity water has scrubbed coating from steel.. - (9/10/98).

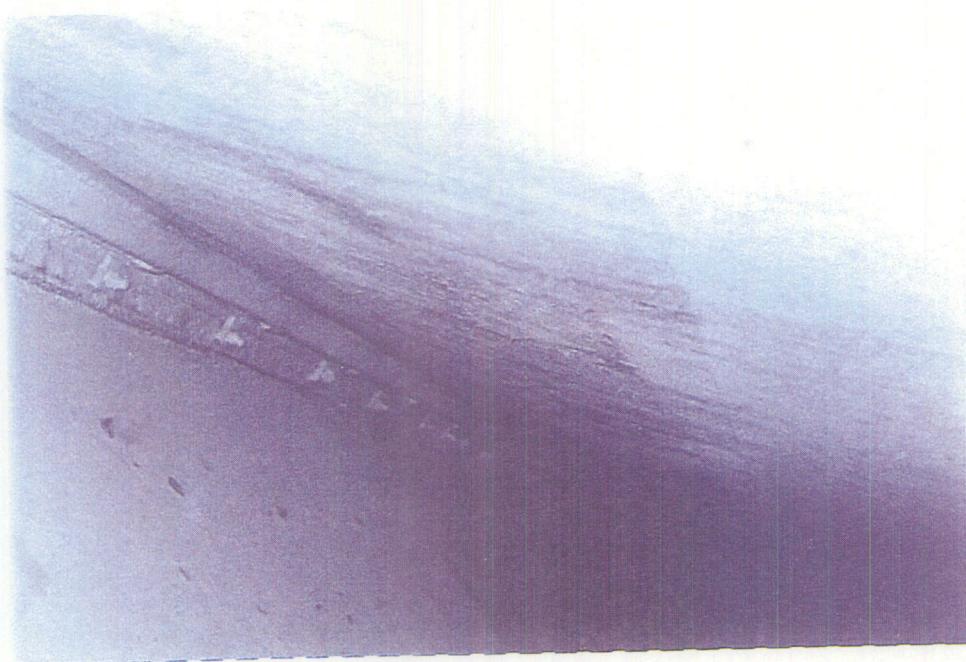
Photo 6 - Morris Dam - 70' x 18' Drum Gate #1 (east) - Upstream side of gate chamber and u/s faceplate. Coating thin on faceplate. View of stop angle and rail.. - (9/10/98).

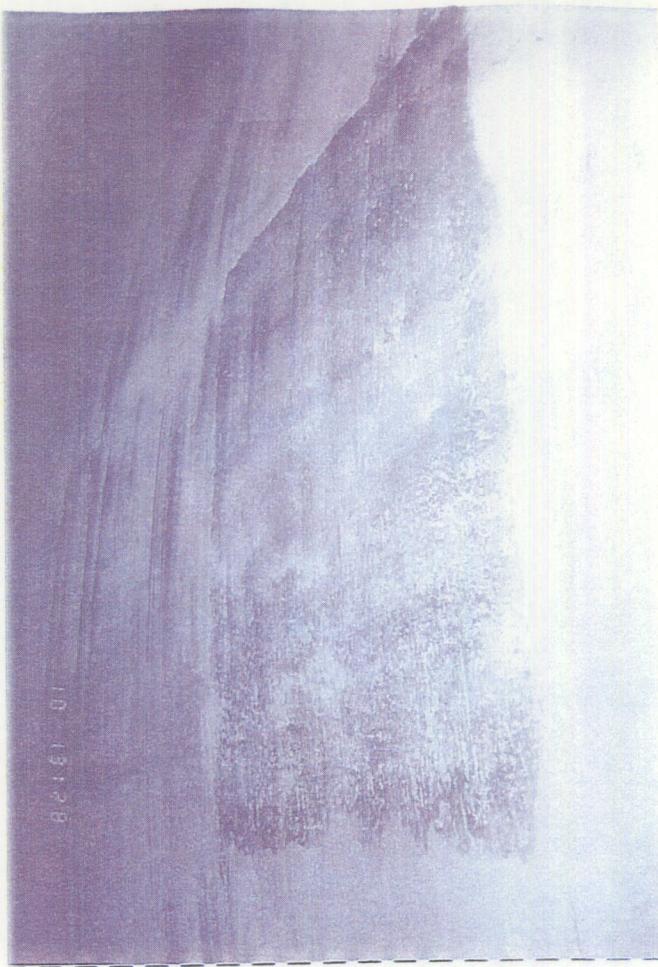
Photo 7 - Morris Dam - 70' x 18' Drum Gate #1 - View of upstream faceplate inside gate chamber. Note areas of missing paint.- (9/10/98).

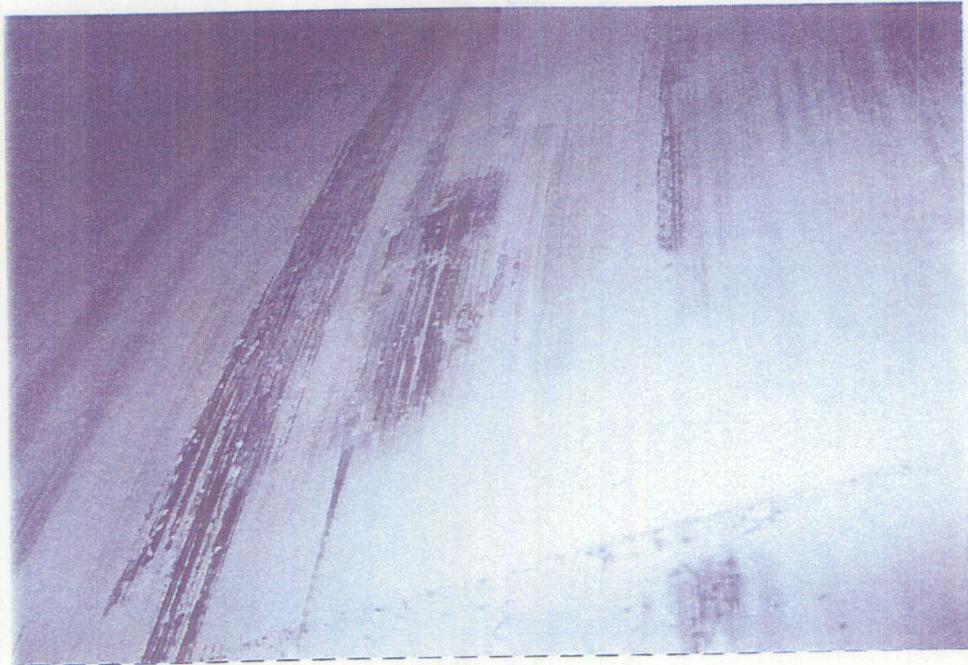
Photo 8 - Morris Dam - 70' x 18' Drum Gate #1 (east) - View of upstream faceplate inside gate chamber. Note areas of missing paint.. - (9/10/98).

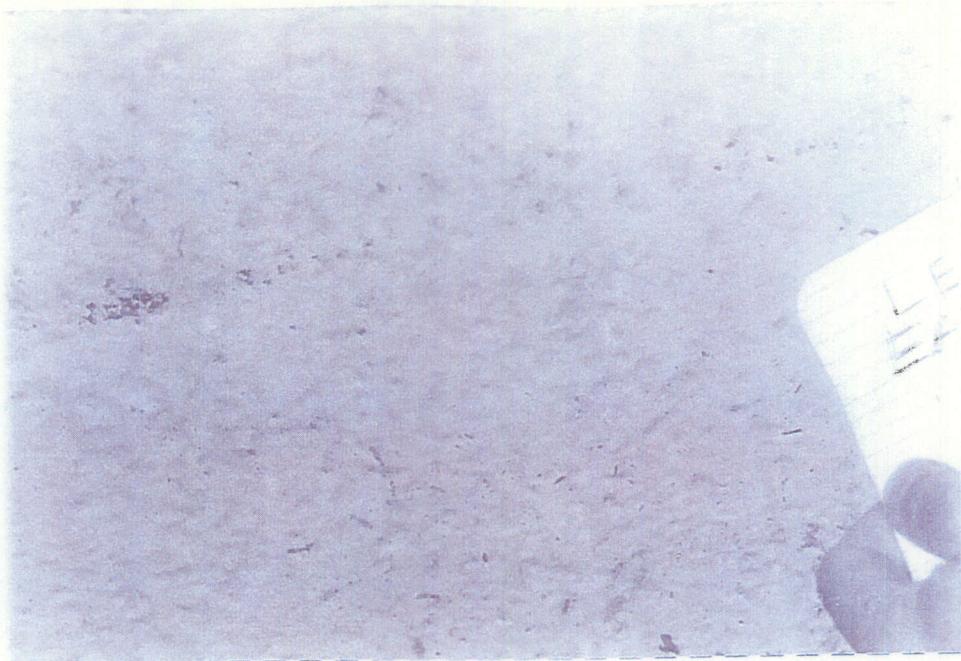
Photo 9 - Morris Dam - 70' x 18' Drum Gate #1 - Closeup of u/s faceplate. Note extensive pitting and loss of material.- (9/10/98).

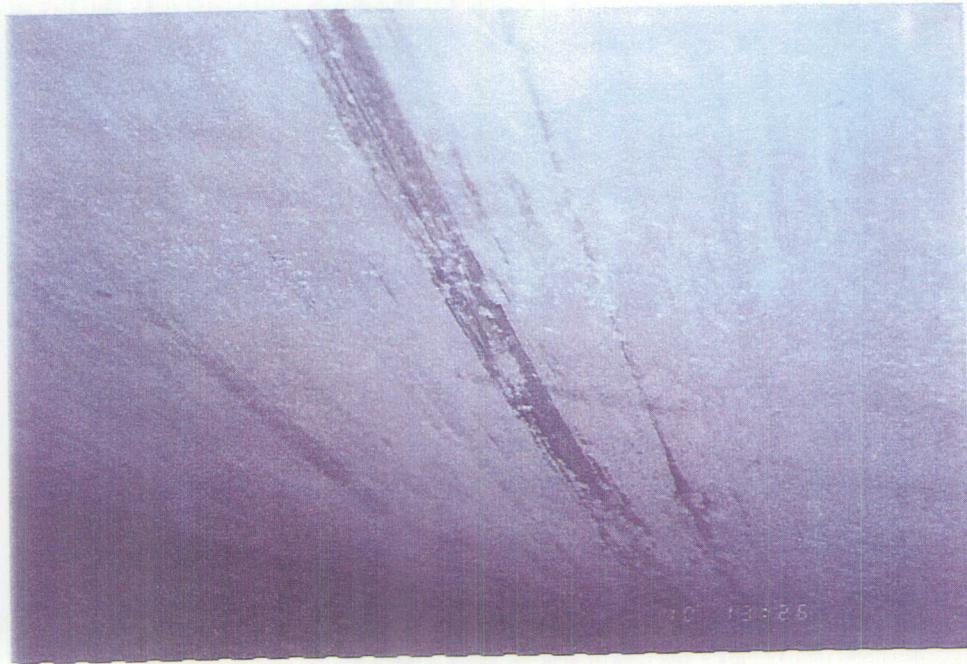
Photo 10 - Morris Dam - 70' x 18' Drum Gate #1 (east) - Upstream faceplate at midpoint. Note 2" wide scrapping/gouging marks, Probably caused by shield guard (next photo). - (9/10/98).

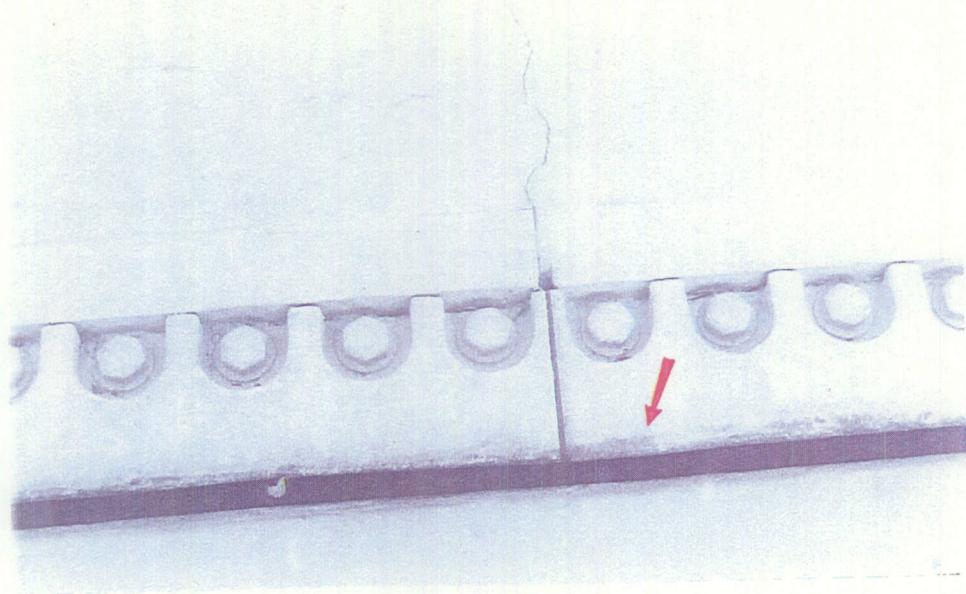
Photo 11 - Morris Dam - 70' x 18' Drum Gate #1 - Spillway crest, Gate #1, Looking down at shield guard. Arrow points at suspected scrapped edge causing marks shown on previous photo.- (9/10/98).

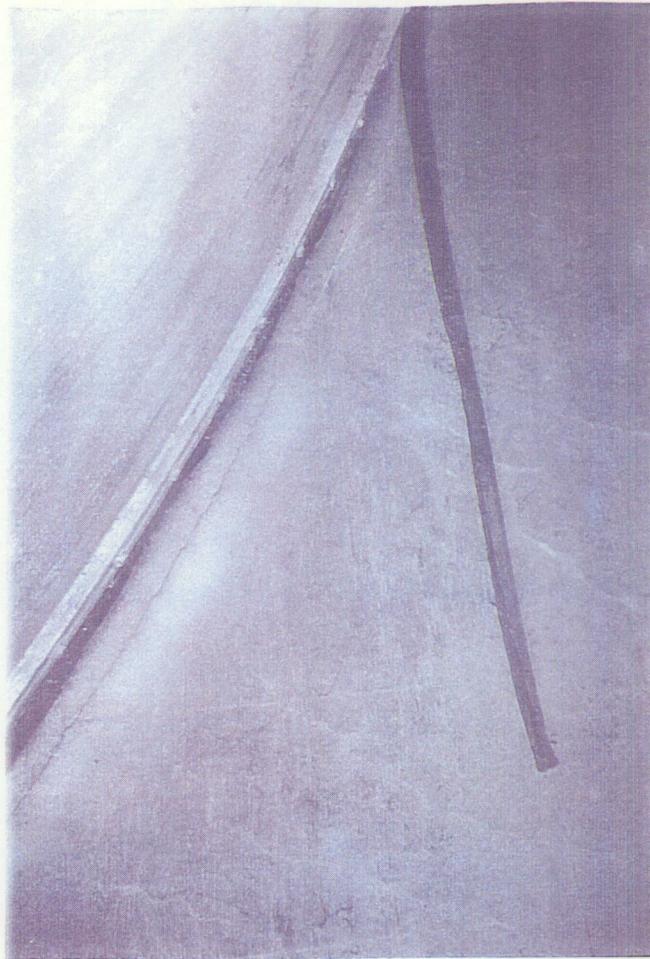
Photo 13 - Morris Dam - 70' x 18' Drum Gate #1 - Upstream side of gate chamber, right end of upstream faceplate, right end chamber wall and right side end seals. Note music note seal rotted and bulb torn from stem.- (9/10/98).
