EQUIPMENT INSPECTION / EVALUATION REPORT

MORRIS DAM INLET/OUTLET WORKS
MODERNIZATION
County of Los Angeles
Department of Public Works

MECHANICAL EXAMINATION REPORT

Morris Dam Inlet/Outlet Works Modernization

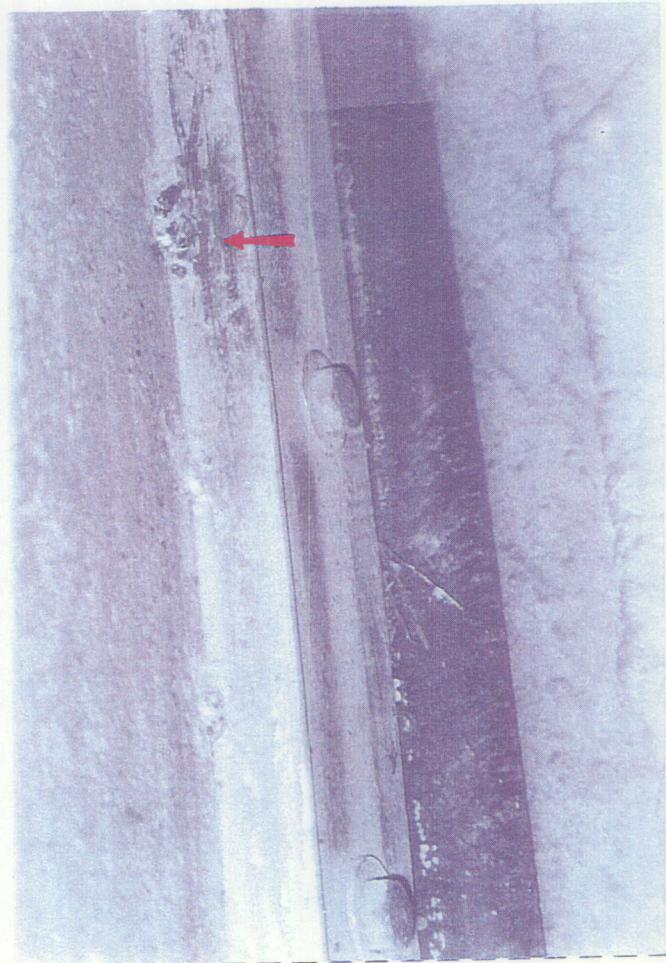
Photo 14 - Morris Dam - 70' x 18' Drum Gate #1 (east) - Right side end music note seals. View of scrap mark on side of $\frac{1}{2}$ " seal stop bar. Scrap mark indicates possible interference with edge of shield guard, (next photo).. - (9/10/98).

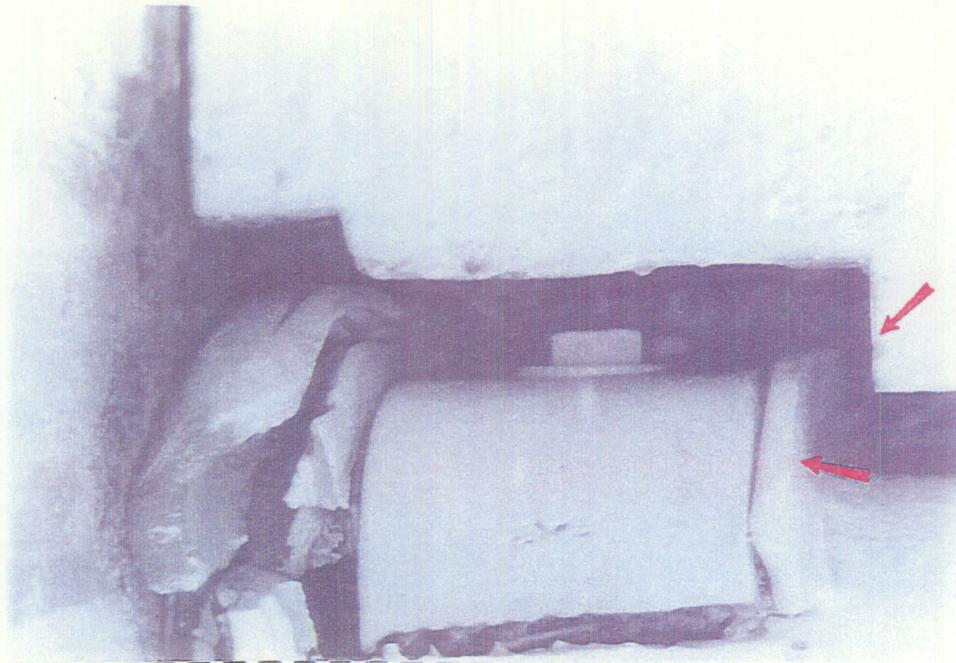
Photo 15 - Morris Dam - 70' x 18' Drum Gate #1 - Top of spillway crest, right end, Gate #1, looking down at rt. side end seal assembly, & rightmost notched shield guard. Left arrow points to $\frac{1}{2}$ " seal stop bar referred to in previous photo. Upper arrow points to probably cause of scrapping- (9/10/98).

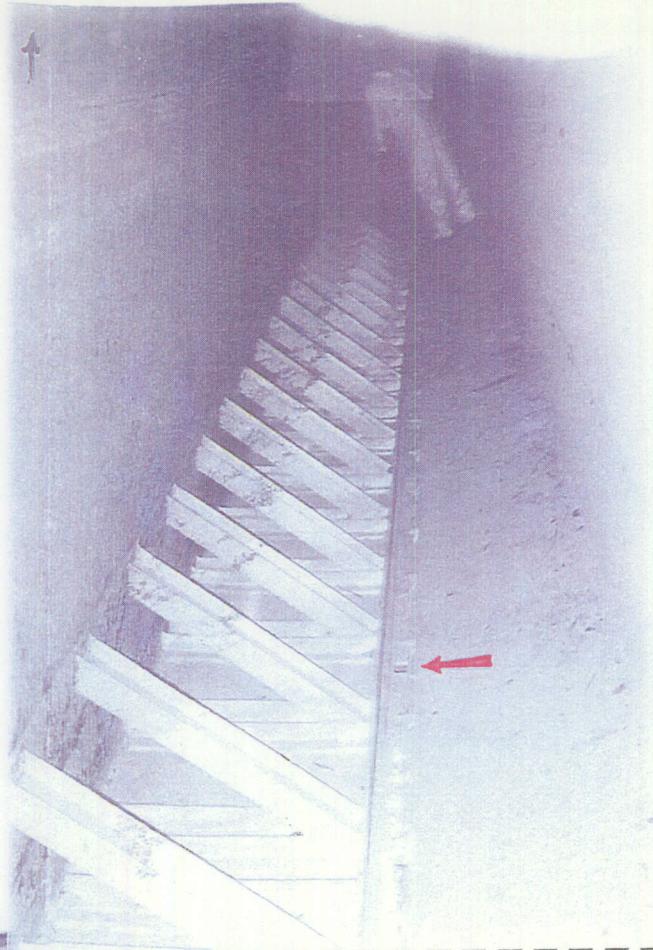
Photo 18 - Morris Dam - 70' x 18' Drum Gate #1 (east) - D/S side of chamber, Gate resting in lowered position on rail. Left arrow points to supply hole cut in web of rail. (next photo). - (9/10/98).

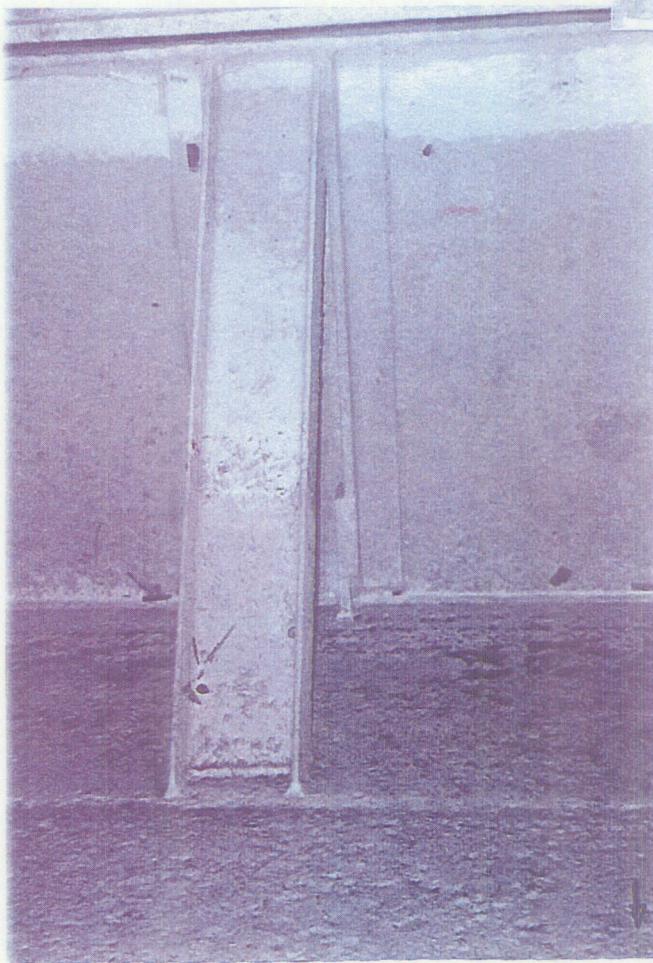
Photo 19 - Morris Dam - 70' x 18' Drum Gate #1 - Strike plate on bottom of gate resting on rail. Arrow points to cut out supply hole (previous photo). - (9/10/98).

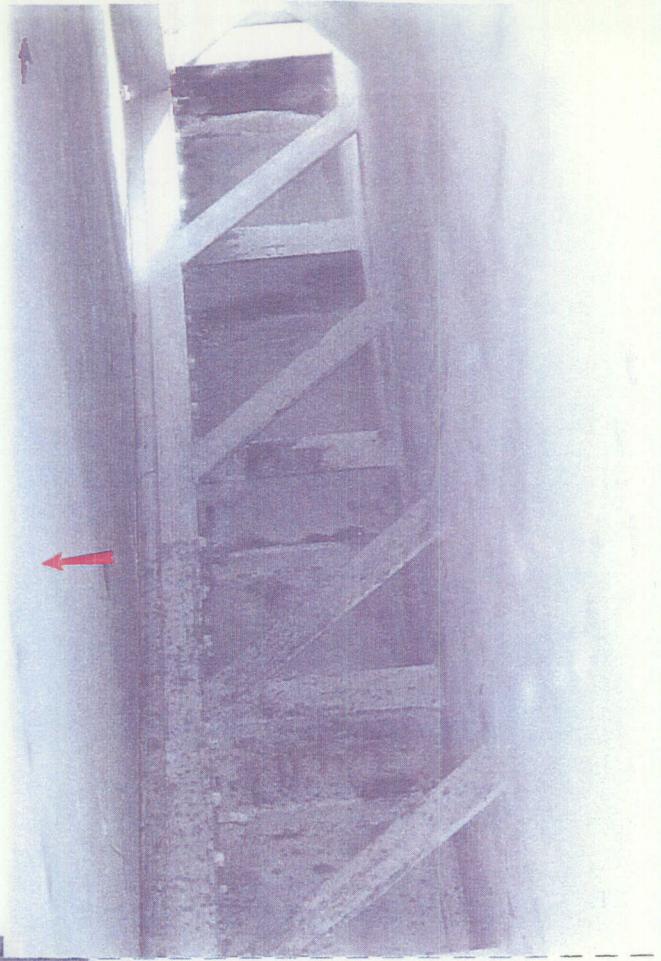
Photo 20 - Morris Dam - 70' x 18' Drum Gate #1 (east) - Typical brace on cantilevered portion. Braces are generally well coated, but pitted. - (9/10/98).

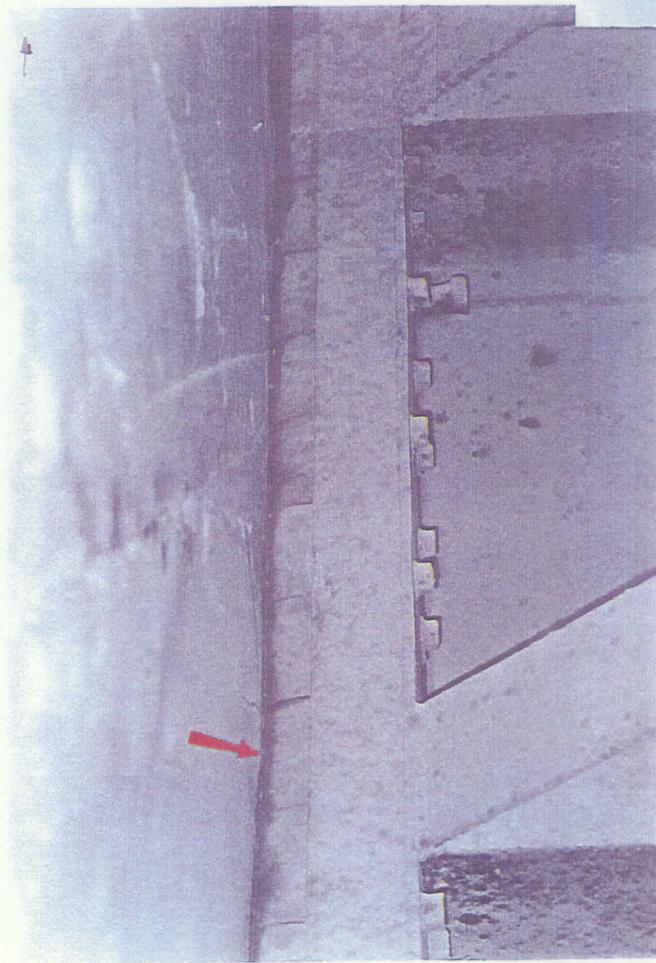
Photo 21 - Morris Dam - 70' x 18' Drum Gate #1 - Right side of Gate #1, cantilevered portion of u/s faceplate.

Paint is generally good, brace structure is satisfactory, but braces are pitted. Left arrow points to right chamber wall.

Right arrow point end plates - satisfactory. - (9/10/98).

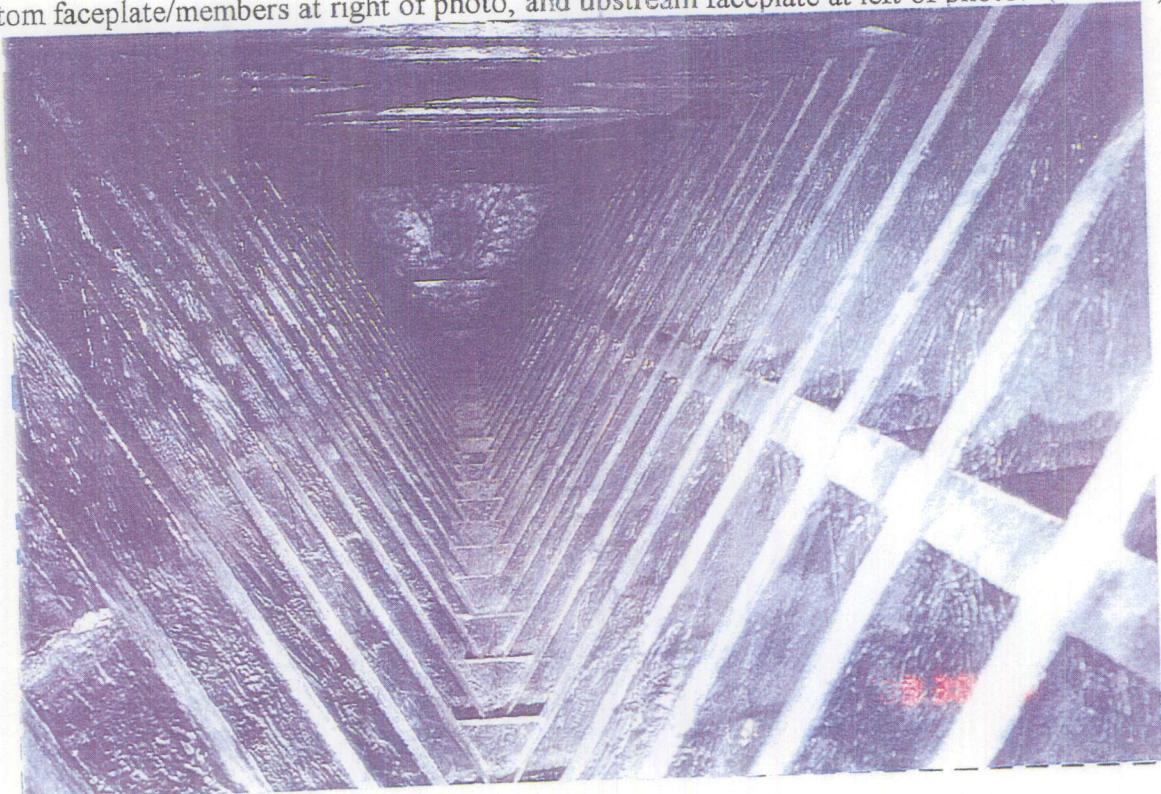
Photo 6 - Morris Dam - 70' x 18' Drum Gate #1 (interior)- Lower leve, looking towards left end, with bottom faceplate on right of photo. Note ponding water in all horizontal webs. Upstream members at ft of photo. (9/30/98).

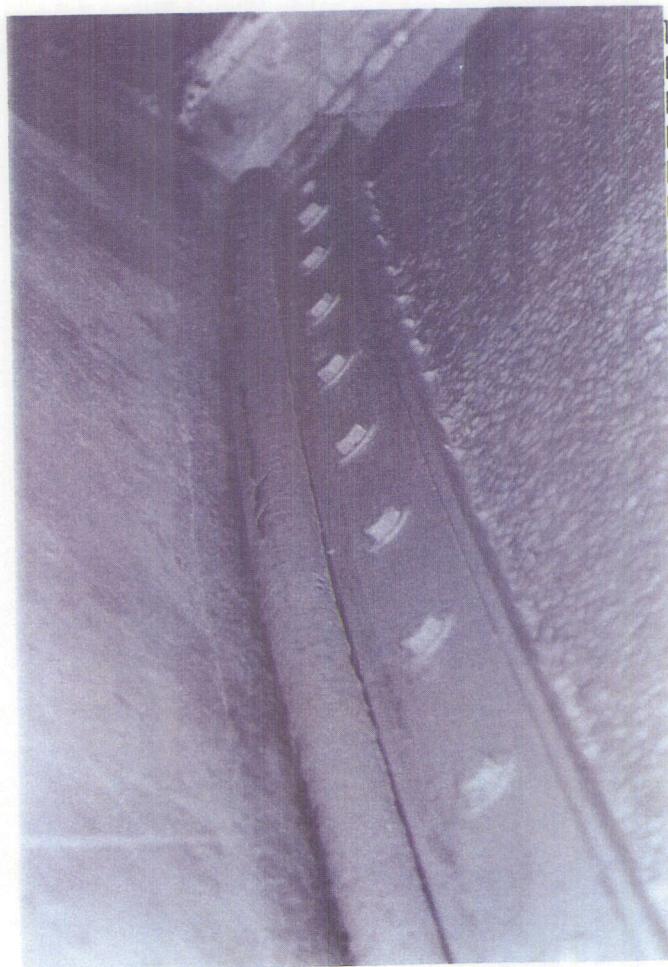
Photo 2 - Morris Dam - 70' x 18' Drum Gate #2 - U/S faceplate, u/s side of chamber, left side of gate, looking towards top of chamber. Note torn hollow music not seal. . - (9/10/98).

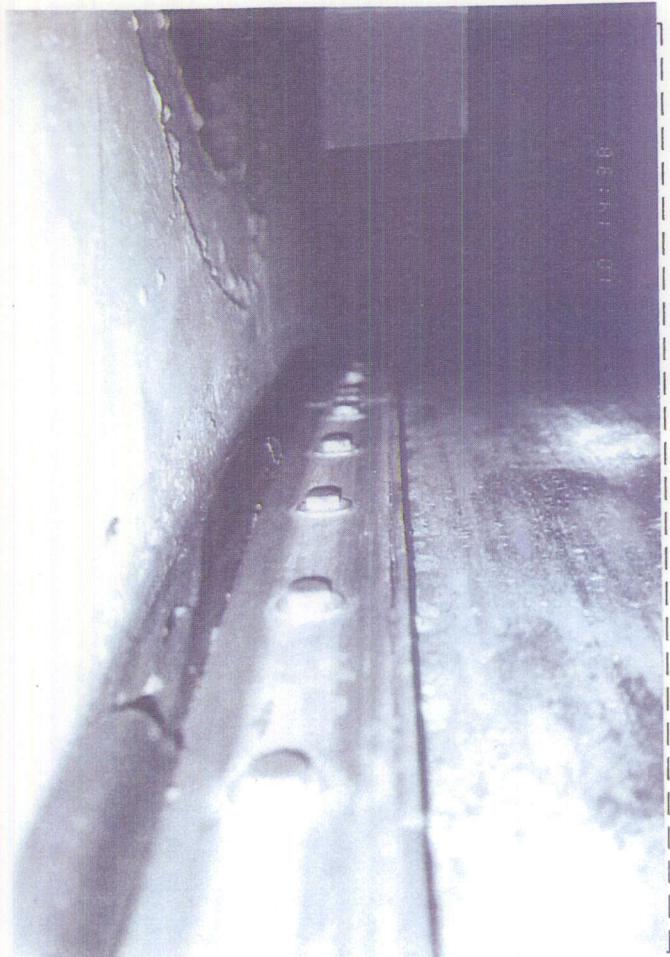
Photo 3 - Morris Dam - 70' x 18' Drum Gate #2 - U/S faceplate, u/s side of gate, looking towards top of gate. seal and clamp bar. Note extensive pitting over faceplate. - (9/10/98).

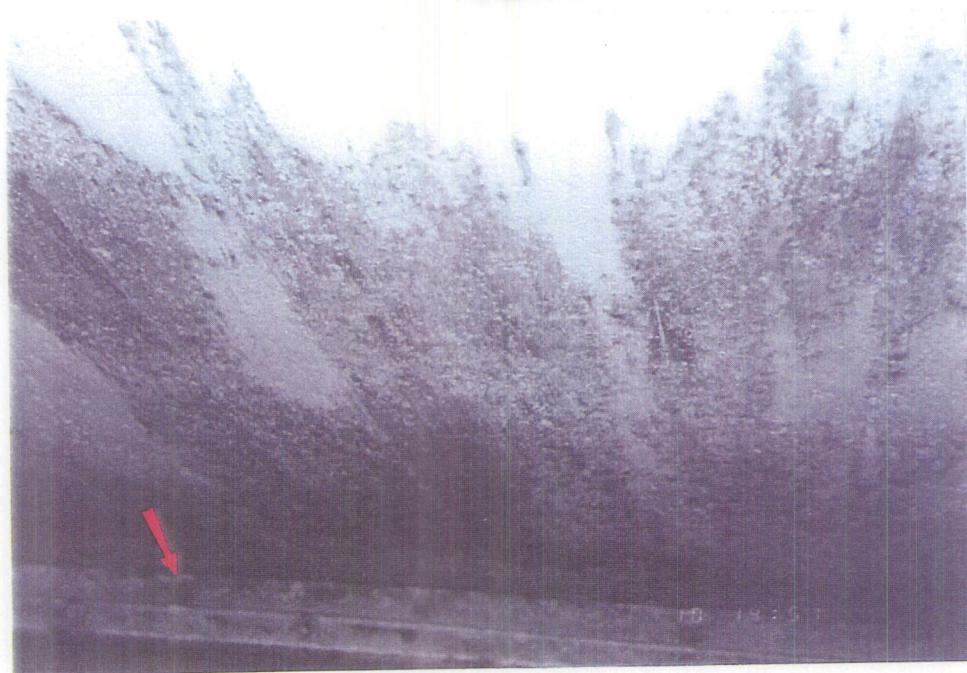
Photo 4 - Morris Dam - 70' x 18' Drum Gate #2 - U/S faceplate, u/s side of chamber, looking towards floor. Note stop screw mark (arrow) on stop angle (arrow), and note failed paint coating and pitting.. - (9/10/98).

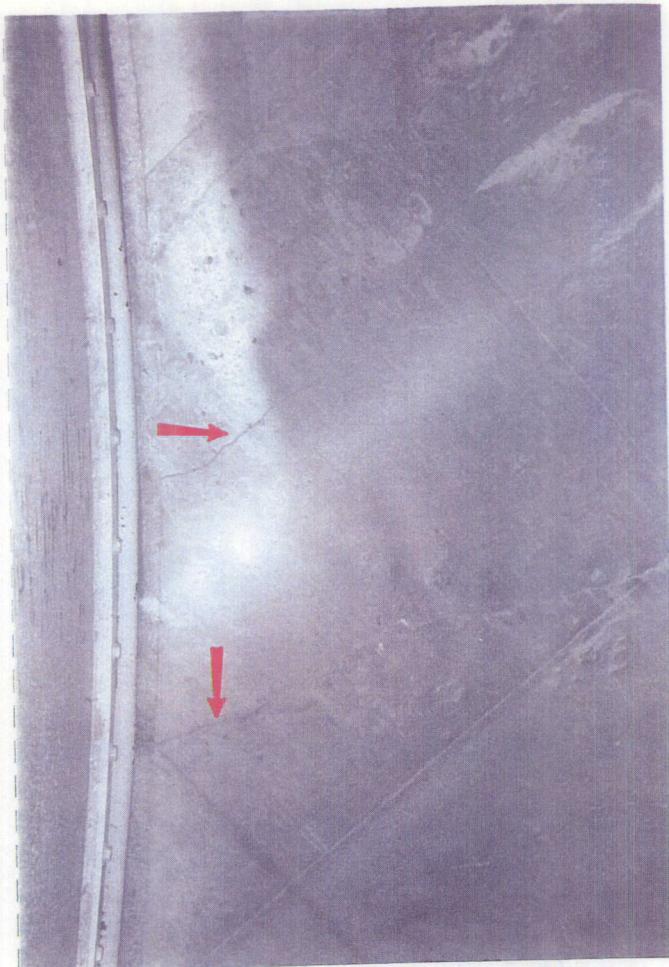
Photo 7 - Morris Dam - 70' x 18' Drum Gate #2 - Right end chamber wall and right side seal assembly. Note cracks. Down arrow (next photo) points to horizontal crack Right arrow is 2nd crack (2nd following photo)- (9/10/98).

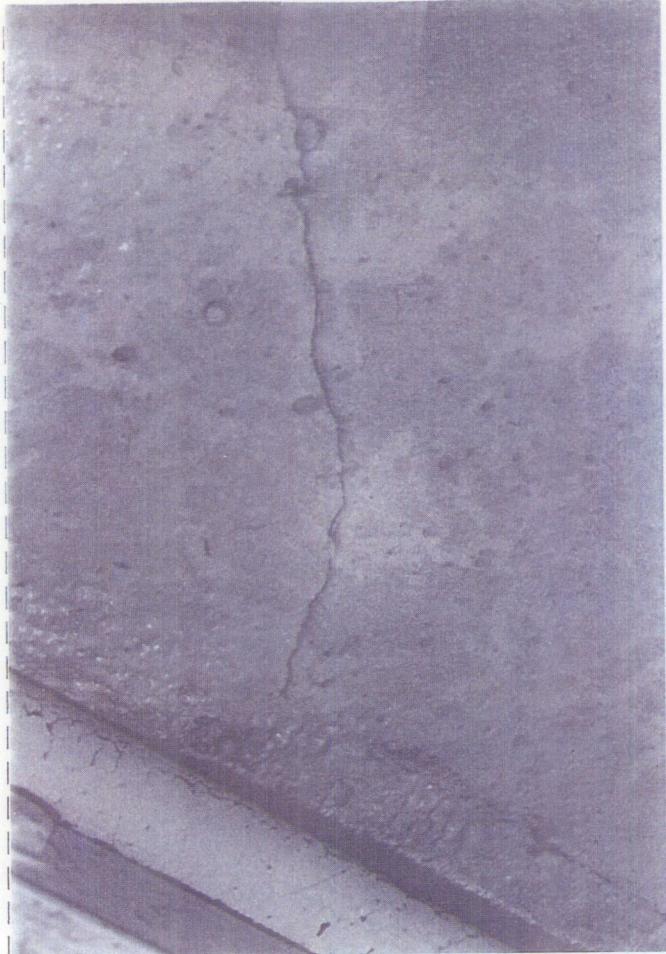
Photo 9 - Morris Dam - 70' x 18' Drum Gate #2 - Closeup of crack upper (right) arrow, two previous photos.- (9/10/98).

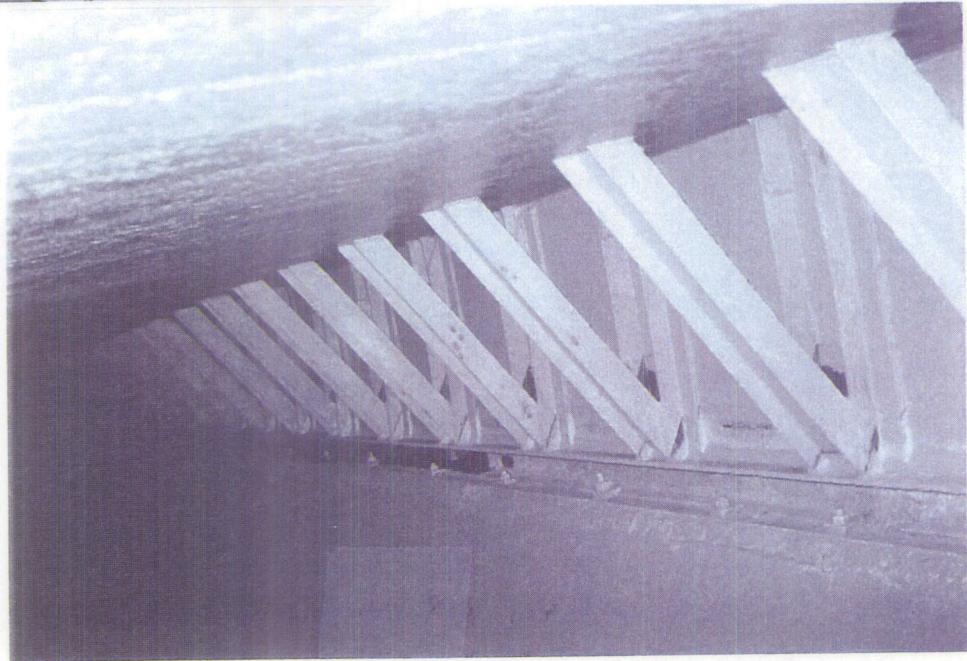
Photo 10 - Morris Dam - 70' x 18' Drum Gate #2 - D/S of gate chamber, looking towards right end of gate. Bottom faceplate on right of photo. Cantilevered bottom portion of u/s faceplate with braces. Braces look sound but pitted.. - (9/10/98).

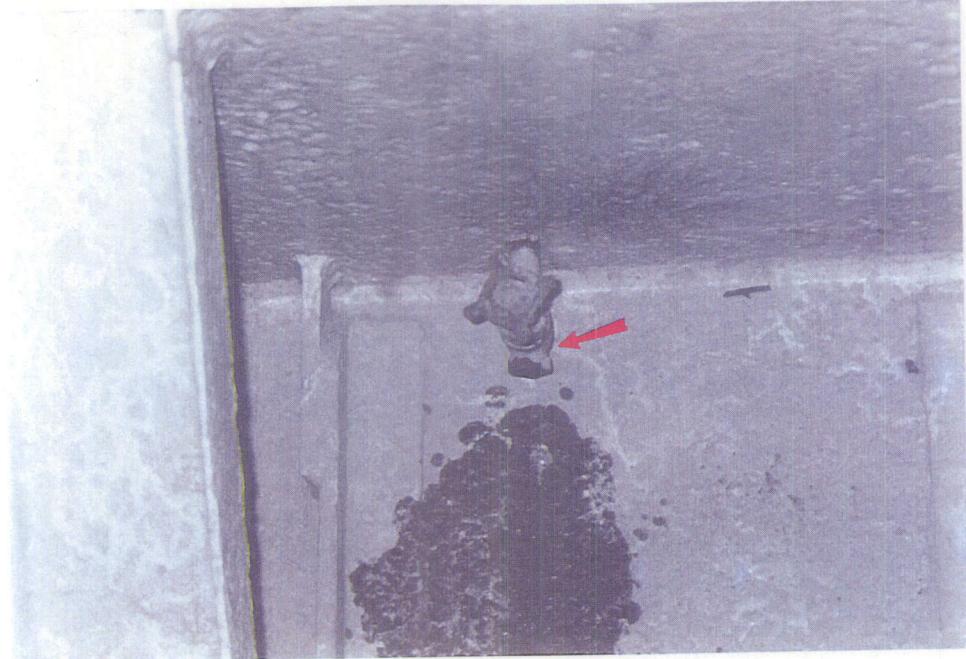
Photo 11 - Morris Dam - 70' x 18' Drum Gate #2 - One drain cock located on left side of gate . Rust on cantilever is from drain.- (9/10/98).

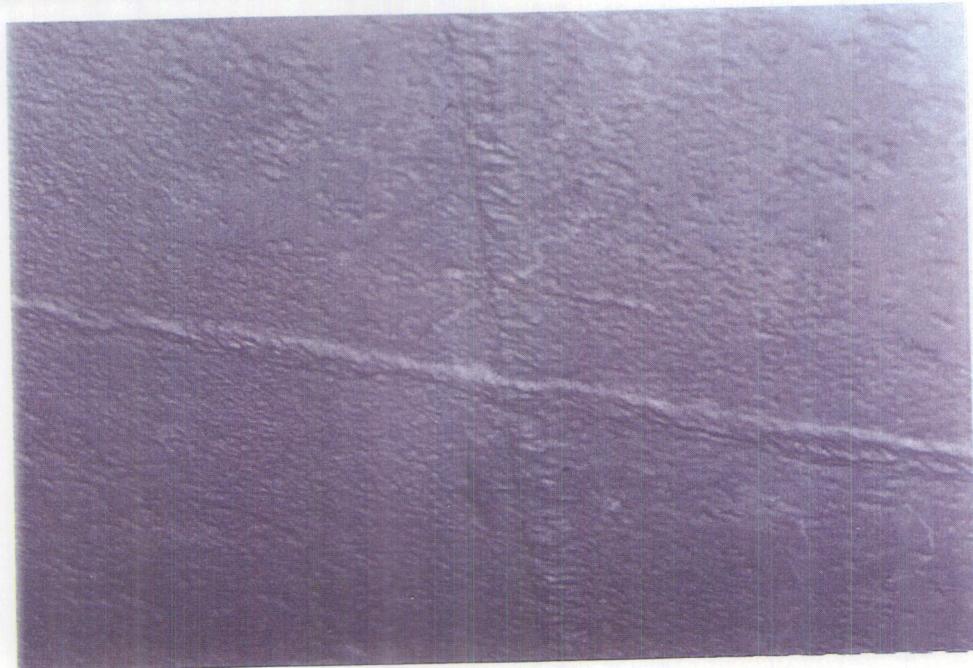
Photo 14 - Morris Dam - 70' x 18' Drum Gate #2 - Bottom faceplate at intersection of vertical and horizontal welds, typical. Welds okay. Note extensive pitting over faceplate.. - (9/10/98).

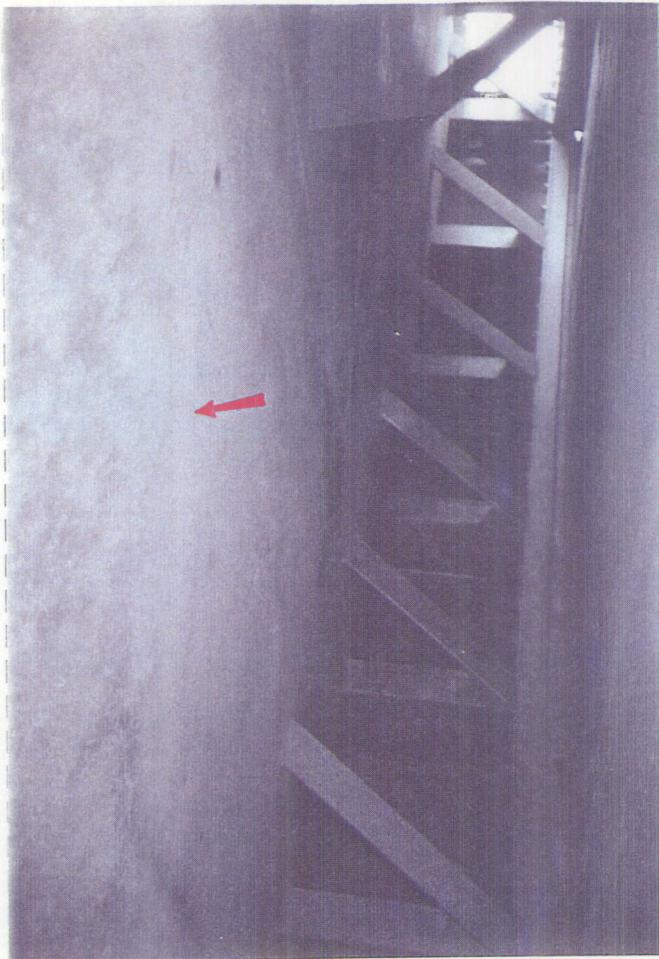
Photo 15 - Morris Dam - 70' x 18' Drum Gate #2 - Left side of gate, viewed from d/s side of gate chamber. Cantilevered portion of u/s faceplate. Note end plates on drum gate in good condition, bracing in good condition, but pitted. Looking towards top. Lift is hatch to spillway. - (9/10/98).

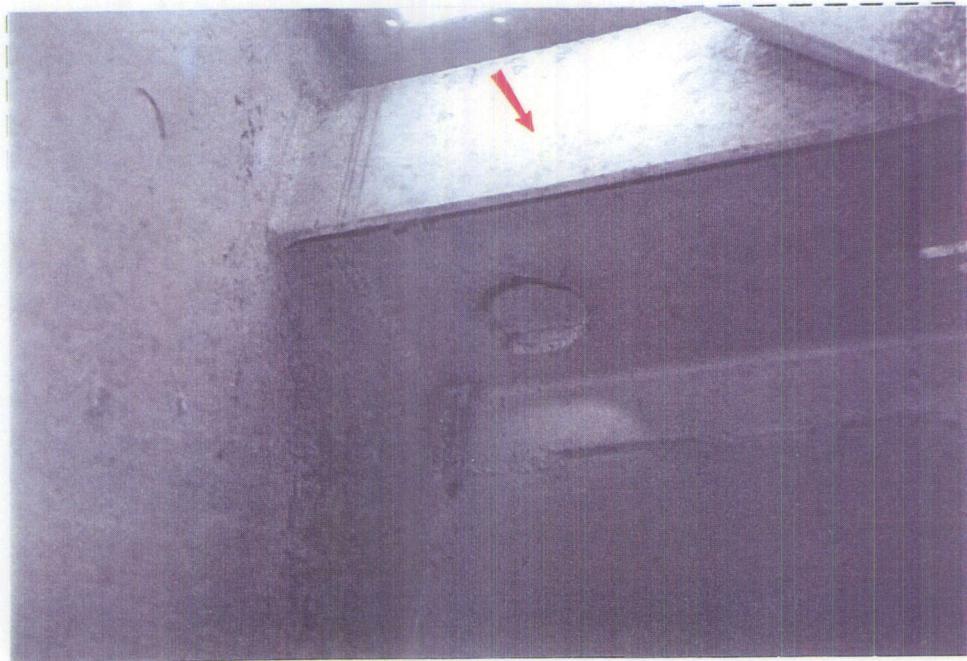
Photo 16 - Morris Dam - 70' x 18' Drum Gate #2 - Left side of gate, cantilevered segment. Portion of horizontal u/s faceplate beam (W12x31.8) Note drain hole in corner. - (9/10/98).

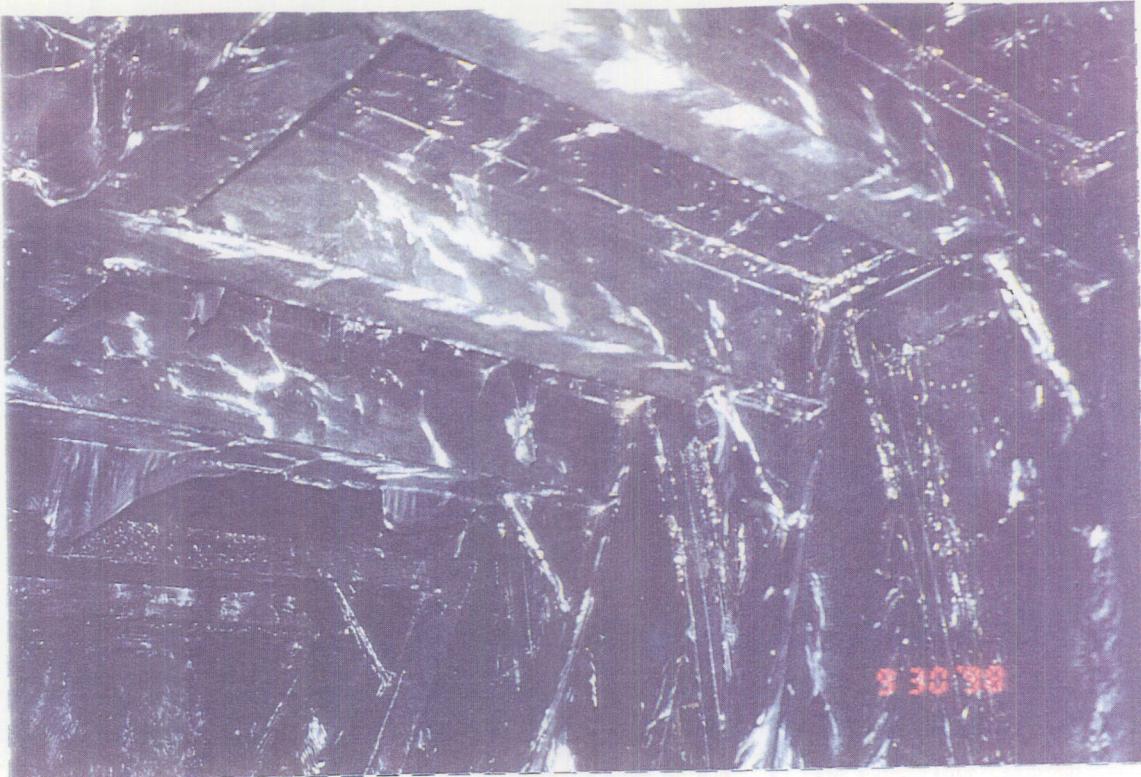
Photo 3 - Morris Dam - 70' x 18' Drum Gate #2 (interior)- Looking up at downstream faceplate. Coating is in good condition.- (9/30/98).

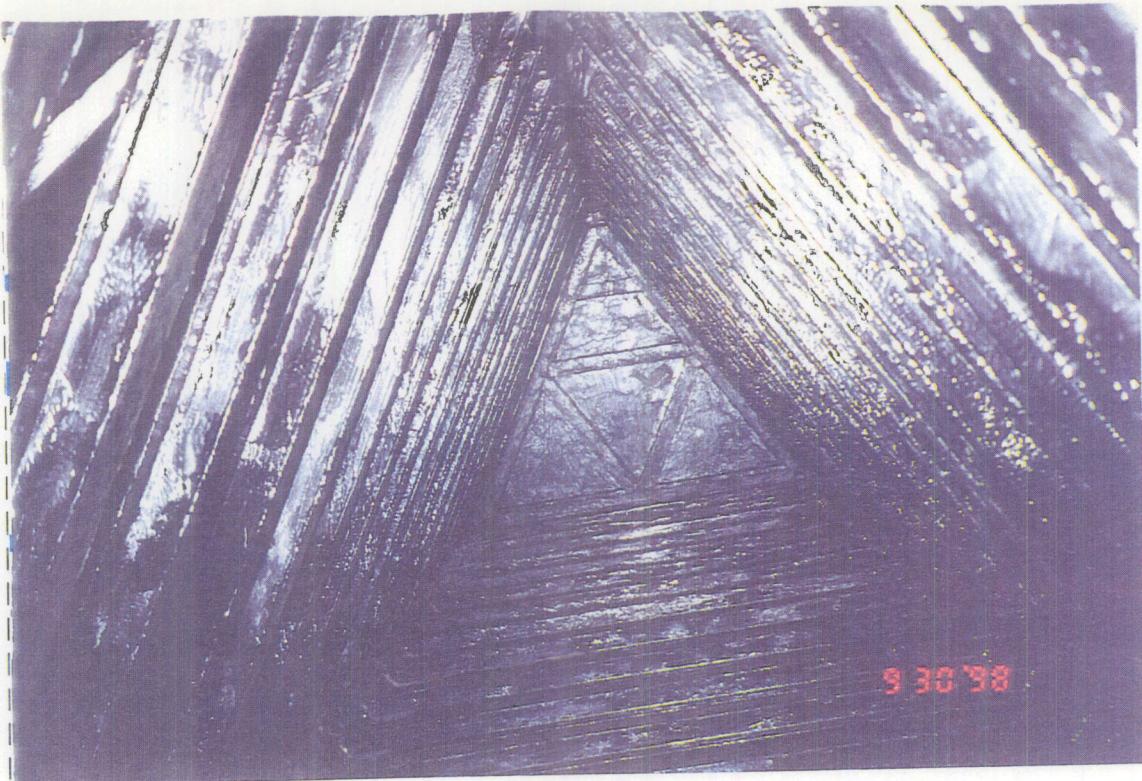
Photo 9 - Morris Dam - 70' x 18' Drum Gate #2 (interior)- Inside gate, upper level, looking at right end of gate through middle of internal brace members.- (9/30/98).

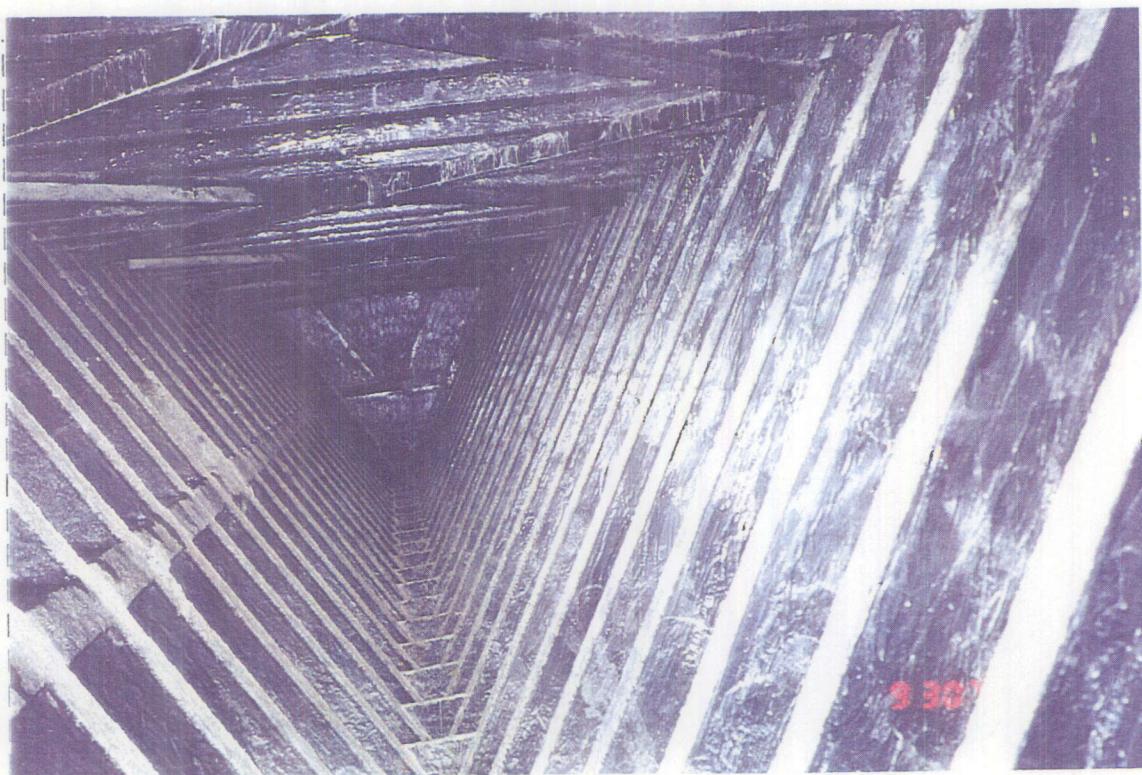
Photo 13 - Morris Dam - 70' x 18' Drum Gate #2 (interior)- Inside gate, lower level, looking to right end of gate. Note good condition of coating and structural members.- (9/30/98).

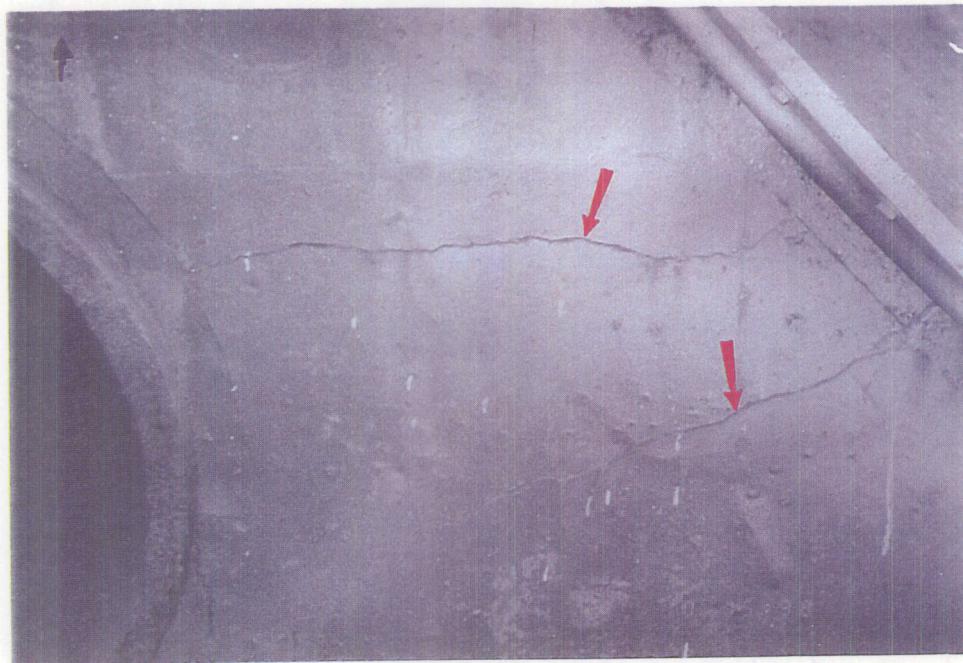
Photo 1 - Morris Dam - 70' x 18.' Drum Gate #3 - Two cracks on left end concrete chamber wall, u/s of gate at 30" discharge pipe.- (9/10/98).

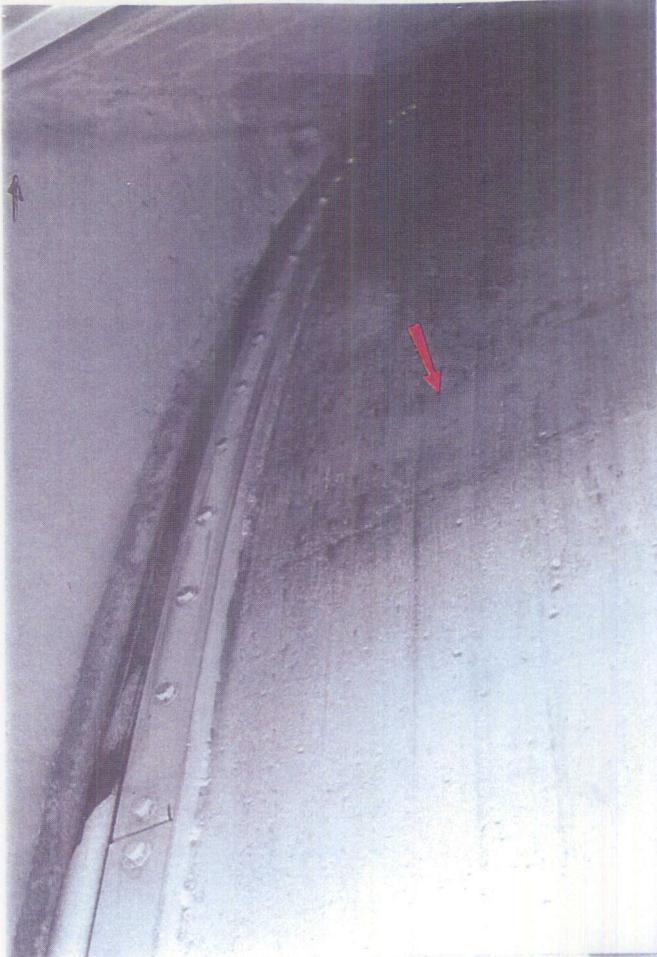
Photo 3 - Morris Dam - 70' x 18.' Drum Gate #3 - Upstream faceplate, left side of gate and left end seal assembly. Note paint on lower 7' portion is good, but note pitting.- (9/10/98).

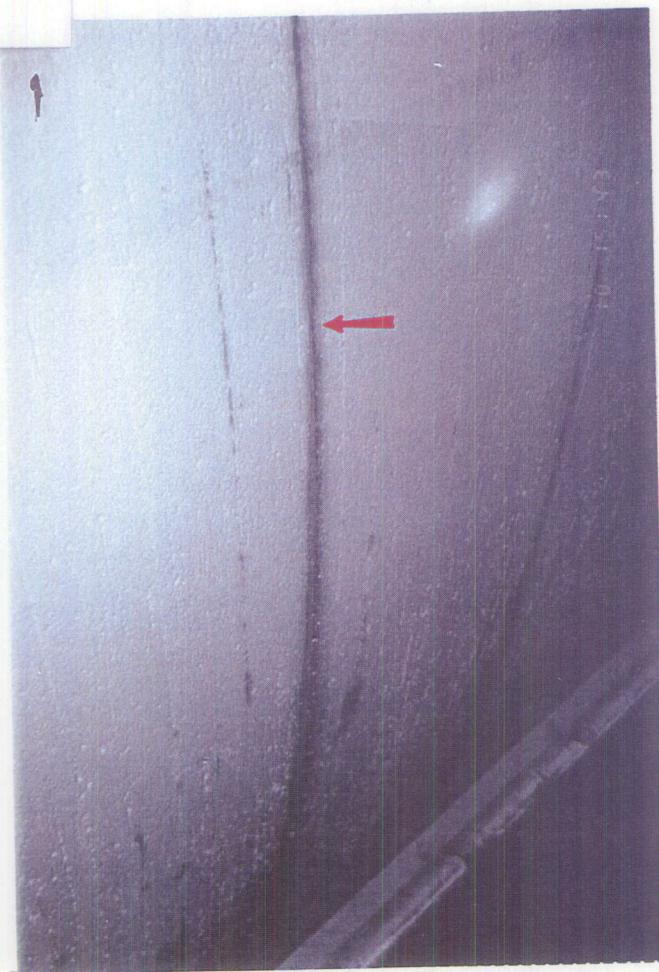
Photo 4 - Morris Dam - 70' x 18' Drum Gate #3 - Upstream faceplate, upstream gate chamber. Left arrow points to scrap mark on faceplate indicating shield guard interference.. - (9/10/98).

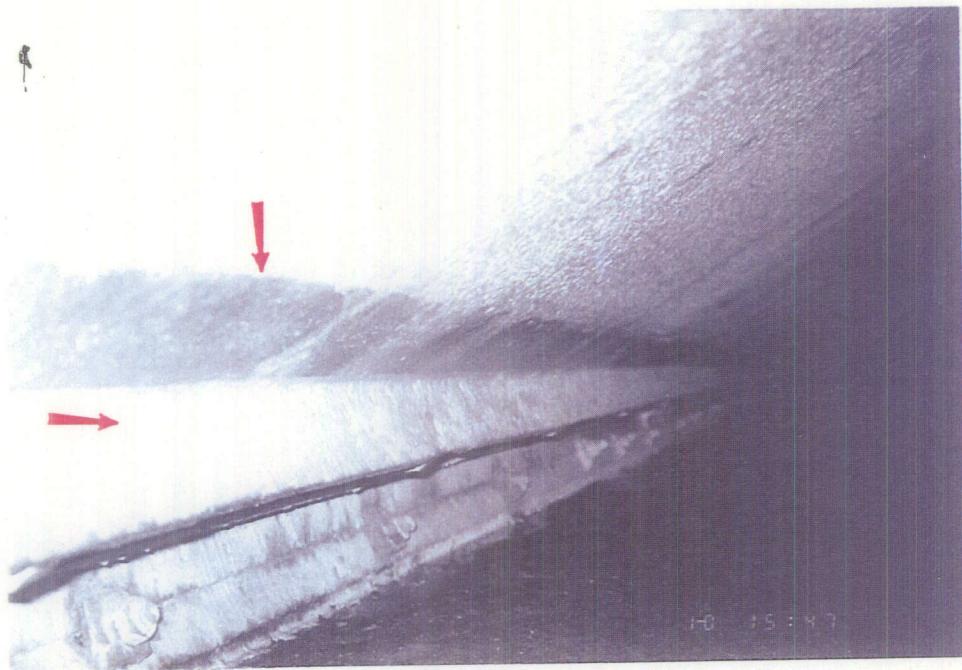
Photo 5 - Morris Dam - 70' x 18.' Drum Gate #3 - Upstream faceplate near bottom of gate. Right arrow points along stop angle. (Stop rail shown clipped to concrete.) Down arrow points to 5" band where paint has been completely eroded. A 7' arc above band, paint is good.- (9/10/98).

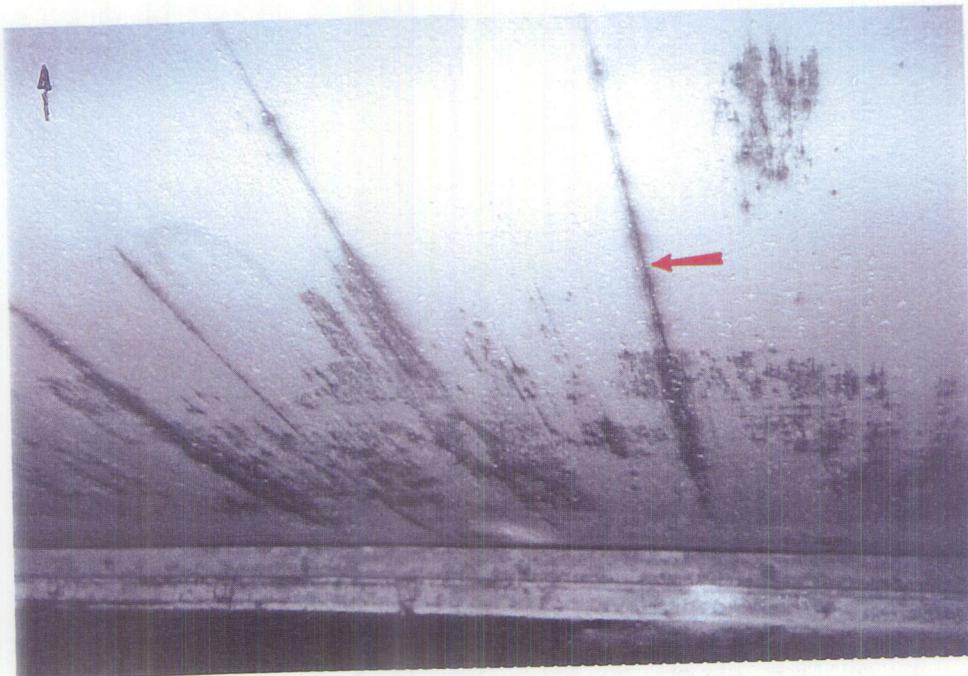
Photo 6 - Morris Dam - 70' x 18' Drum Gate #3 - Upstream faceplate, looking towards bottom edge. Left arrow points to scrap mark.. - (9/10/98).

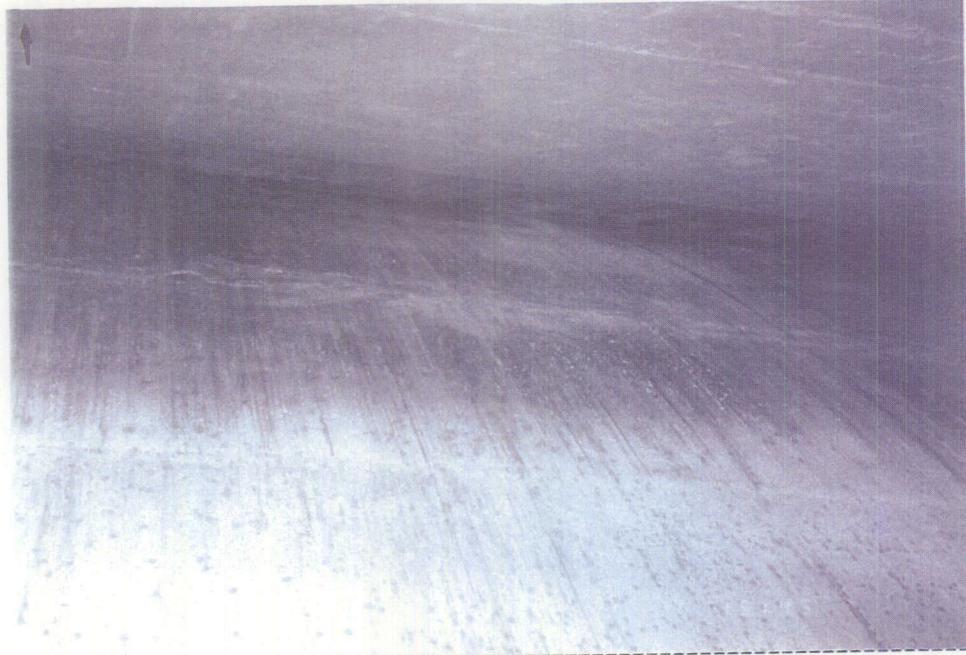
Photo 7 - Morris Dam - 70' x 18' Drum Gate #3 - Upstream faceplate, looking upwards to top. Note extensive faceplate pitting.- (9/10/98).

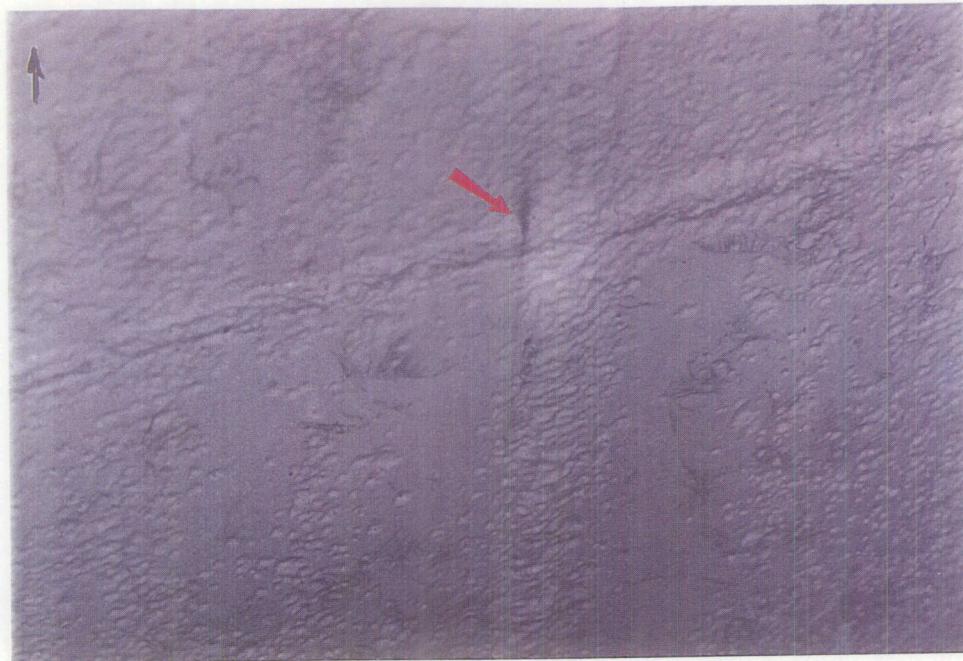
Photo 9 - Morris Dam - 70' x 18' Drum Gate #3 - Bottom faceplate. Note extensive pitting on faceplate. Arrow points to intersection of horizon/vert plate butt weld. Note vertical weld has no crown, and is extremely pitted. Grind and reweld.- (9/10/98).

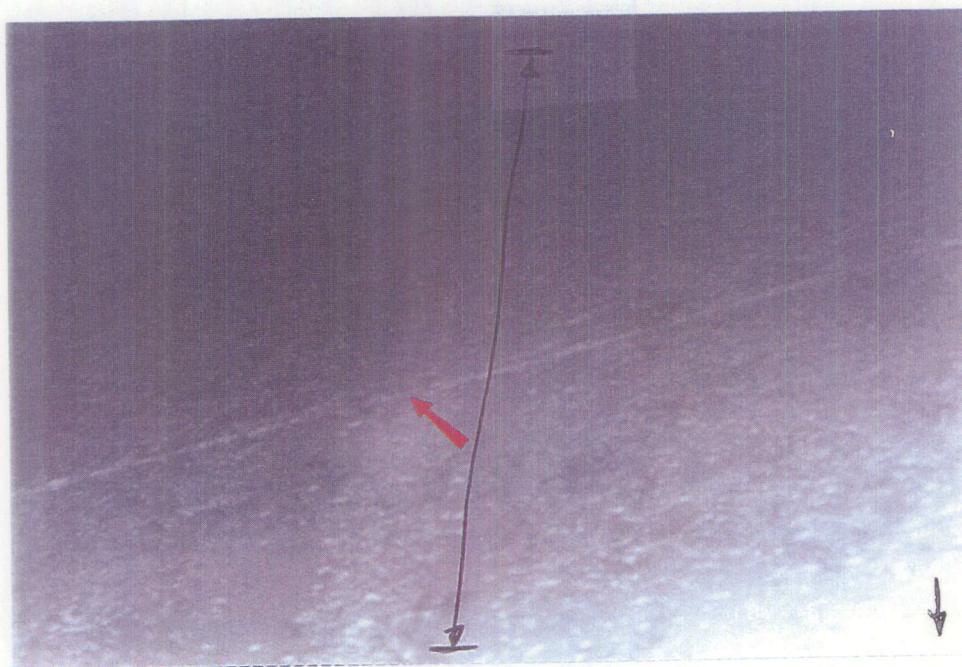
Photo 10 - Morris Dam - 70' x 18' Drum Gate #3 - Bottom faceplate. Arrow points to same intersection as previous photo. Note, extent of pitted weld. Weld joint is discernable, but replaced by a band of pitting.. - (9/10/98).

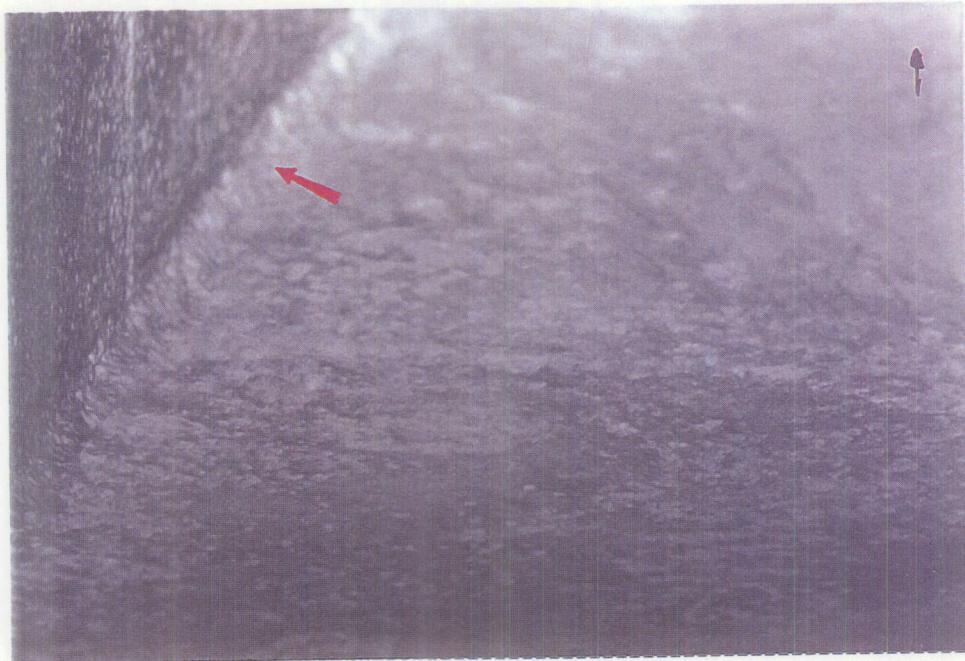
Photo 11 - Morris Dam - 70' x 18.' Drum Gate #3 - Arrow points to edge of bottom faceplate and right side end plates. The edge weld is badly corroded and should be ground and reweld.- (9/10/98).

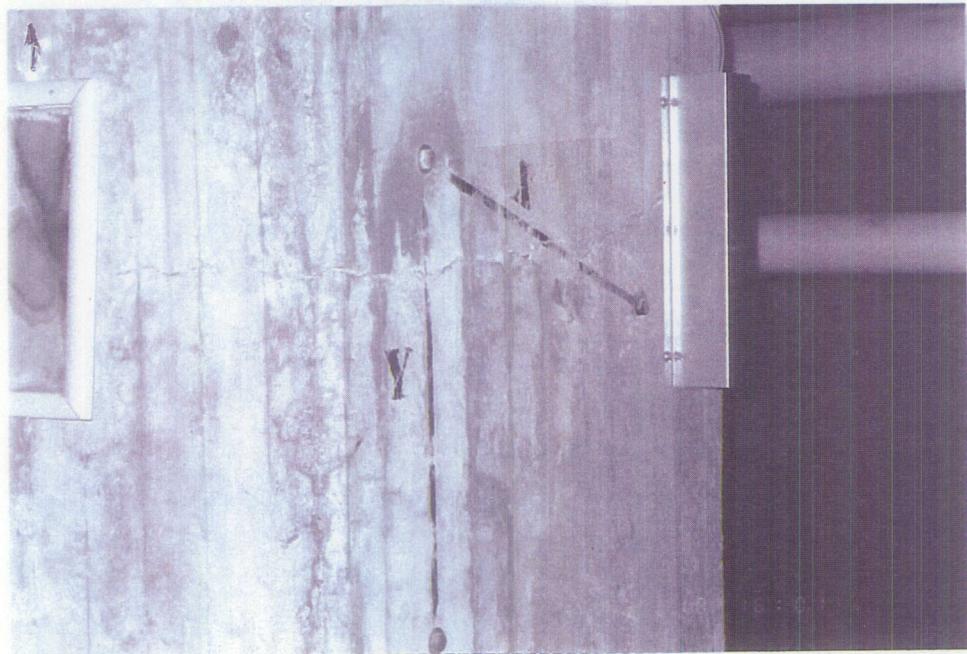
Photo 14 - Morris Dam - 70' x 18' Drum Gate #3 - Doorway entrance to Gate #3 controls. Marks monitor crack on concrete column due to (4/6/65) earthquake.. - (9/10/98).

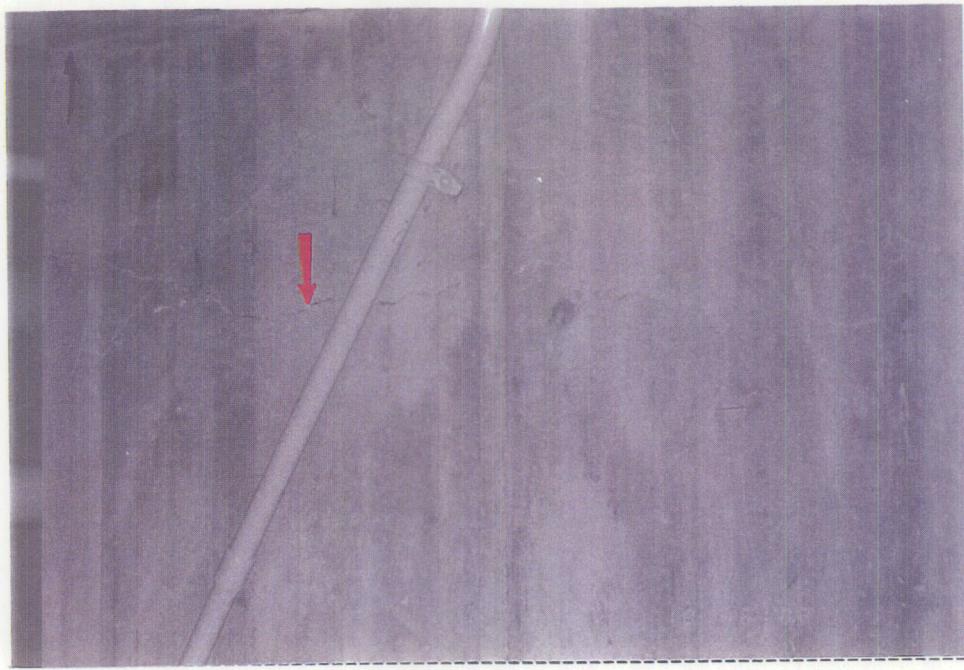
Photo 15 - Morris Dam - 70' x 18.' Drum Gate #3 - Down arrow points to full width horizontal crack on left side chamber end wall due to (4/6/65) earthquake. Crack is not monitored.
