EQUIPMENT INSPECTION / EVALUATION REPORT

MORRIS DAM INLET/OUTLET WORKS
MODERNIZATION
County of Los Angeles
Department of Public Works

MECHANICAL EXAMINATION REPORT

Morris Dam Inlet/Outlet Works Modernization

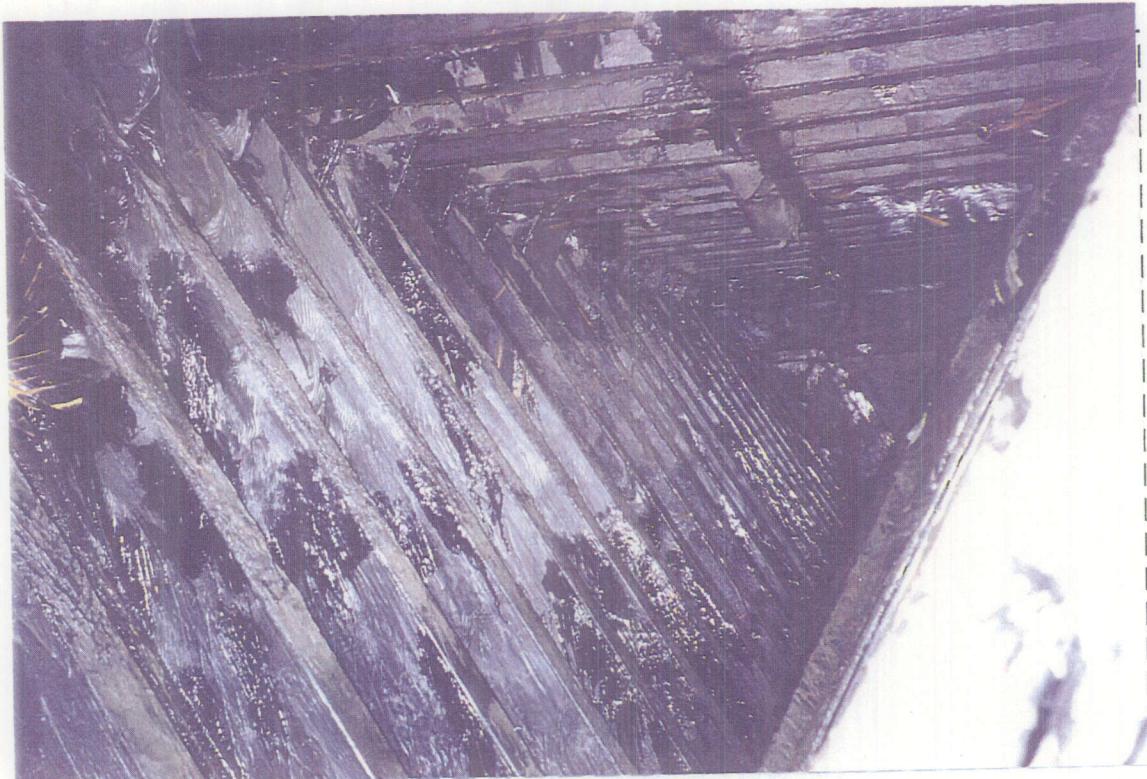
Photo 6 - Morris Dam - 70' x 18' Drum Gate #3 (interior)- Right side, end plates of gate. Note water ponding in web of girder. Coating in good condition. (9/30/98).

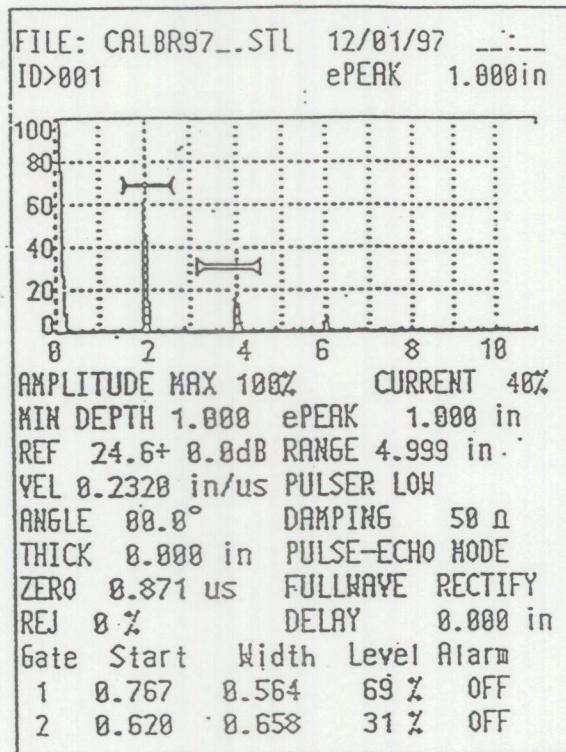
FIGURE 4-1
Calibration Data for Steel Outlet Pipes

Ultrasonic examination of each outlet pipe shell was performed using a Panametrics Epoch III ultrasonic thickness/flaw detector. Calibration waveforms and data for measurements of the steel outlet pipes are shown in figure 4-1. Several measurement locations were selected for each individual pipe diameter and wall thickness. The thickness measurements were taken at various locations about the circumference of the outlet pipe shells. The results of the data were incorporated into spreadsheets for statistical analysis as seen in tables 4-1 through 4-6. Results of the tables are expressed both in terms of the magnitude of deviations in measured wall from specified wall thickness, and as a percentage of the nominal specified wall thickness.

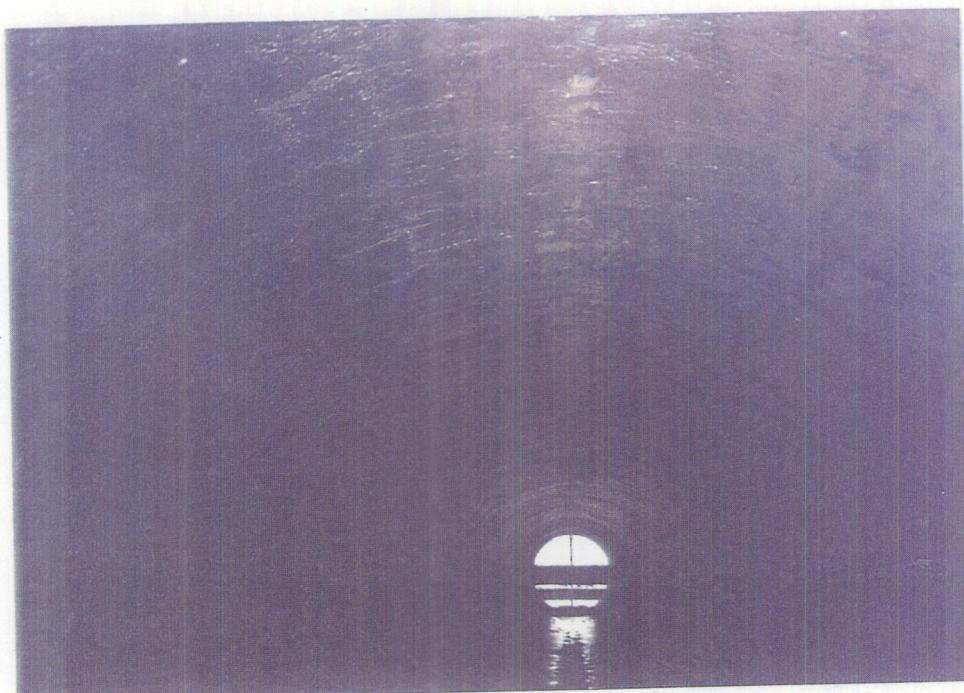
The coal tar epoxy in outlet pipe No. 1 is in good condition except for the upstream end of the outlet pipe (photograph 1). The coal tar epoxy coating has completely deteriorated upstream of the butterfly valve to a distance approximately 20 feet downstream of the butterfly valve. There is a large amount of surface rusting occurring at these locations but there was no significant pitting observed (photographs 2 and 3). There are a number of small-diameter areas with significant amount of coating loss

Photograph 1 - Interior of outlet pipe No. 1.

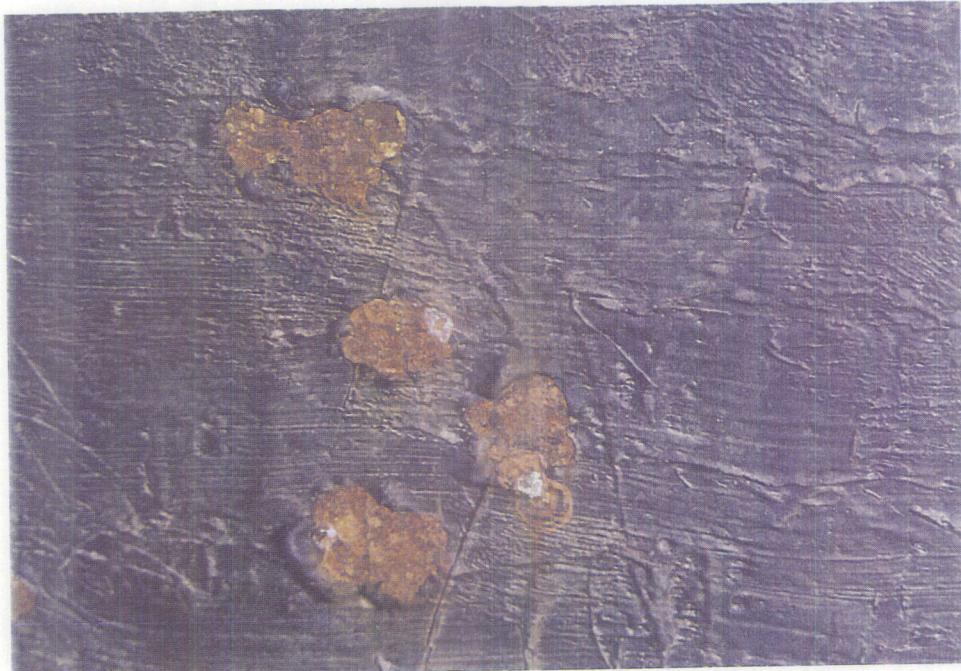
Photograph 3 - Damage to coal tar epoxy lining on interior of outlet pipe No. 1.

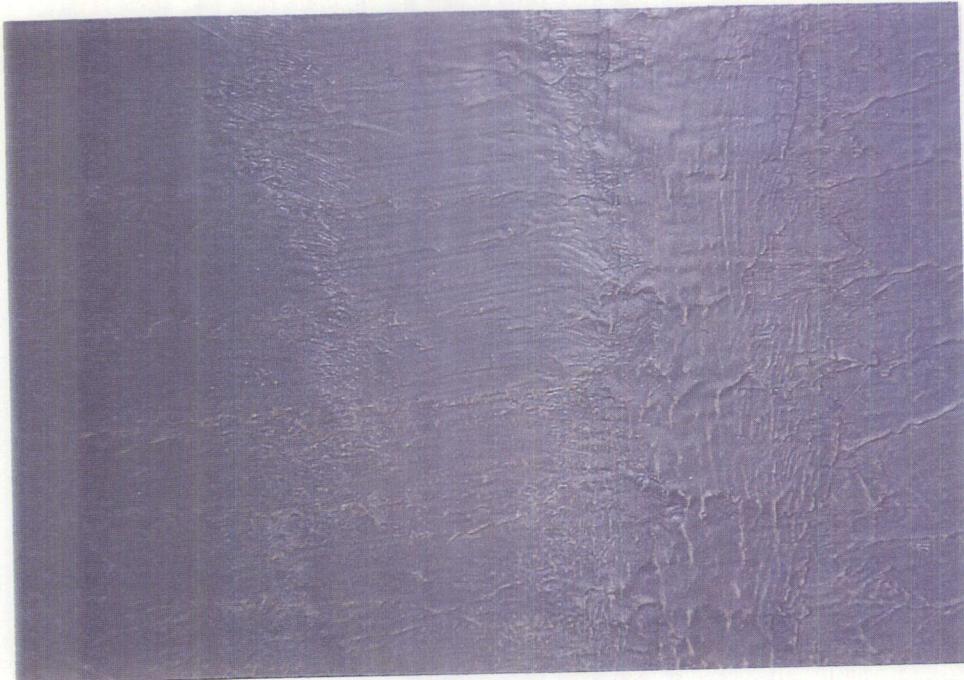
Photograph 4 - Damage to coal tar epoxy lining on interior of outlet pipe No. 1.

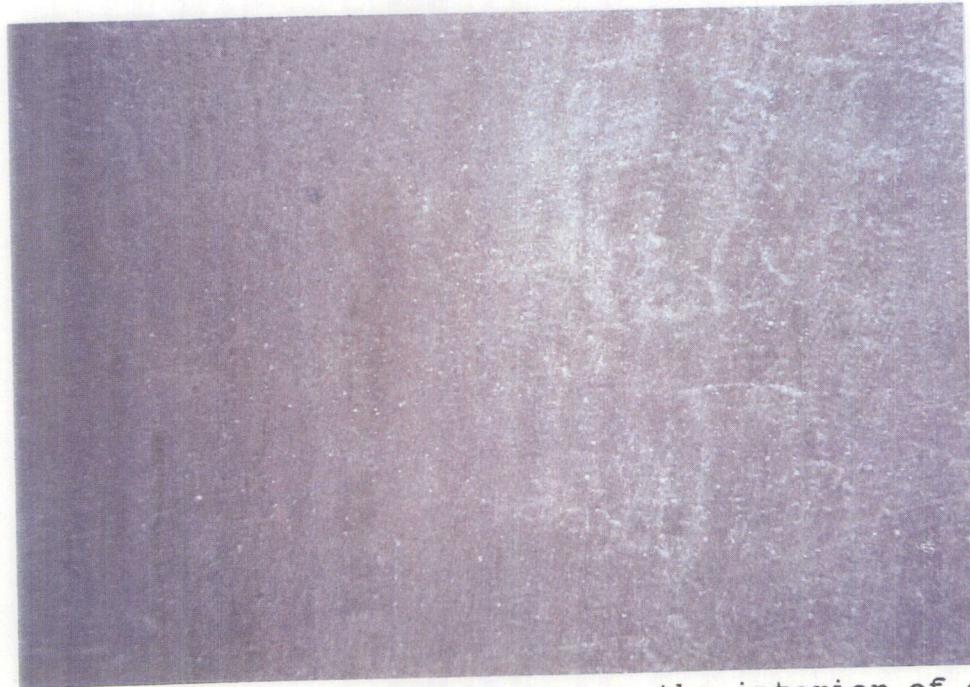
Photograph 5 - Coal tar epoxy lining on interior of outlet pipe
No. 3.

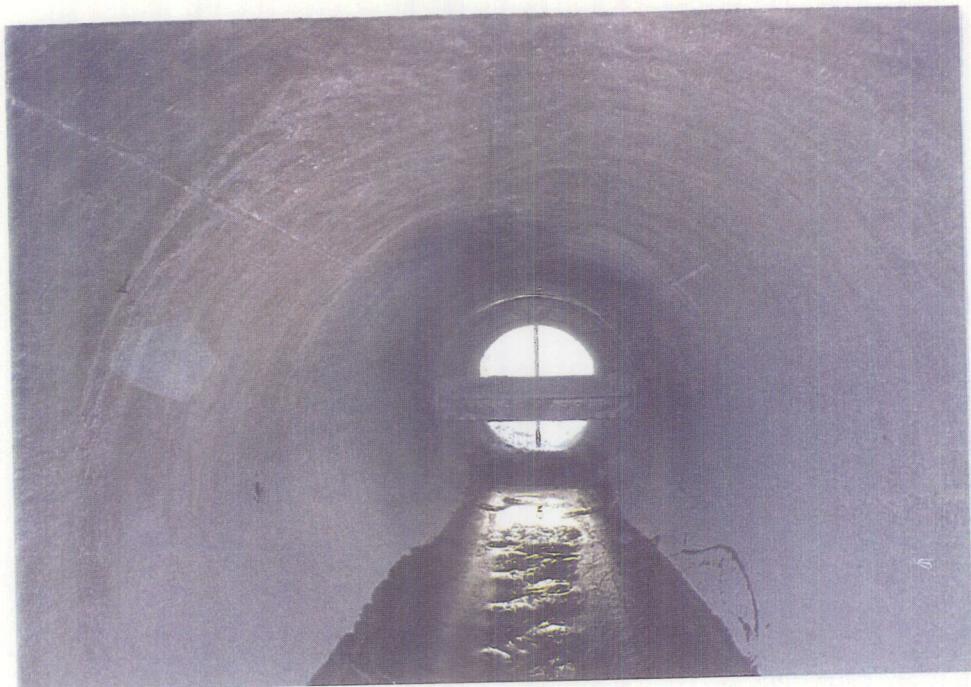
Photograph 6 - Coal tar epoxy lining on the interior of outlet
pipe No. 4.

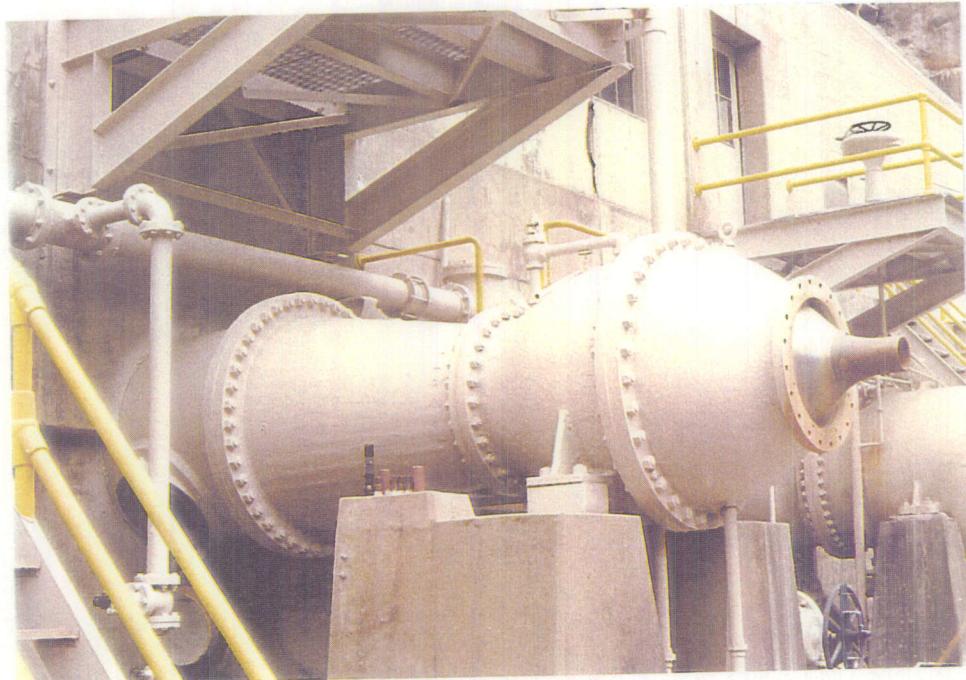
Photograph 9 - Exposed section of outlet pipe No. 2. Note sediment being discharged during sluicing operations.

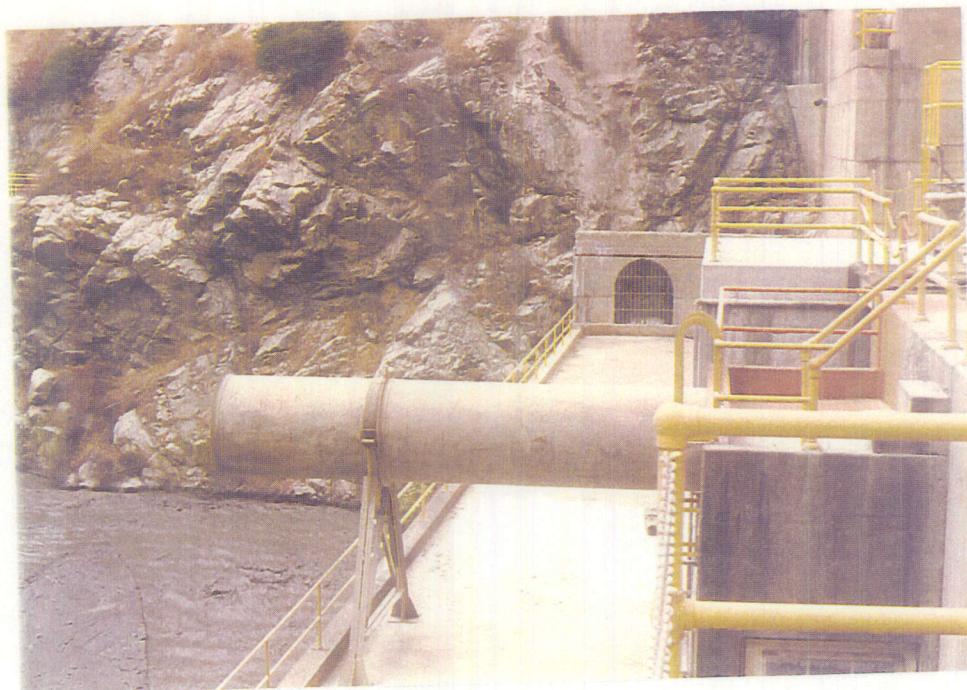
Photograph 10 - Exposed sections of outlet pipe No. 3.

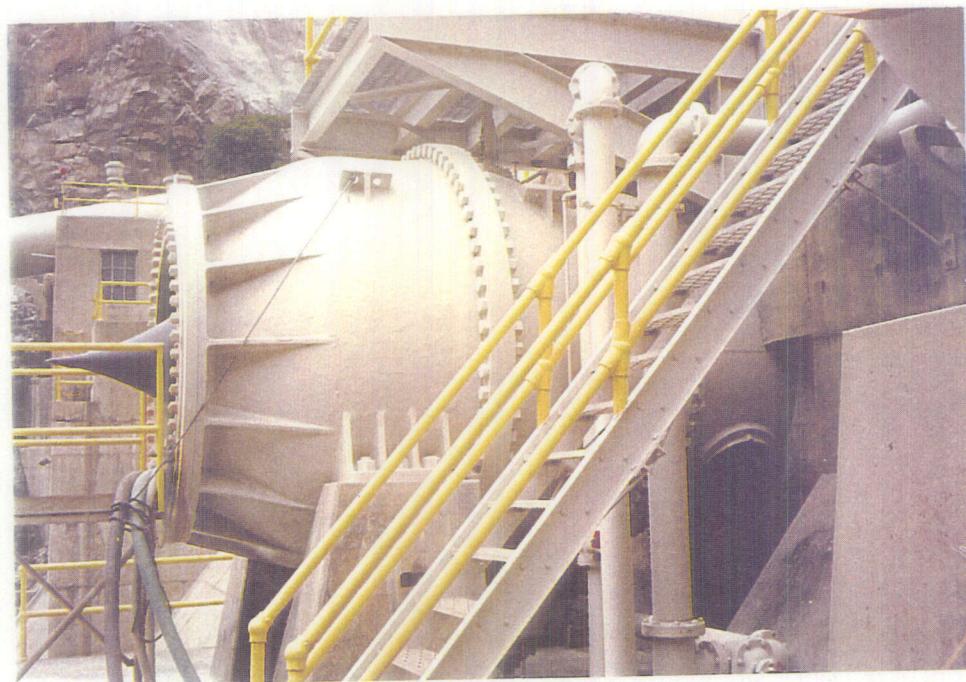
Photograph 11 - Exposed sections of outlet pipe No. 5.

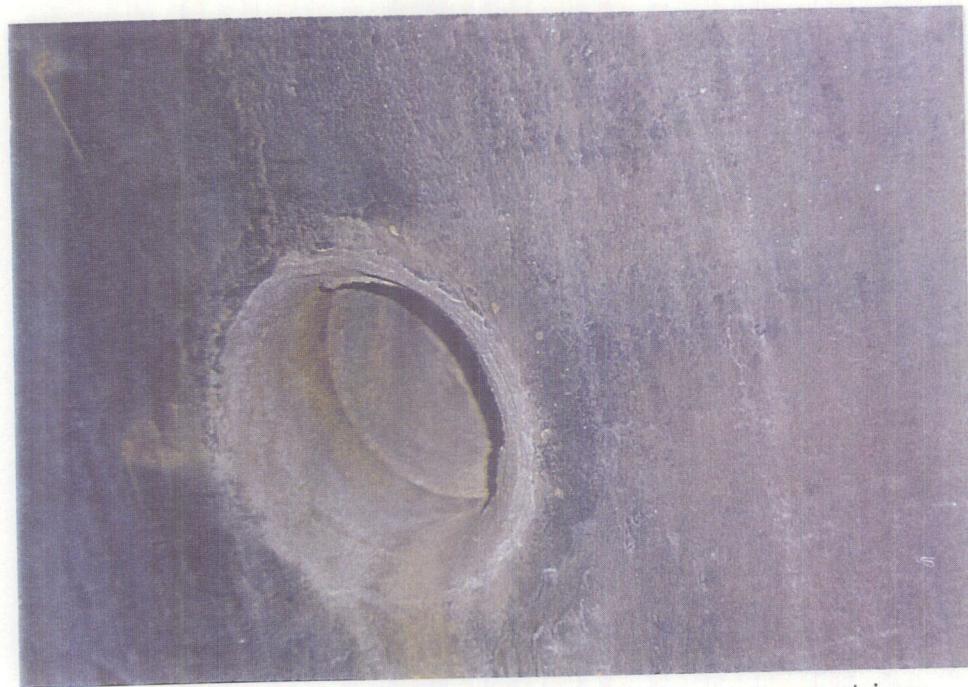
Photograph 12 - Exposed sections of outlet pipe No. 6.

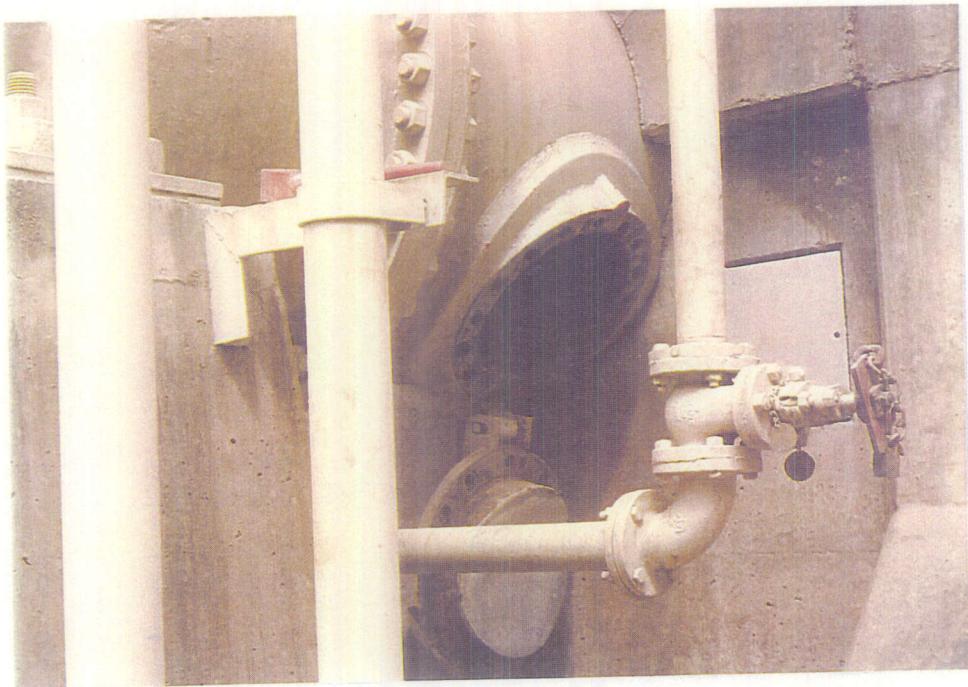
- B) 20-Inch Bypass Pipe Connection - A 20-inch bypass pipe connection is located on outlet pipe Nos. 3 and 4, just upstream of the 18-inch manhole connections. This connection allows the silt to be flushed out of the outlet pipes. The 20-inch pipe connections are in good condition (photograph 14).

Photograph 14 - 20-Inch bypass pipe connection located on outlet pipe No. 4.

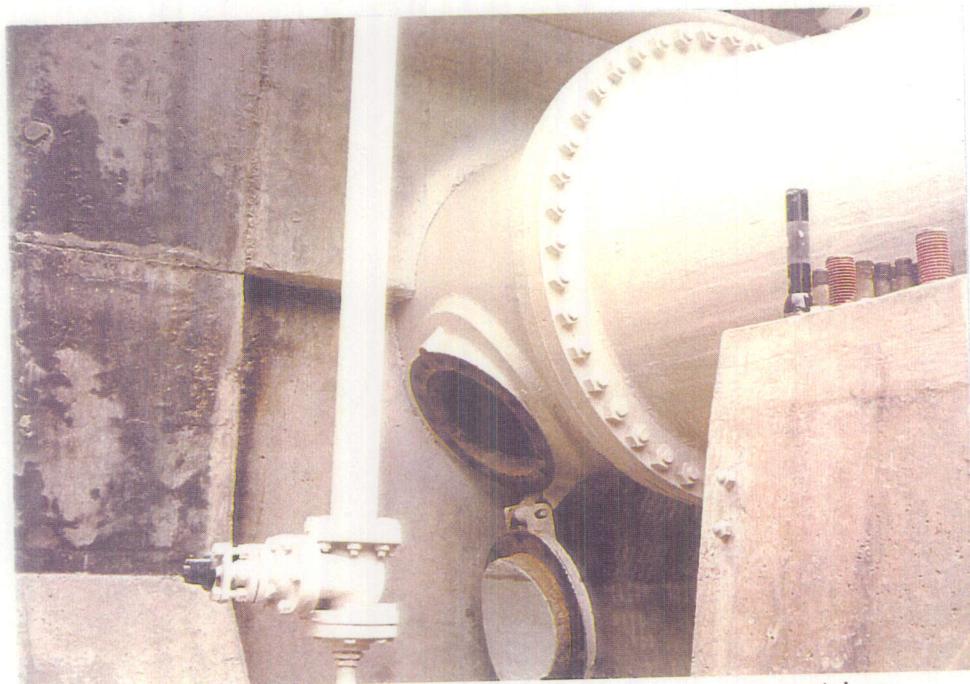
- C) 18-Inch Manhole Connections - An 18-inch-diameter manhole is provided on each outlet pipe for access to the outlet pipe interior (photographs 15 and 16). The manholes are located just upstream of the needle valve assemblies. The manhole connections are well coated with enamel paint and are in good condition.

Photograph 15 - 18-Inch manhole connection.
